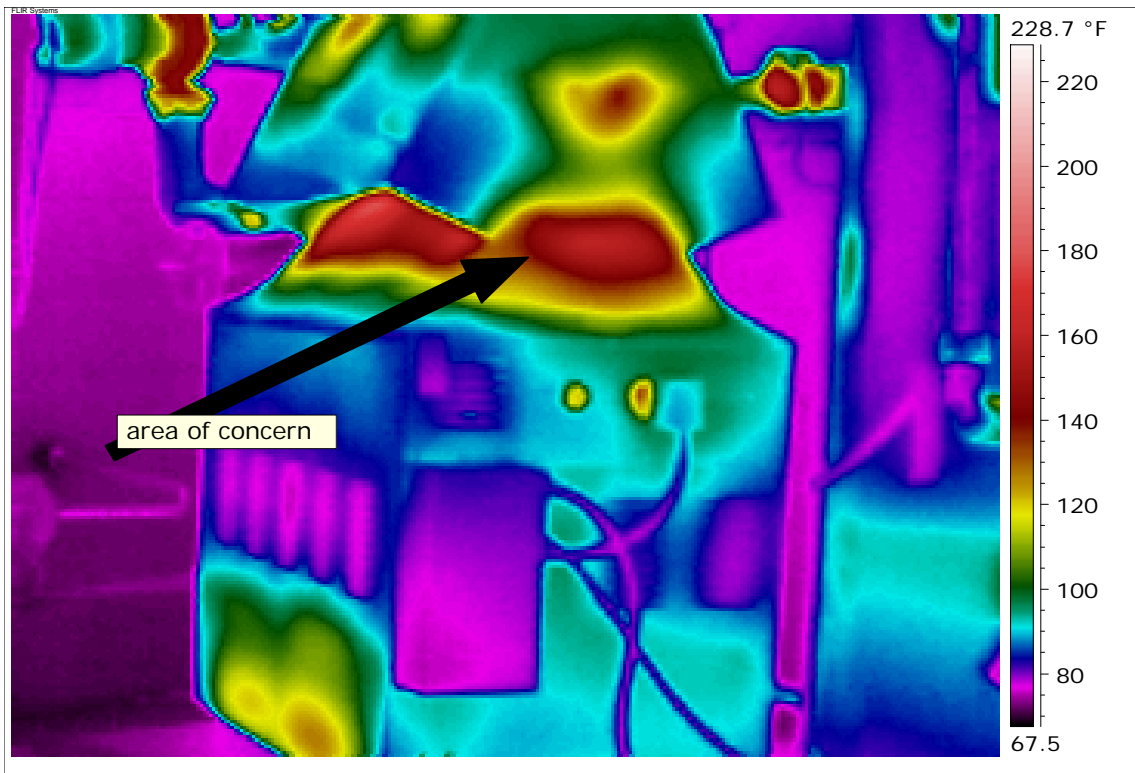
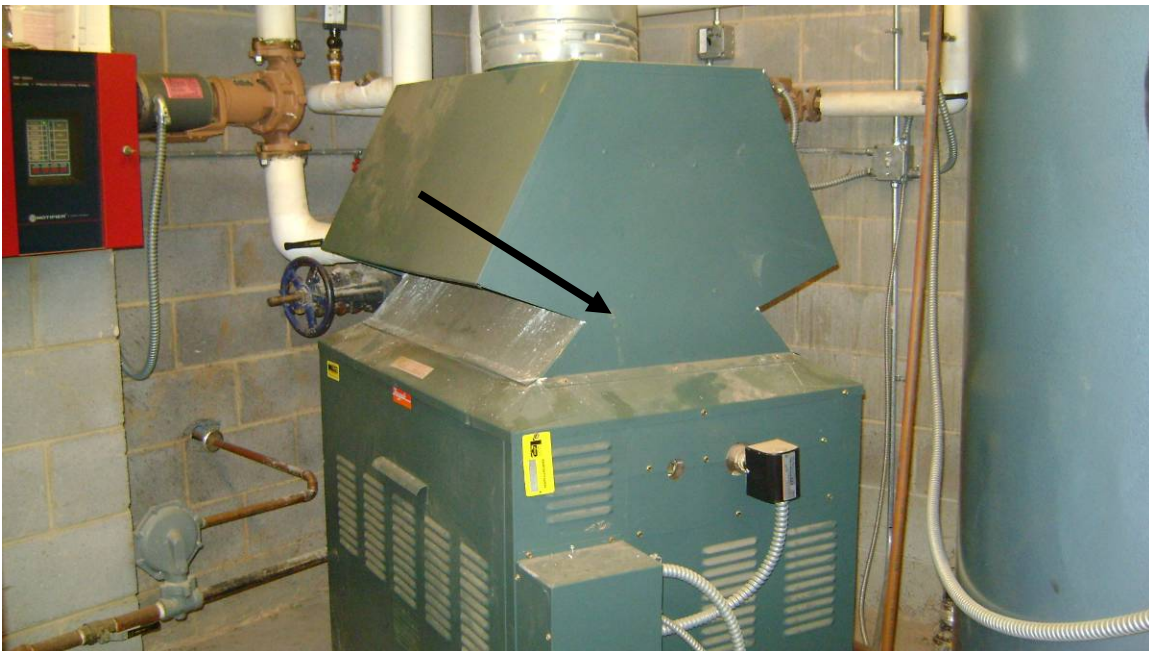
Description: area of concern boiler tech should investigate

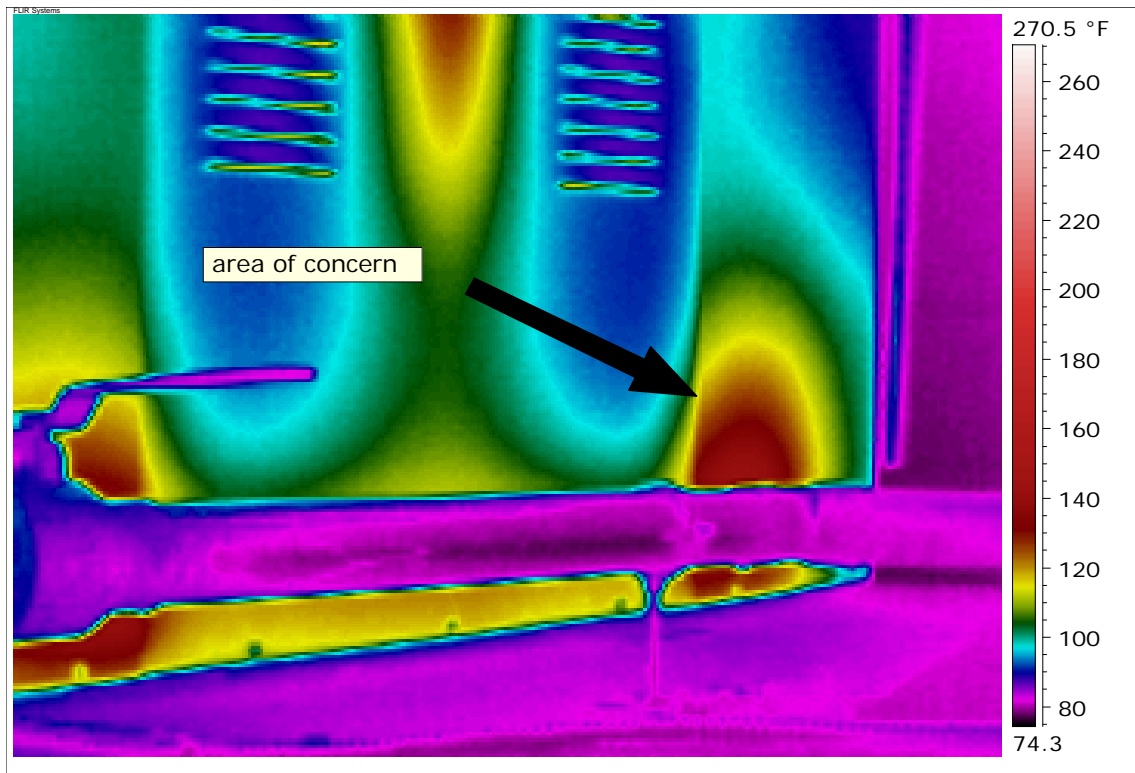
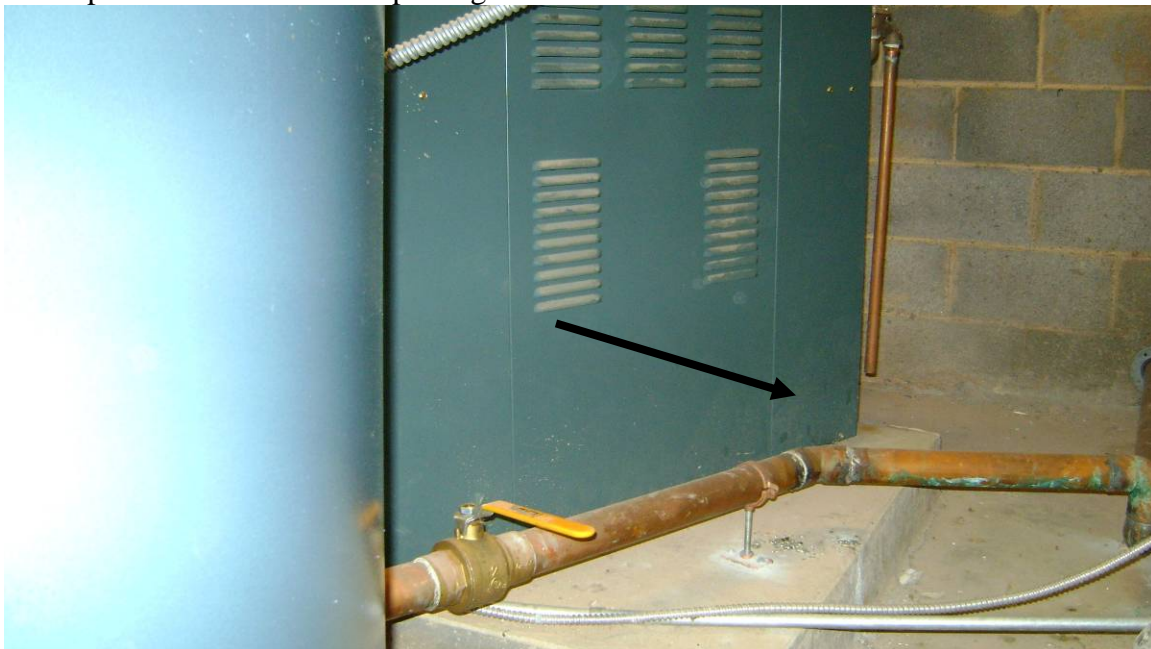
Description: Sub-Surface temp is higher .

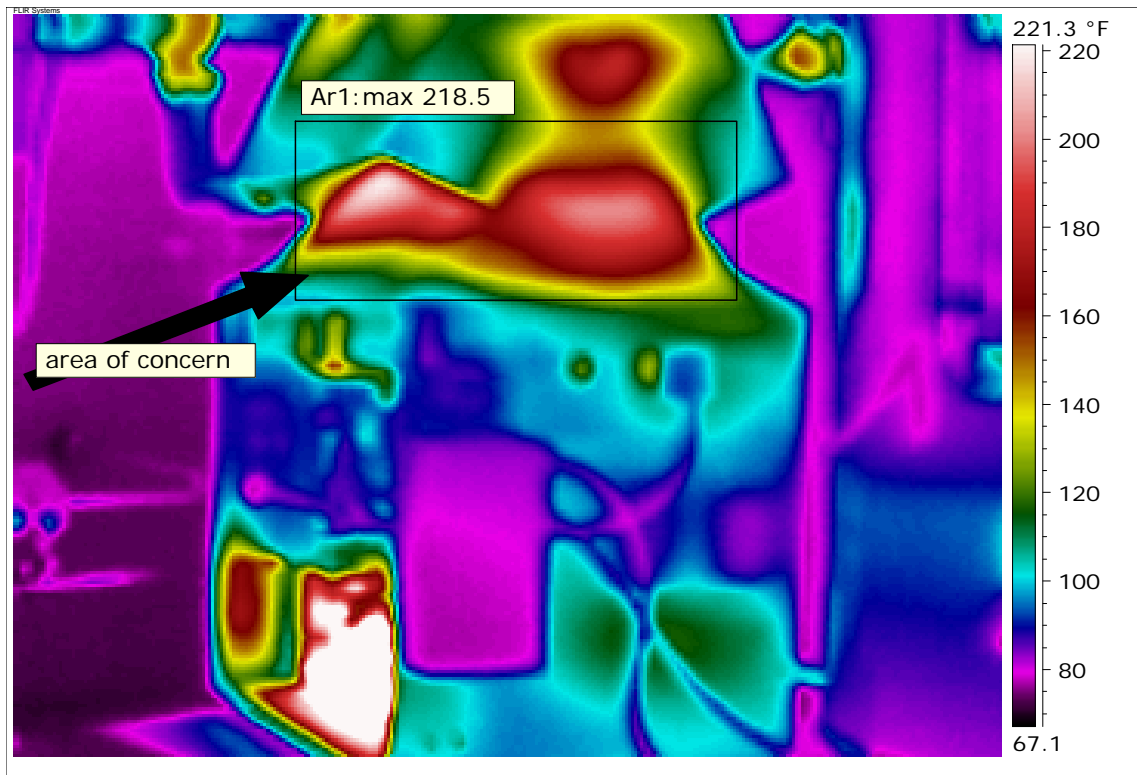
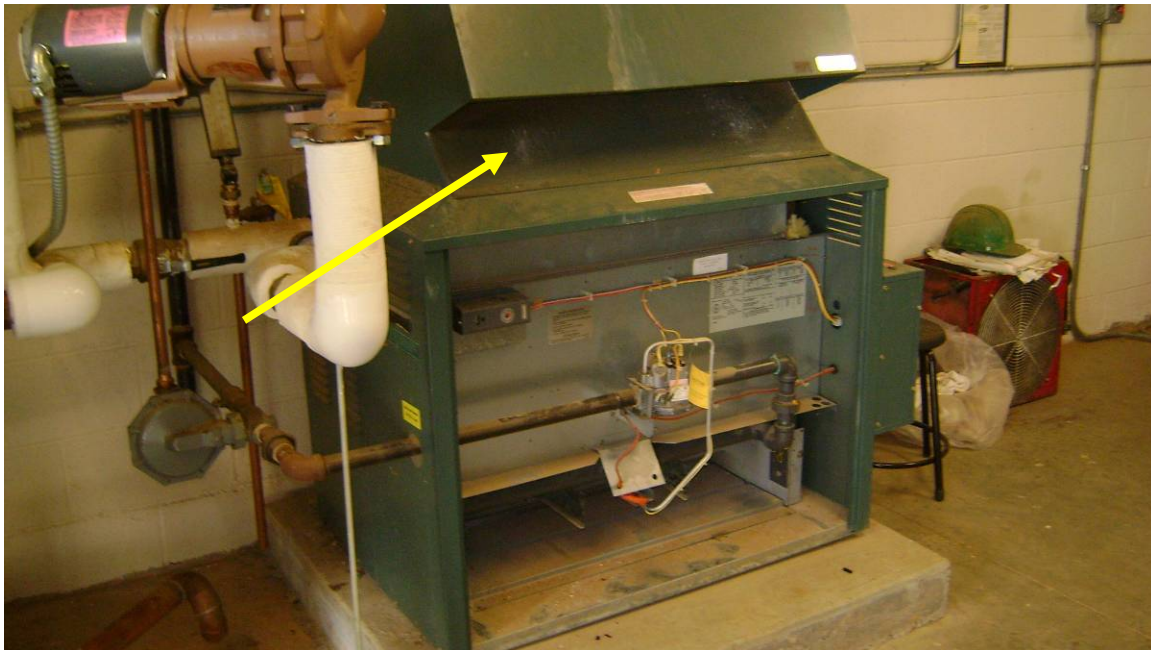
Description: Boiler tech should investigate further

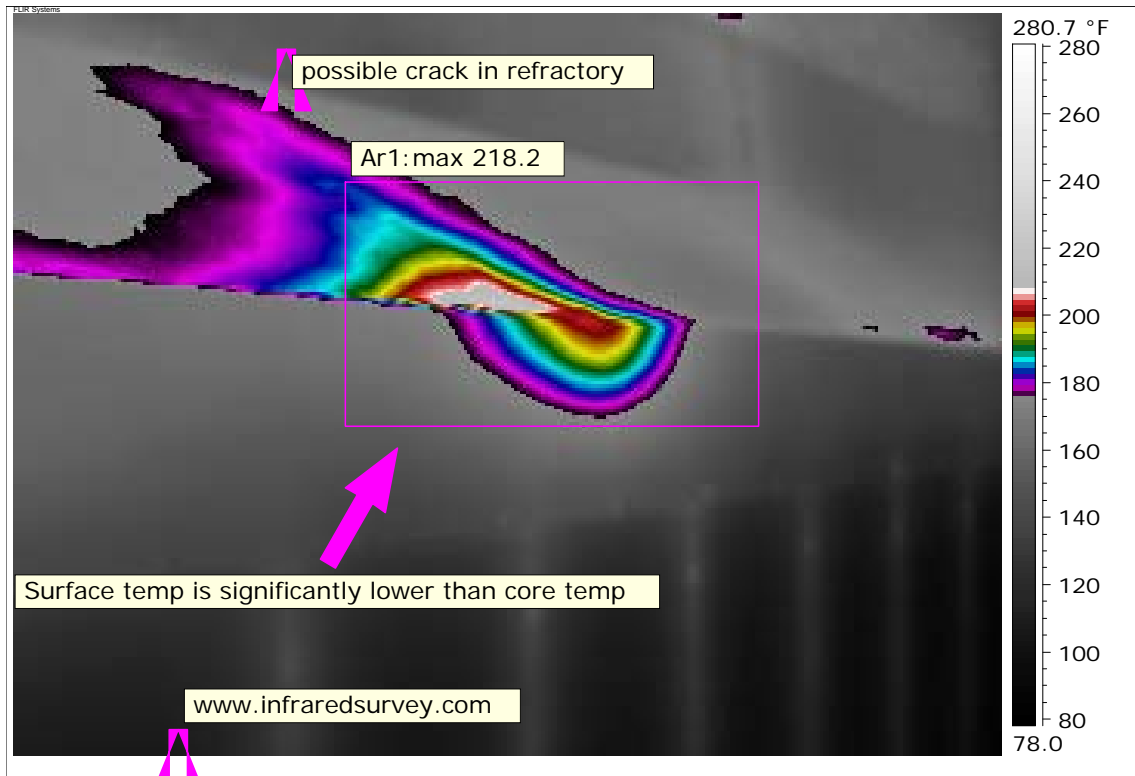
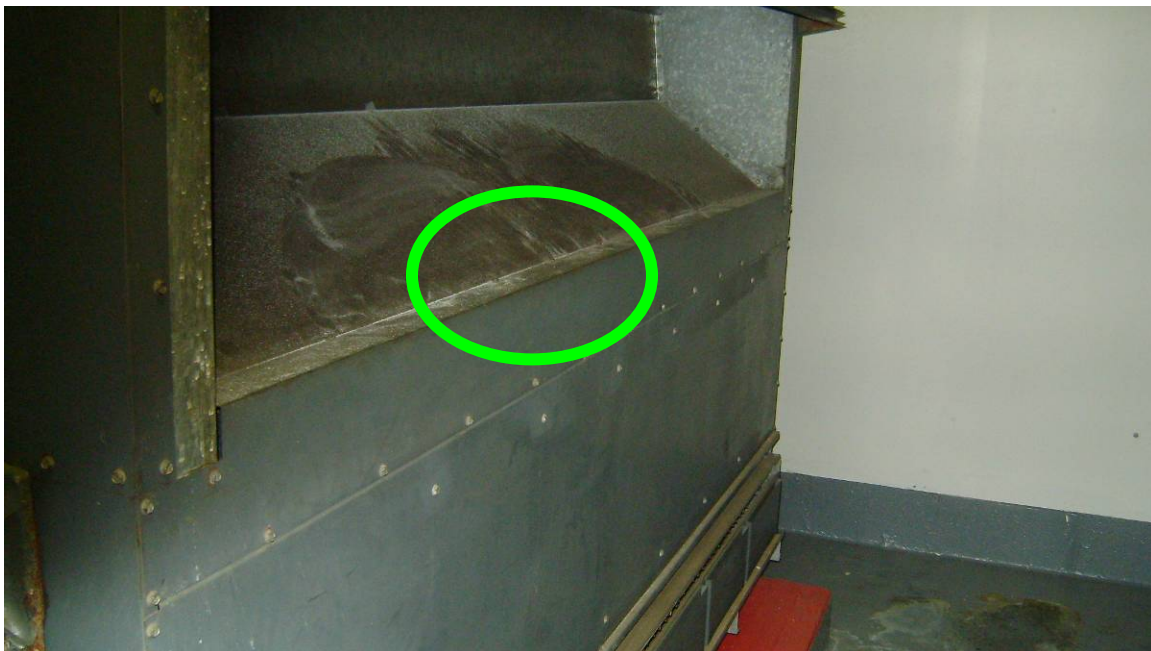
Description: Boiler 2 suspect cracked refractory all boilers should be cleaned and checked for cracks. Combustion is also rolling out of draft hood.
