Infrared Thermographic Report  
For

Report done by  
John Cannamela  
Level II Thermographer  
Sample Report

Infrared Energy Survey OAT-69 F 62%RH Clear  
Average indoor temp 74F 59%RH

## Summary Sample Customer

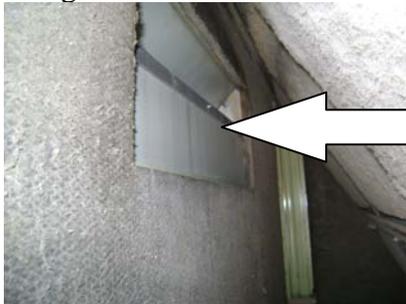
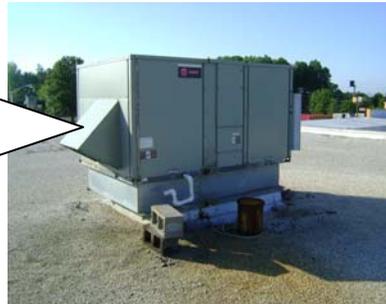
This is your unit it has fixed damper. An economizer is motorized and operated according to outdoor air temp compared to indoor temp. This is part of the 42% savings you can enjoy if installed.

Both units should have economizers installed; greatly reducing power consumption in low temp conditions when cooling in the space is needed.

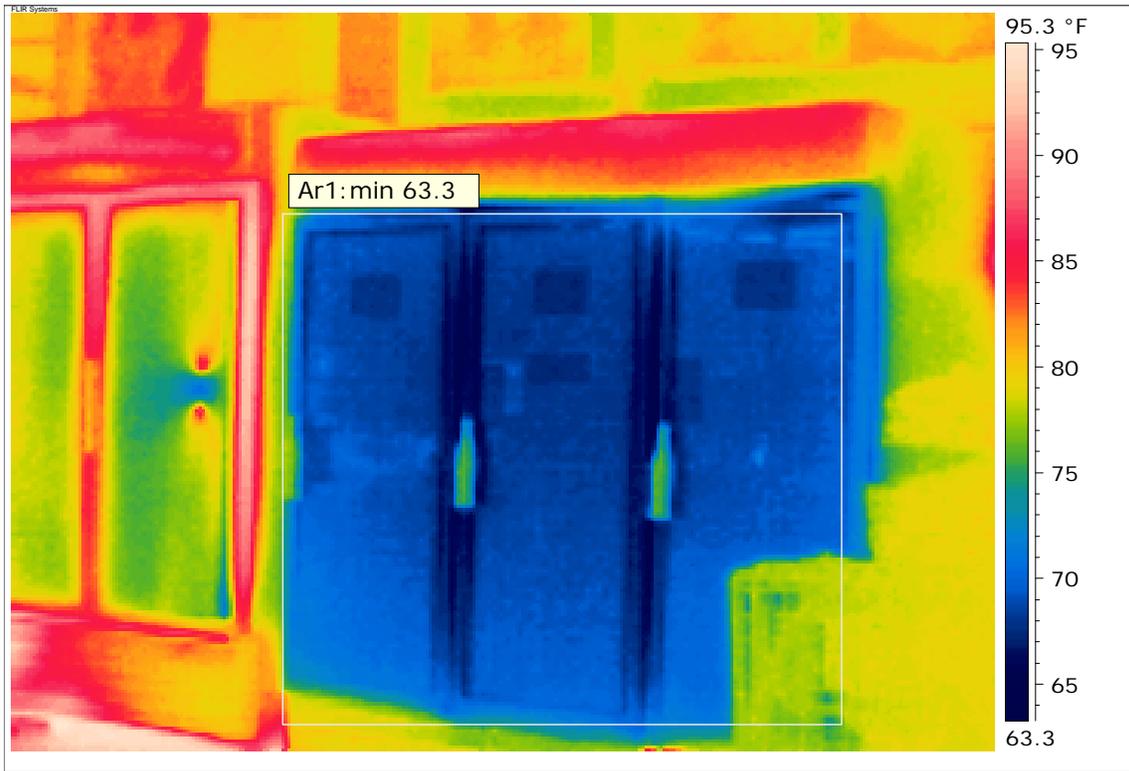
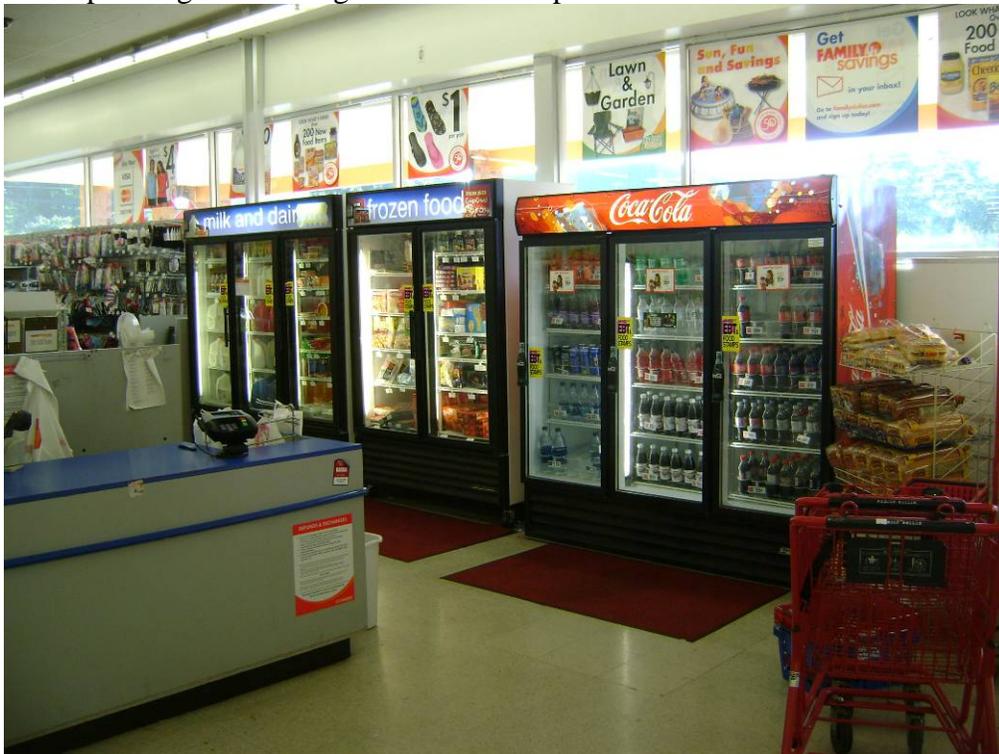
3- 1.5 horsepower coolers show some gasket leakage as shown in thermogram and visual images.

Description: gasket leakage –unit is 12 amps 1.5 HP

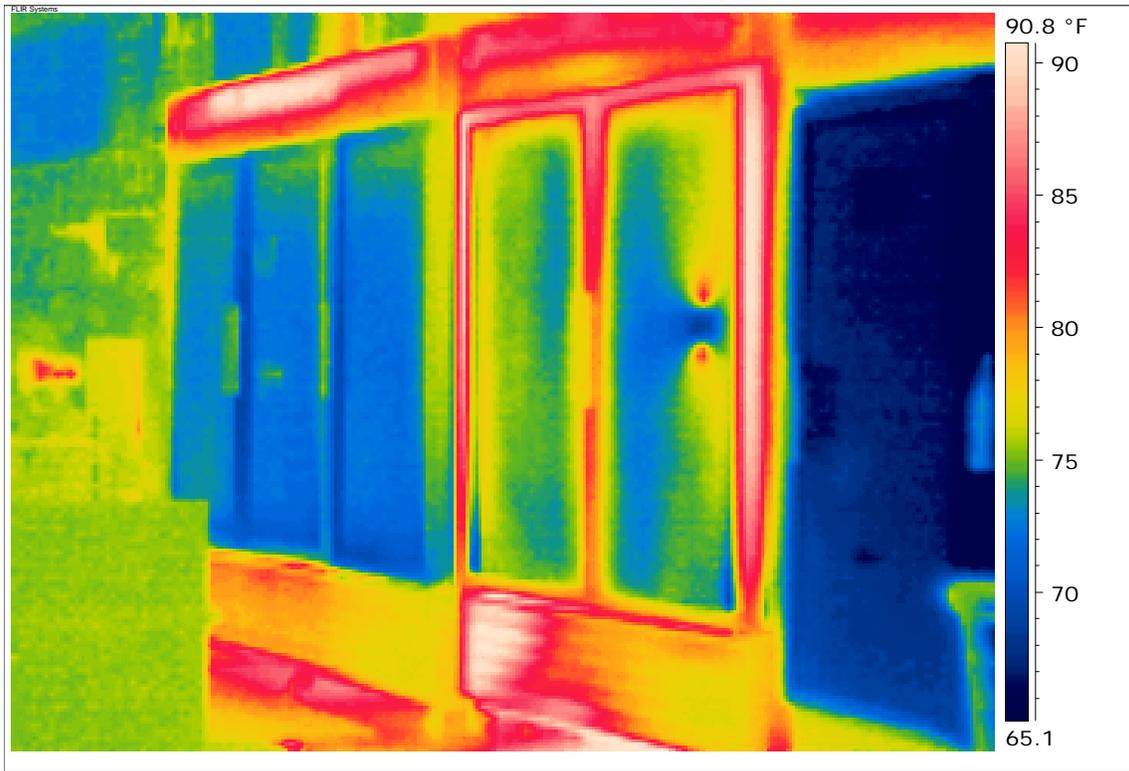
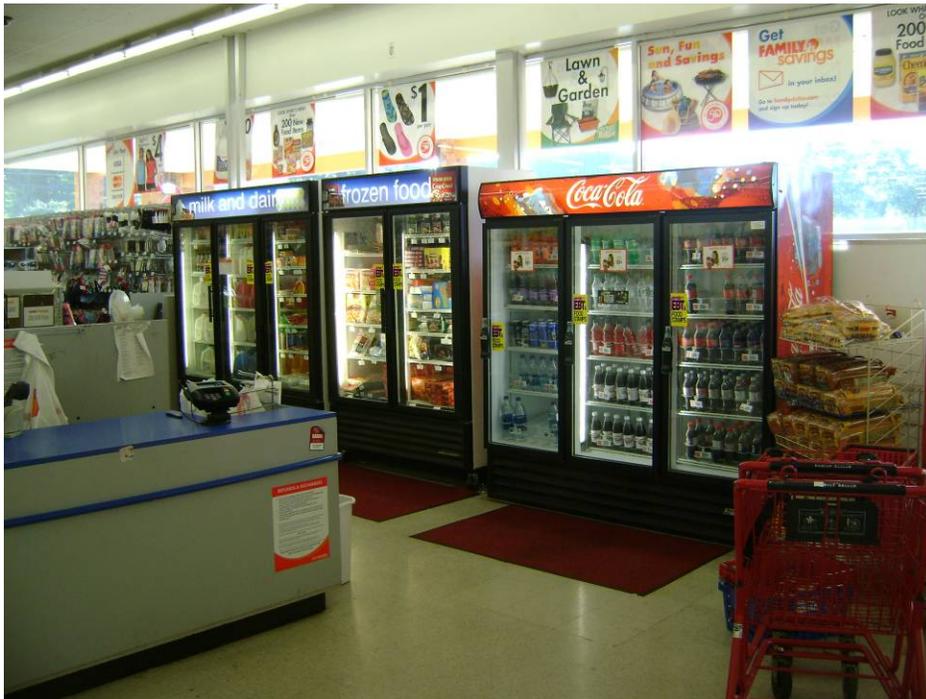
Description: Cold is blue some loss at the doors

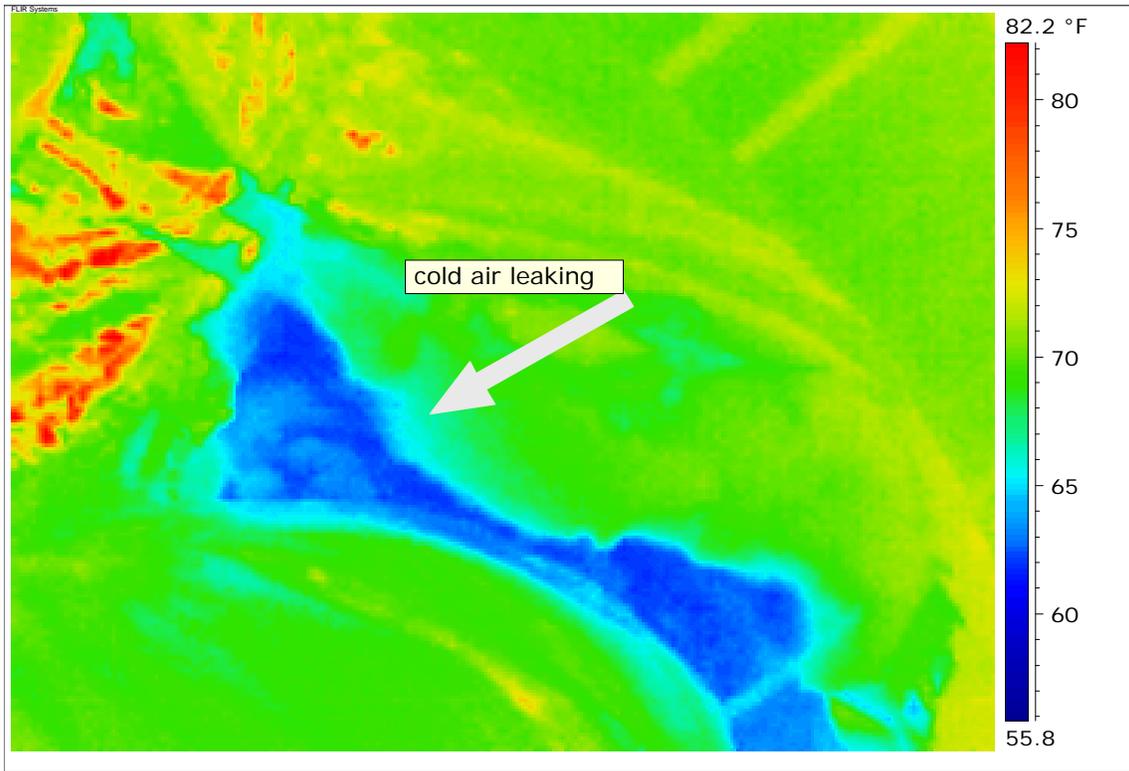
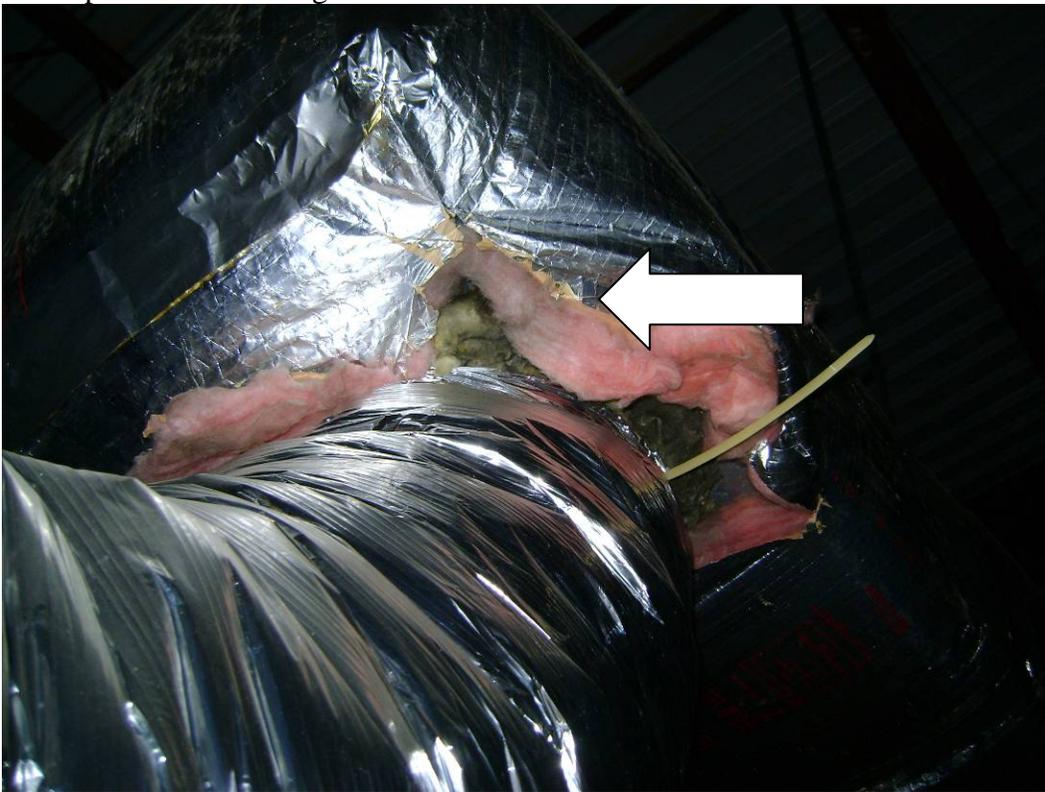
Description: Duct leakage- in blue

Duct leakage was noted with thermal and visual images. Sealing duct will increase system efficiency and reduce wasted energy.

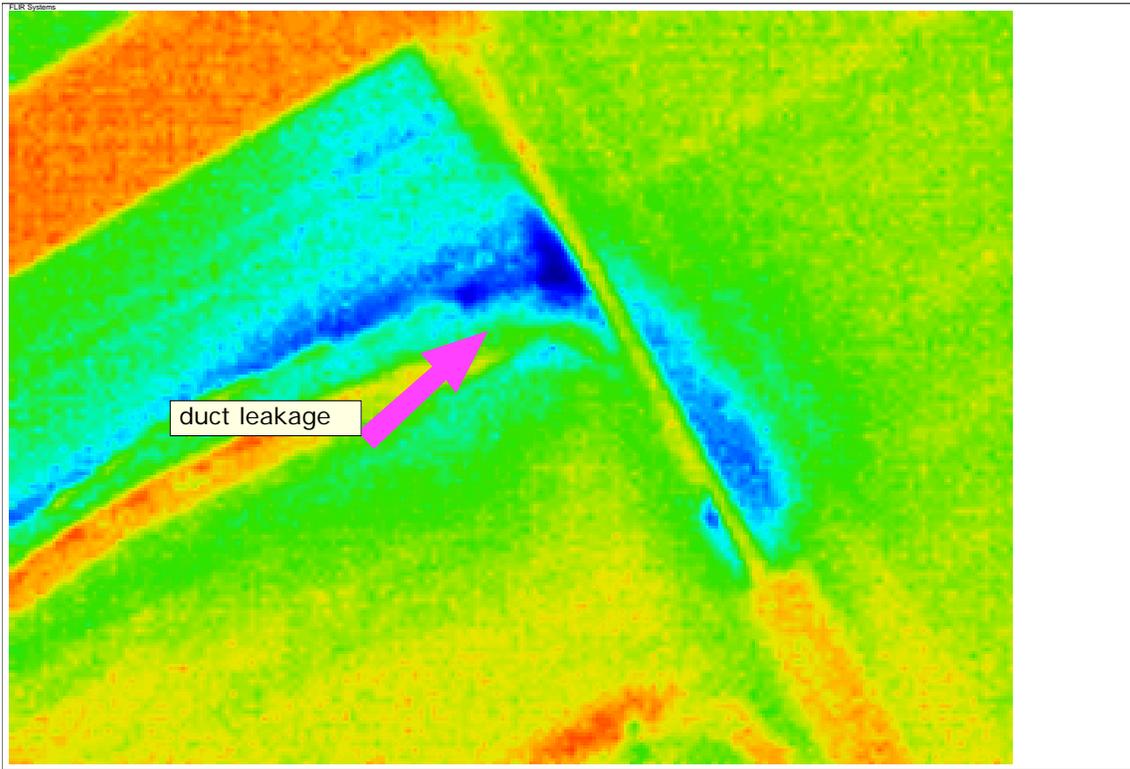
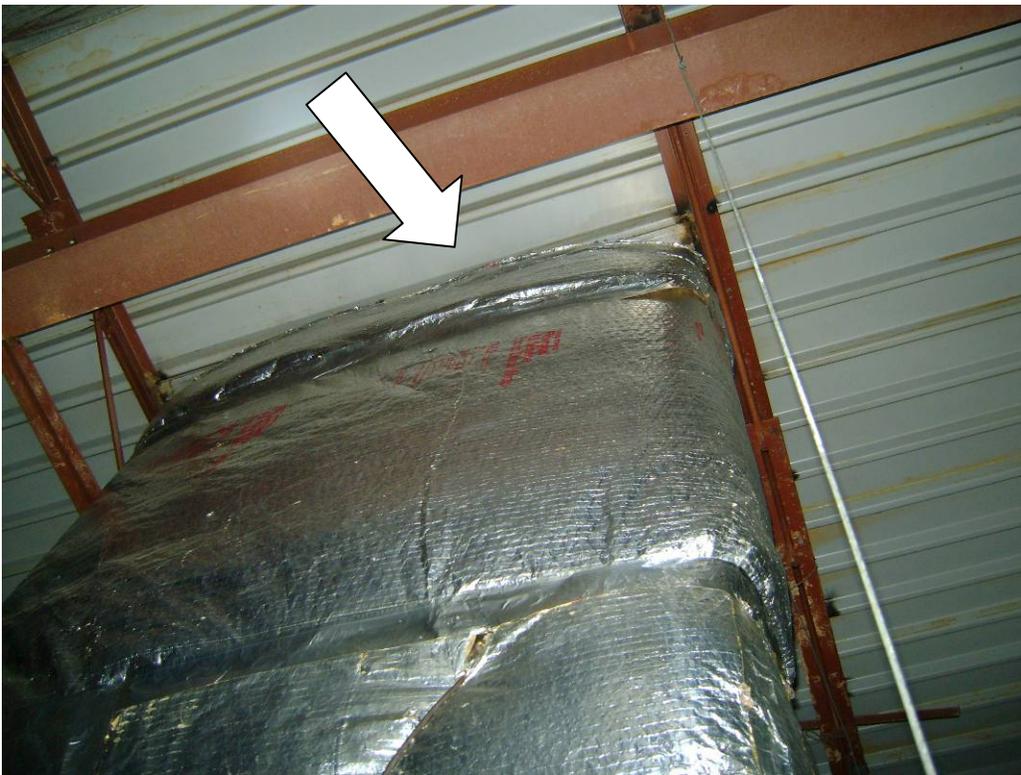
Description: Duct leakage in blue

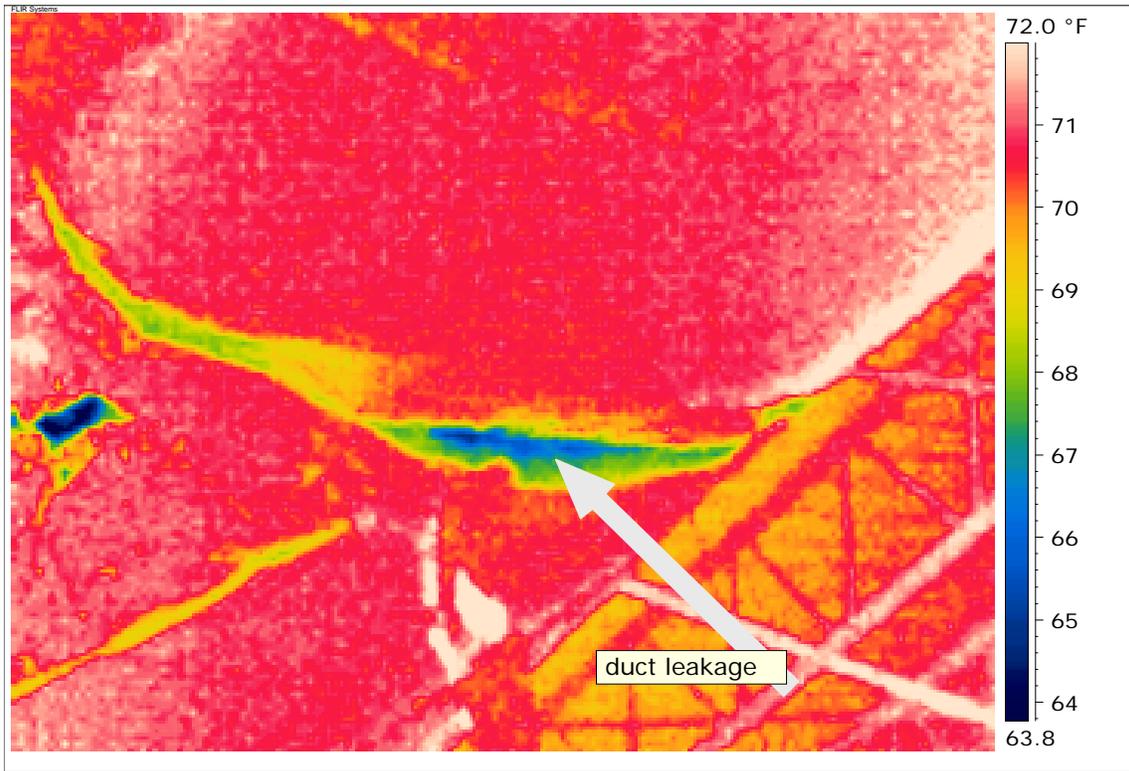
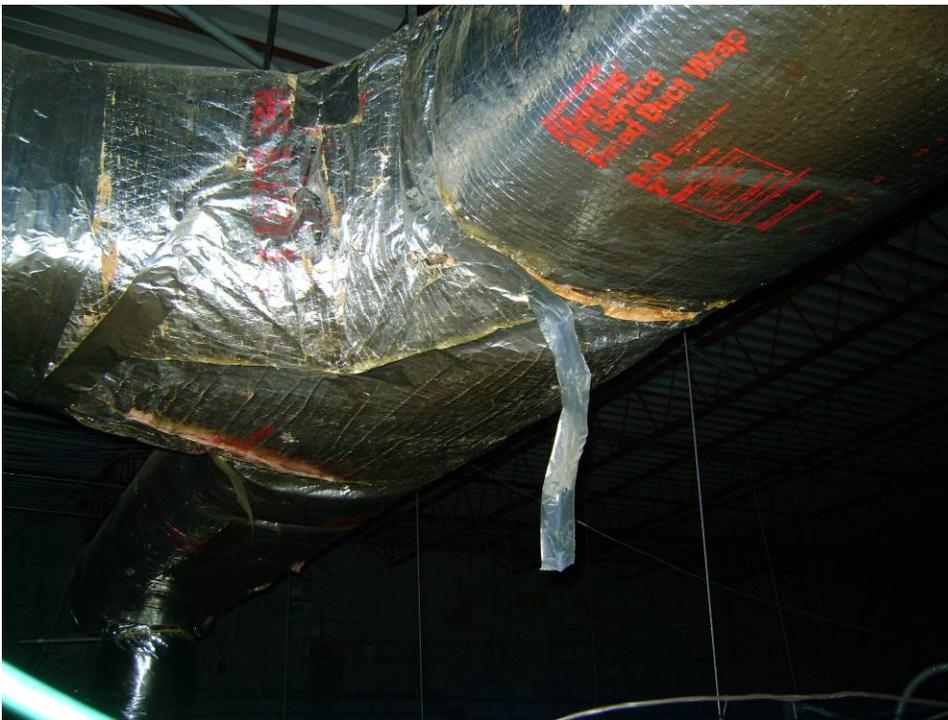
Description: duct leakage in blue

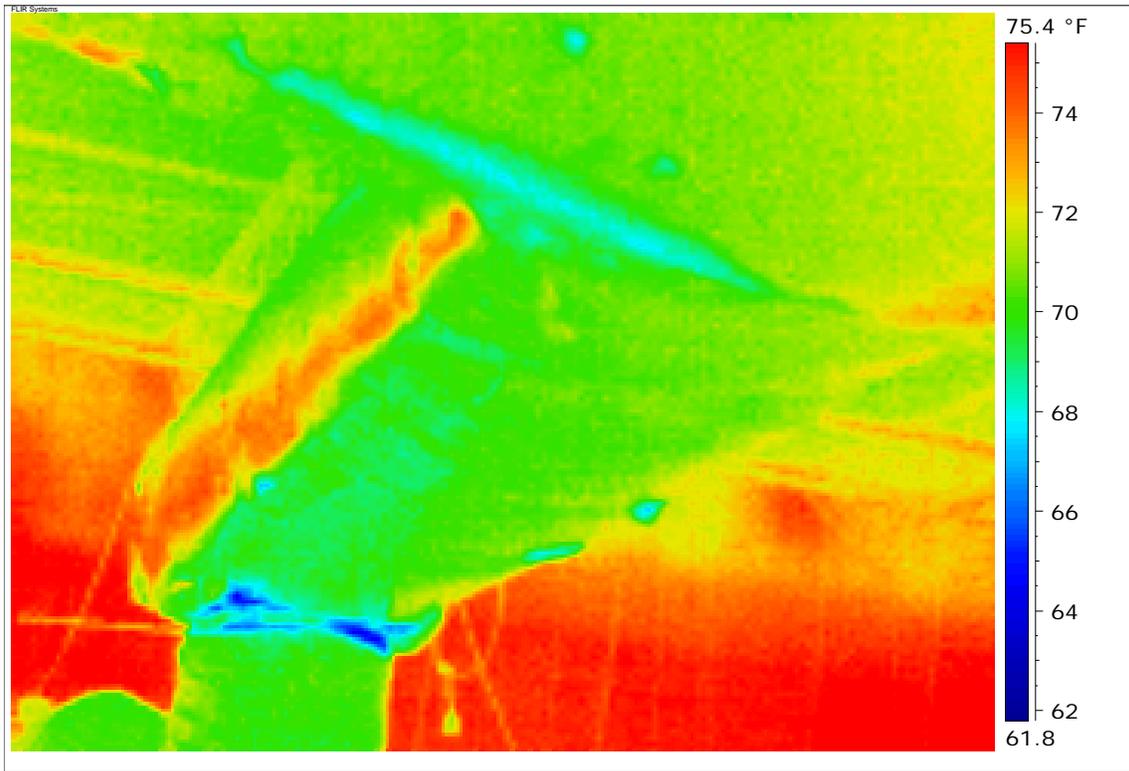
Description: duct leakage in blue

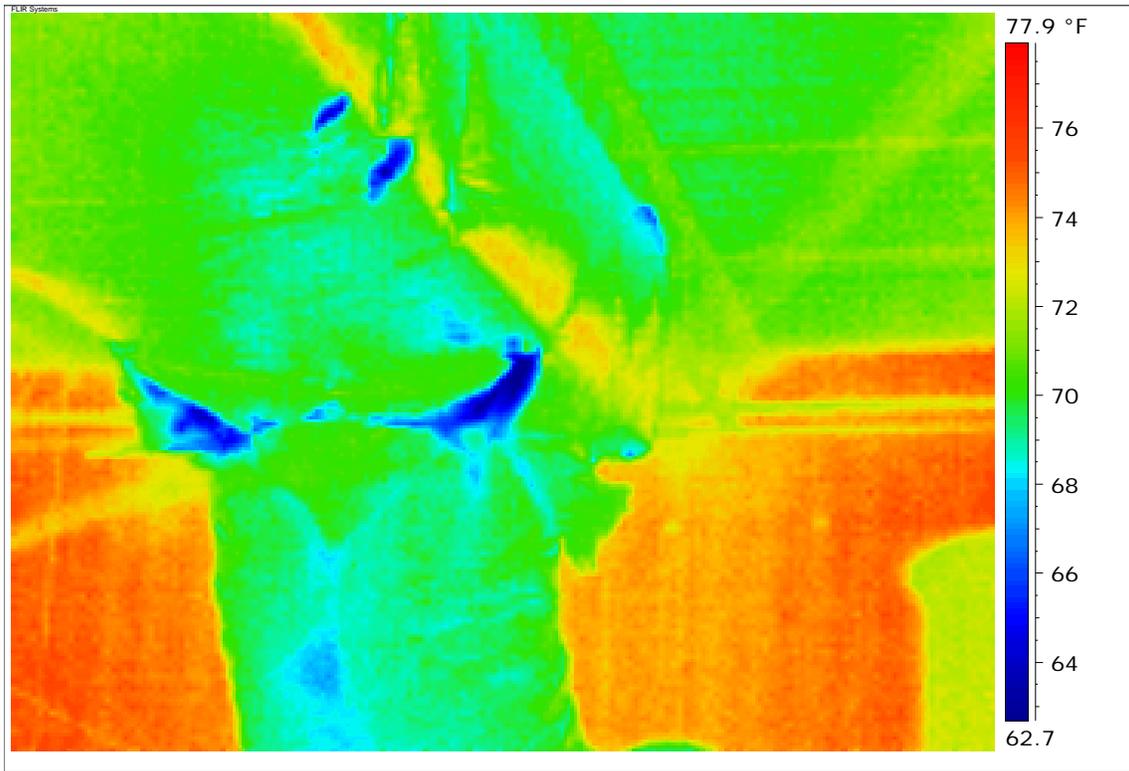
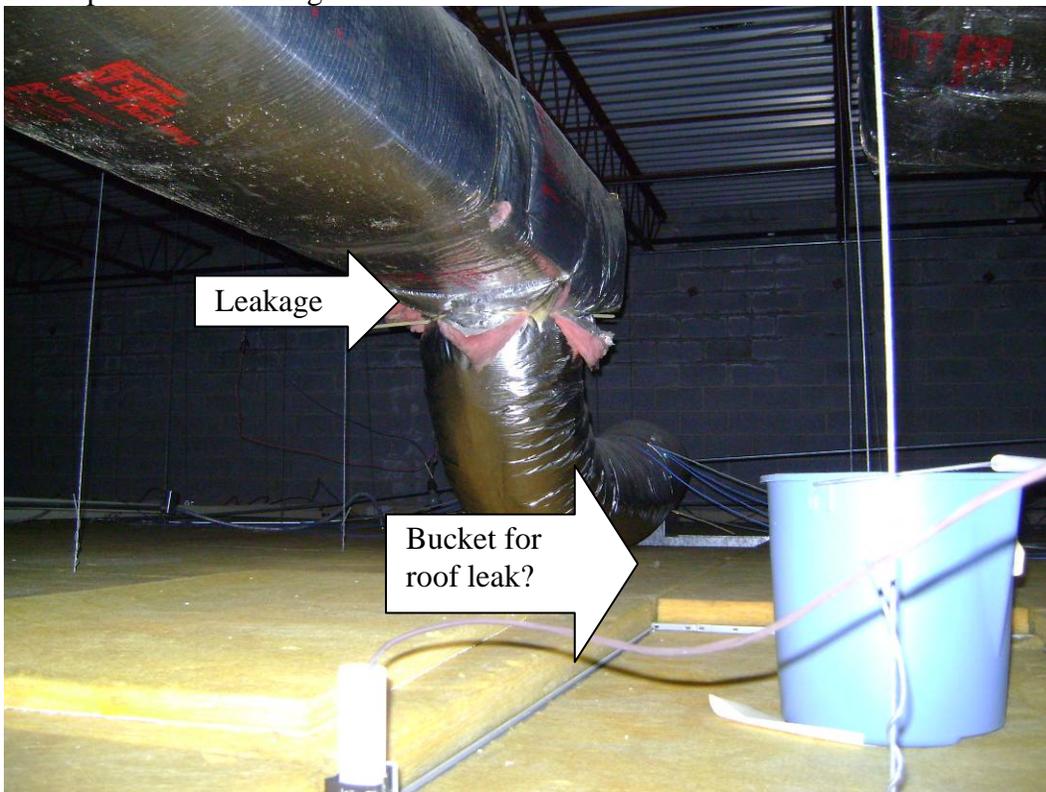
Description: duct leakage in blue

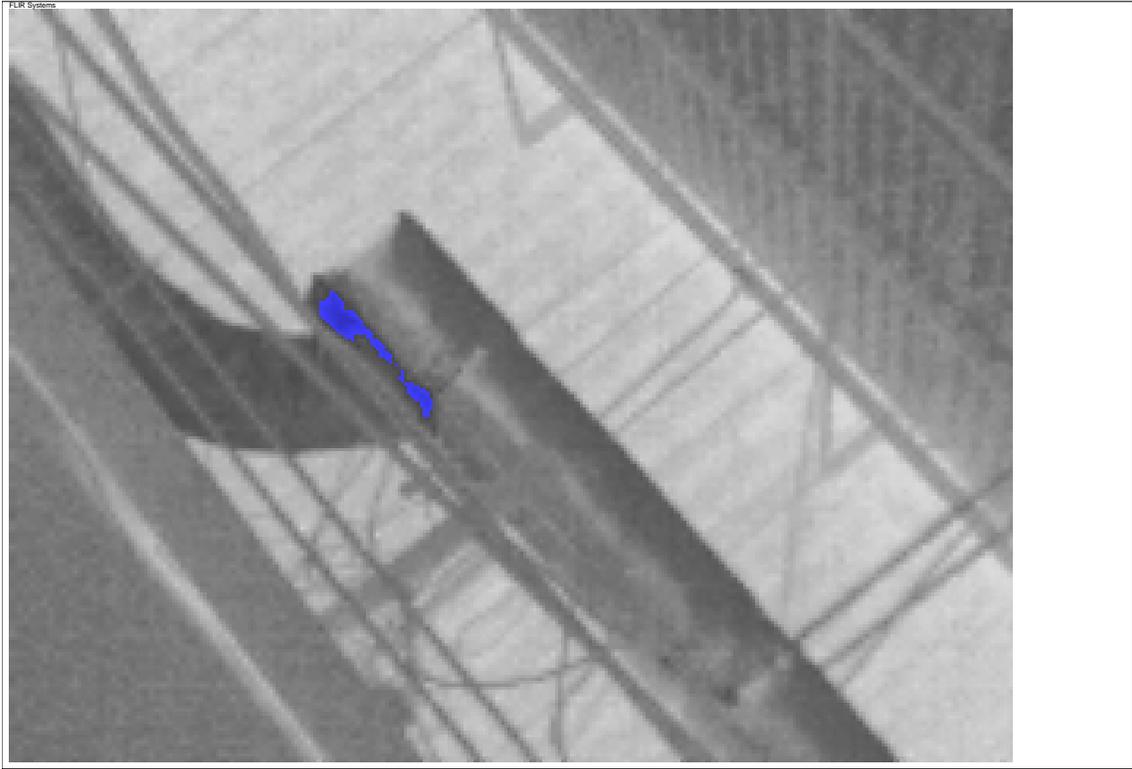
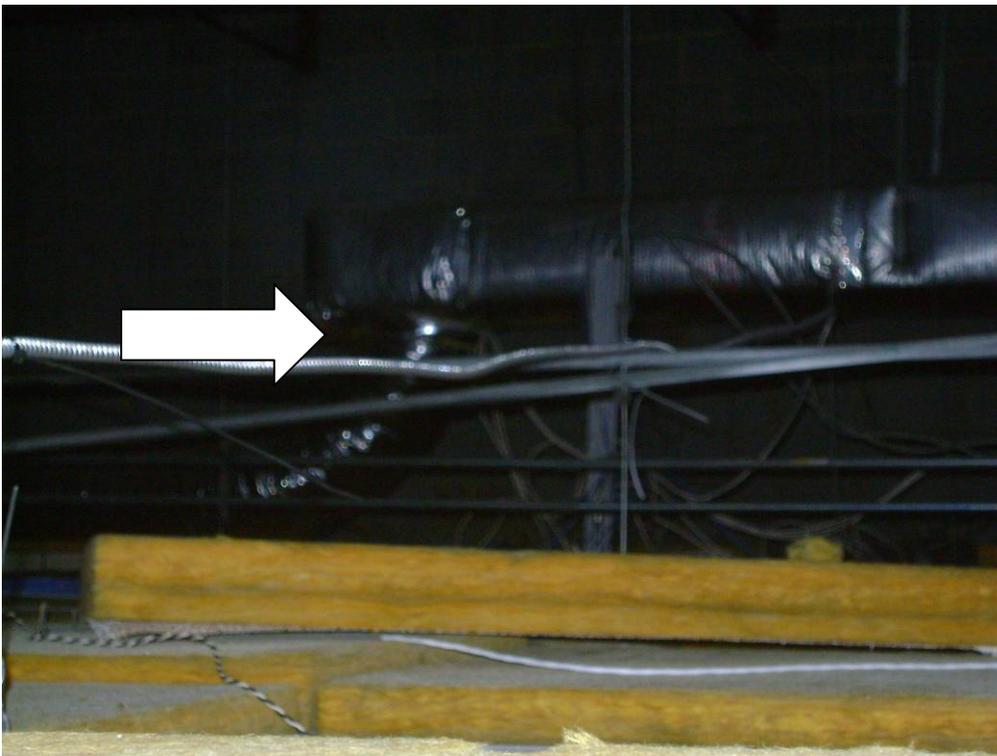
Description: duct leakage

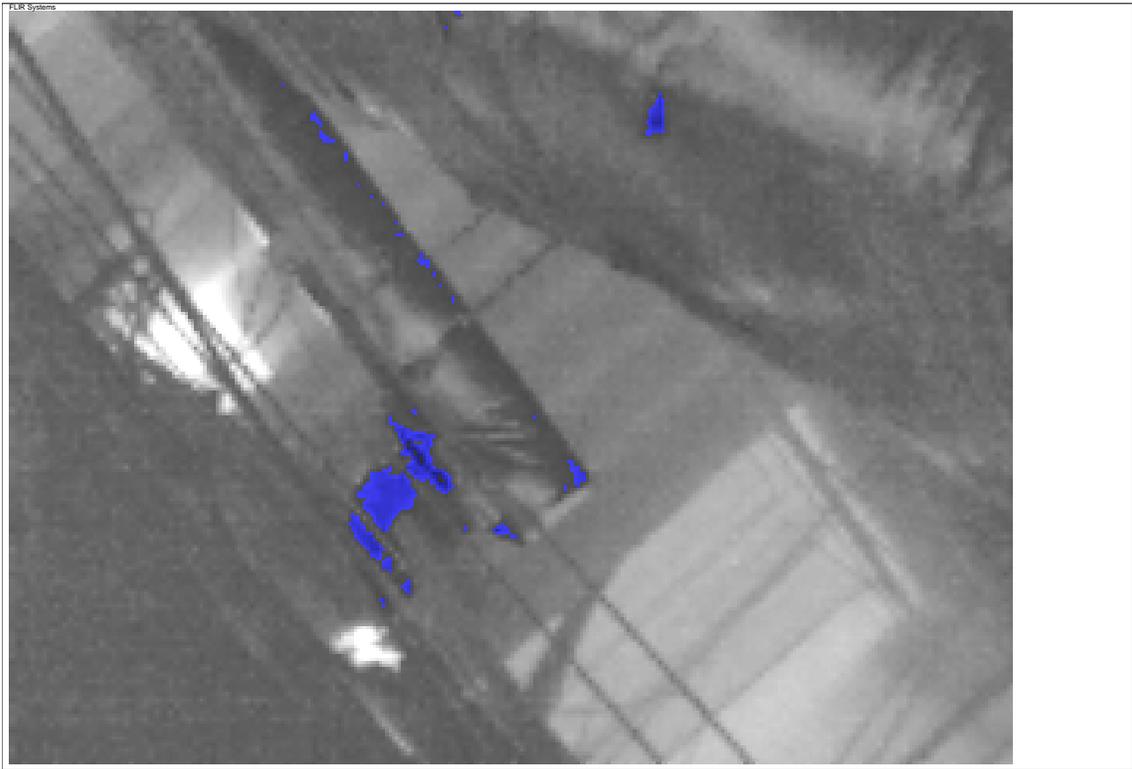
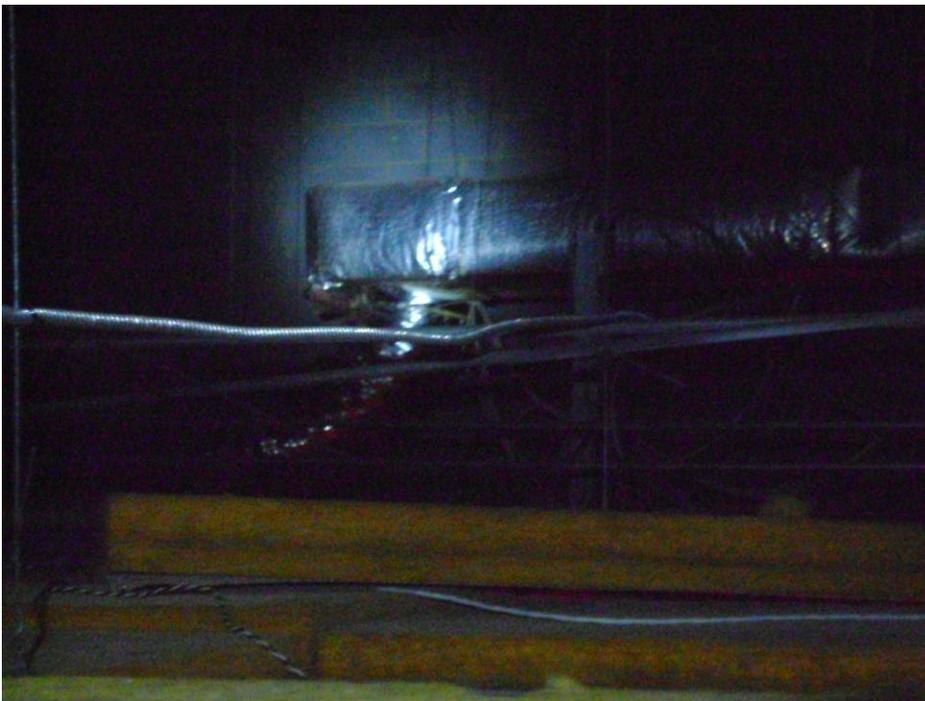
Description: Duct leakage in blue

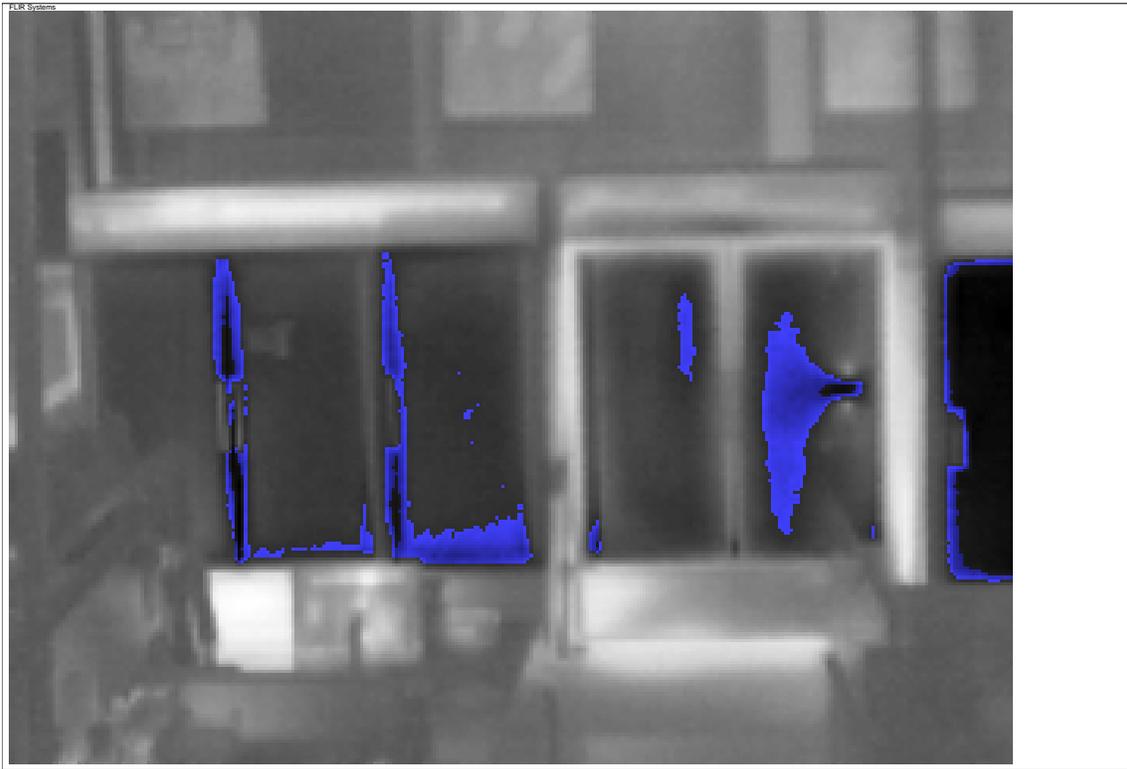
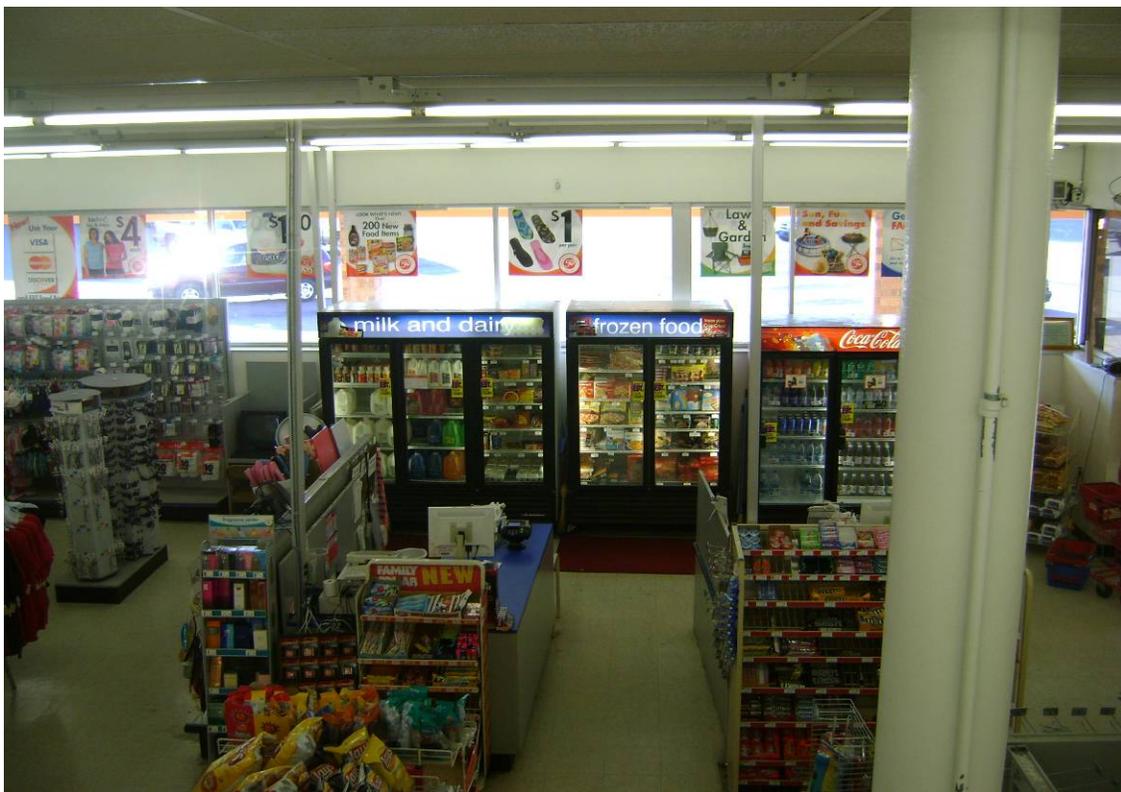
Description: cooler with door leakage

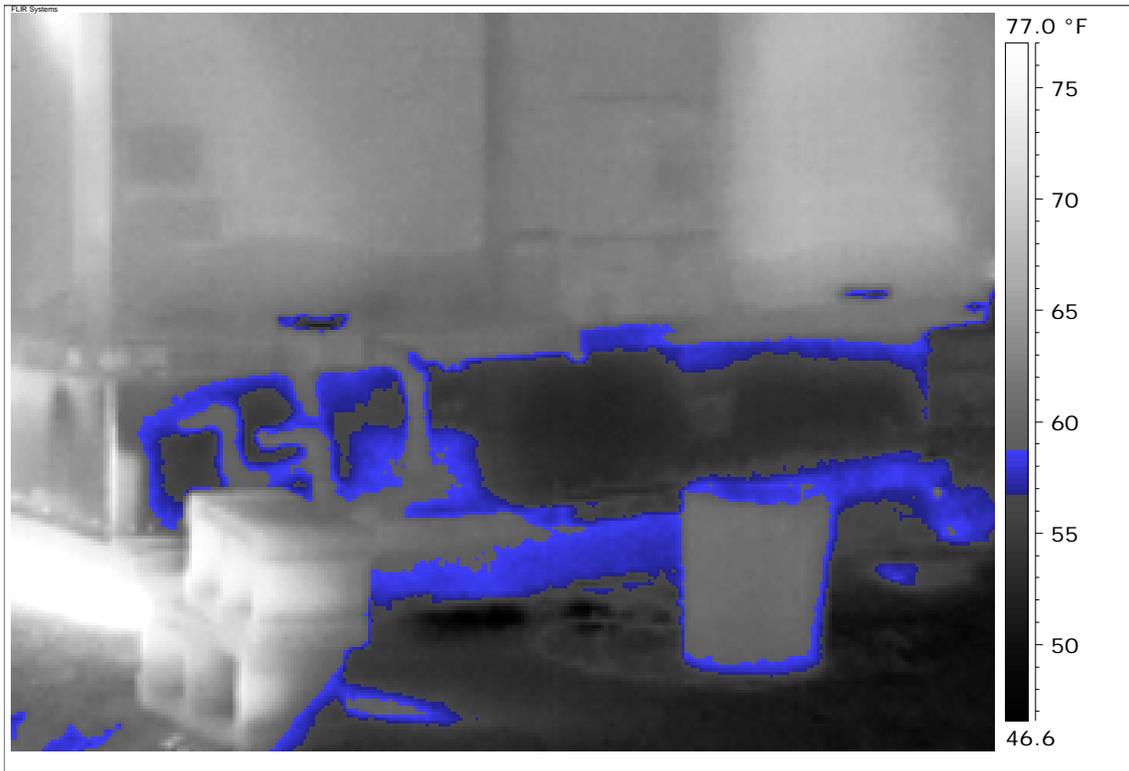
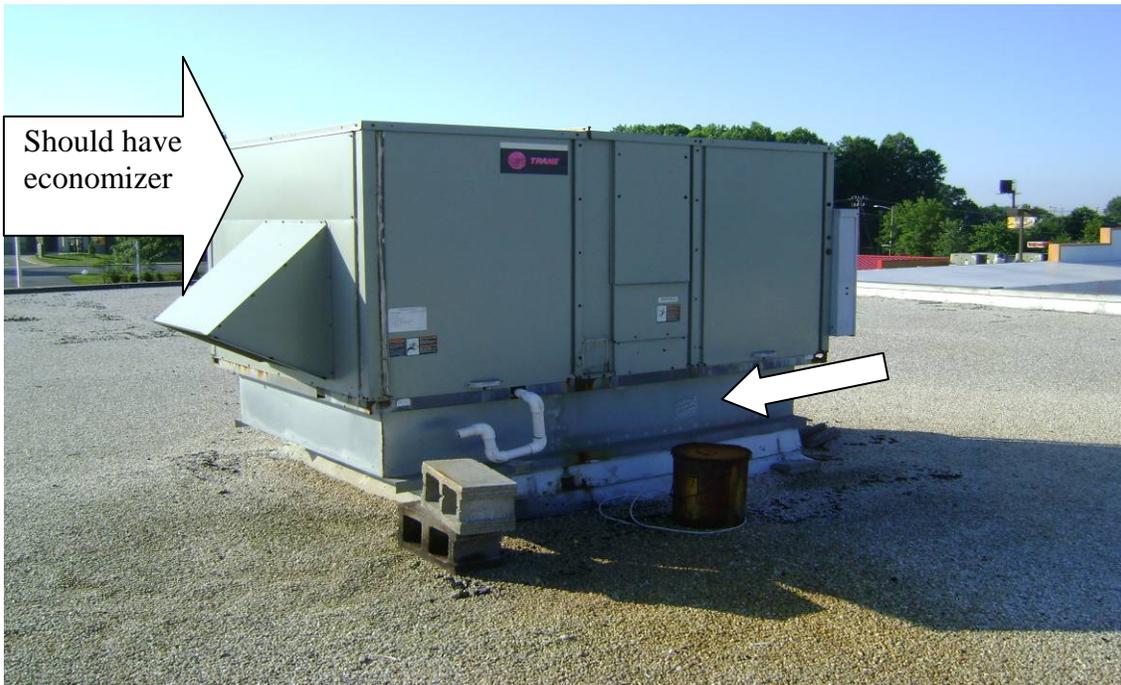
Description: RTU needs more insulation roof curb has air leakage in blue  
Also RTU should have economizer for free cooling in mild weather. The hood on the unit  
is only minimum air.

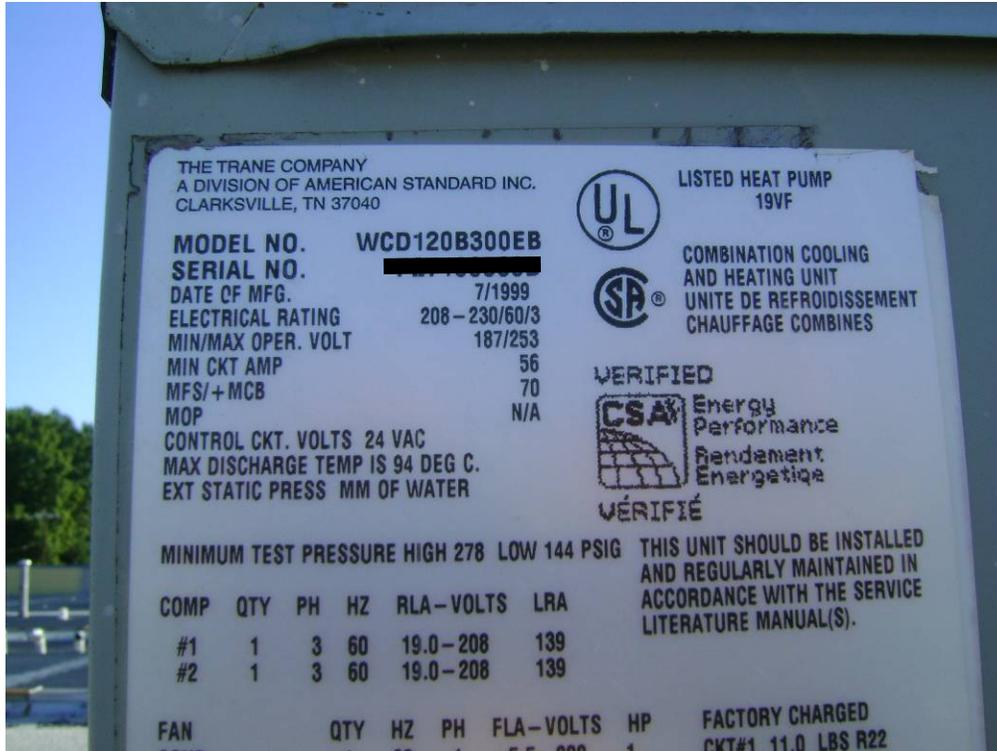
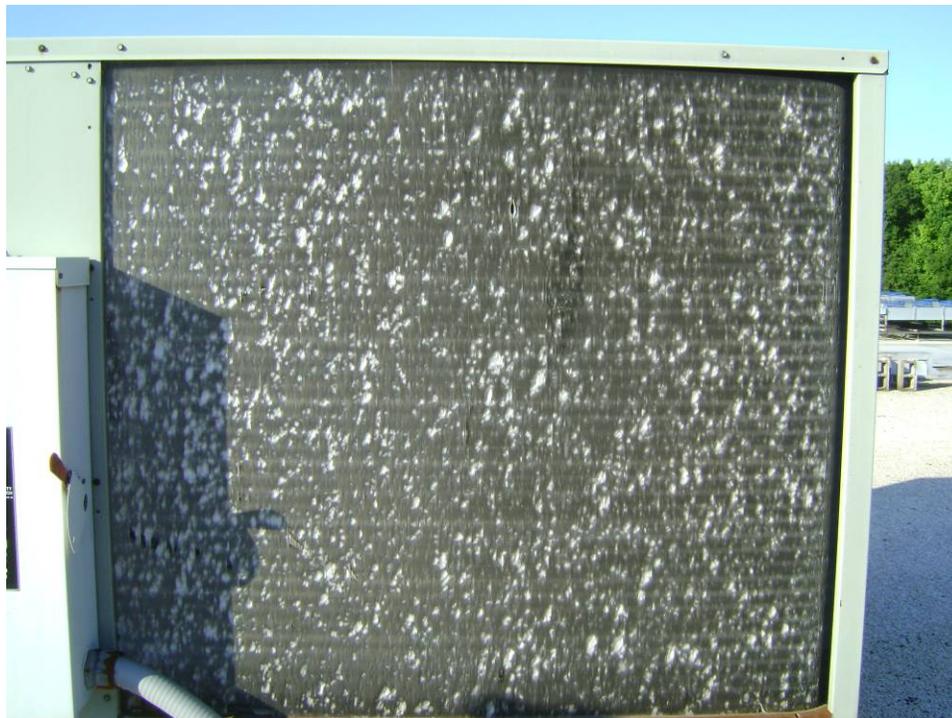
Hail damage ,unit should have hail guard .Unit power consumption is higher due to higher running pressures and poor heat transfer. Possibly one of the reasons the unit is non-operational.

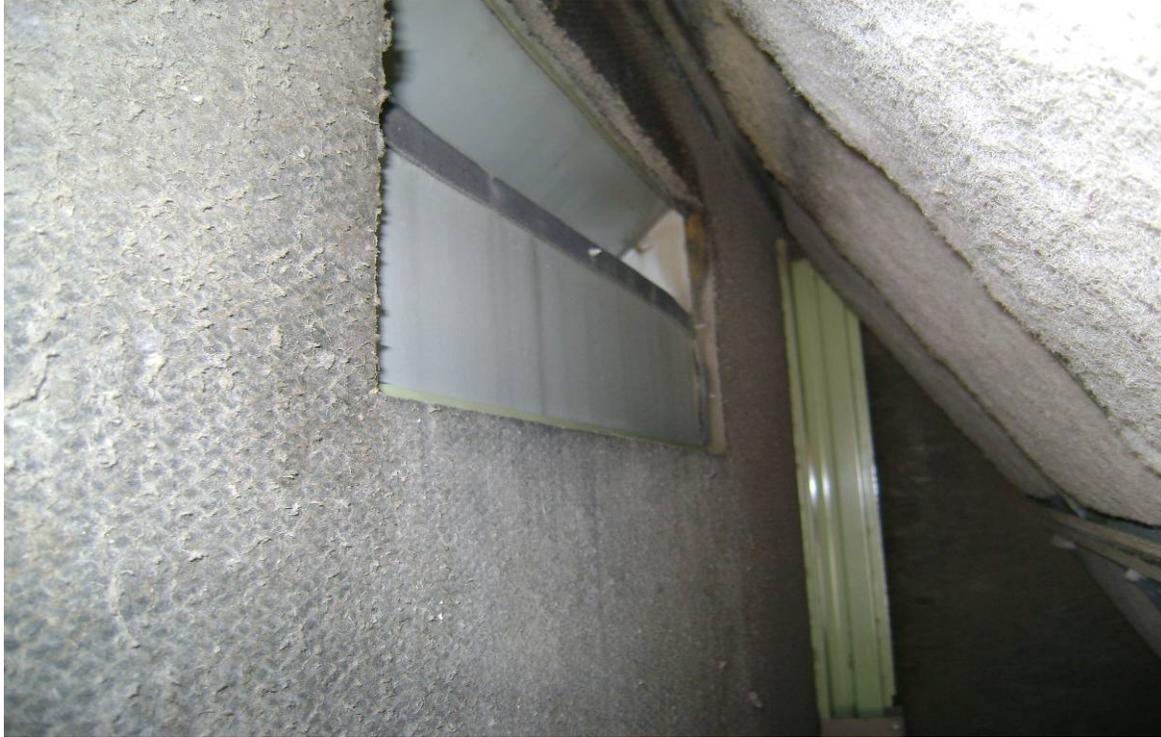
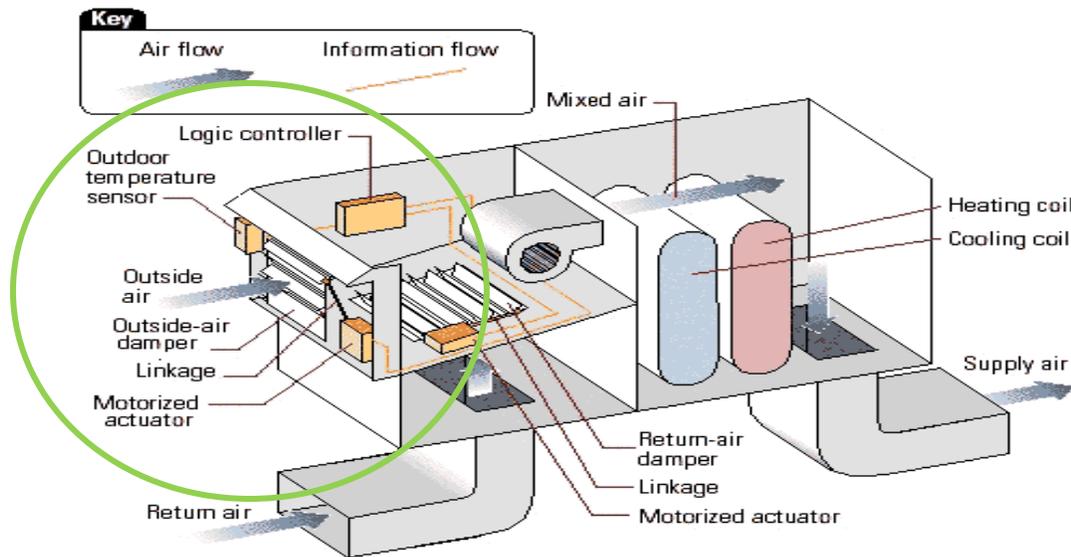
This is minimum outside air fixed damper. If this were an economizer it would allow free cooling in the cooler time of year. This missing feature can save thousands of watts and dollars per year. The economizer would also allow the store controls to purge out the store with fresh air.

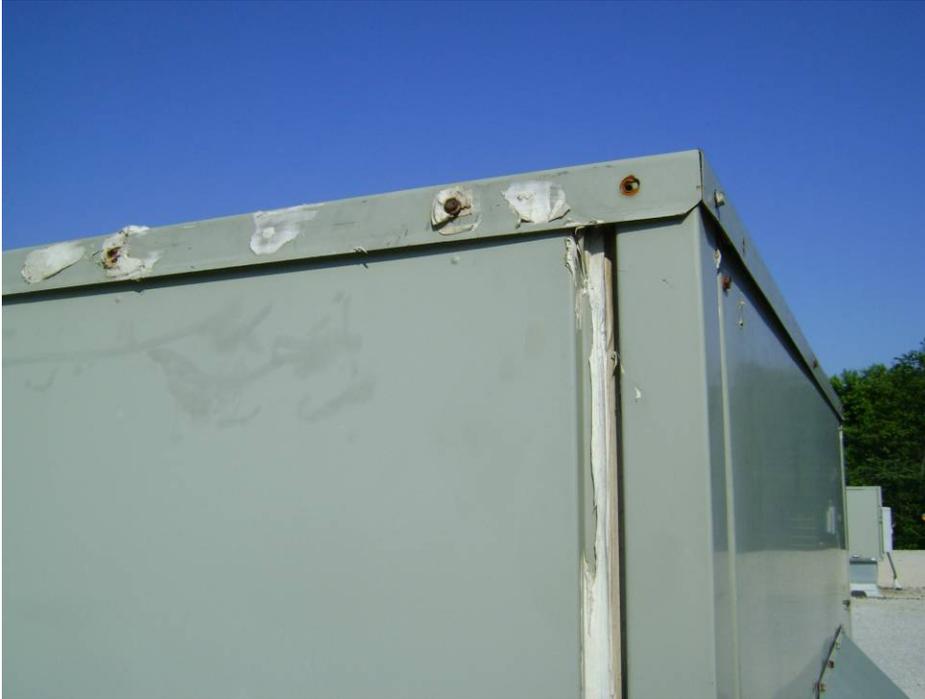
Signs of leakage without economizer system will run in cool conditions which could cause evaporator coil to freeze.
