Sample IR building survey for HVAC and Moisture

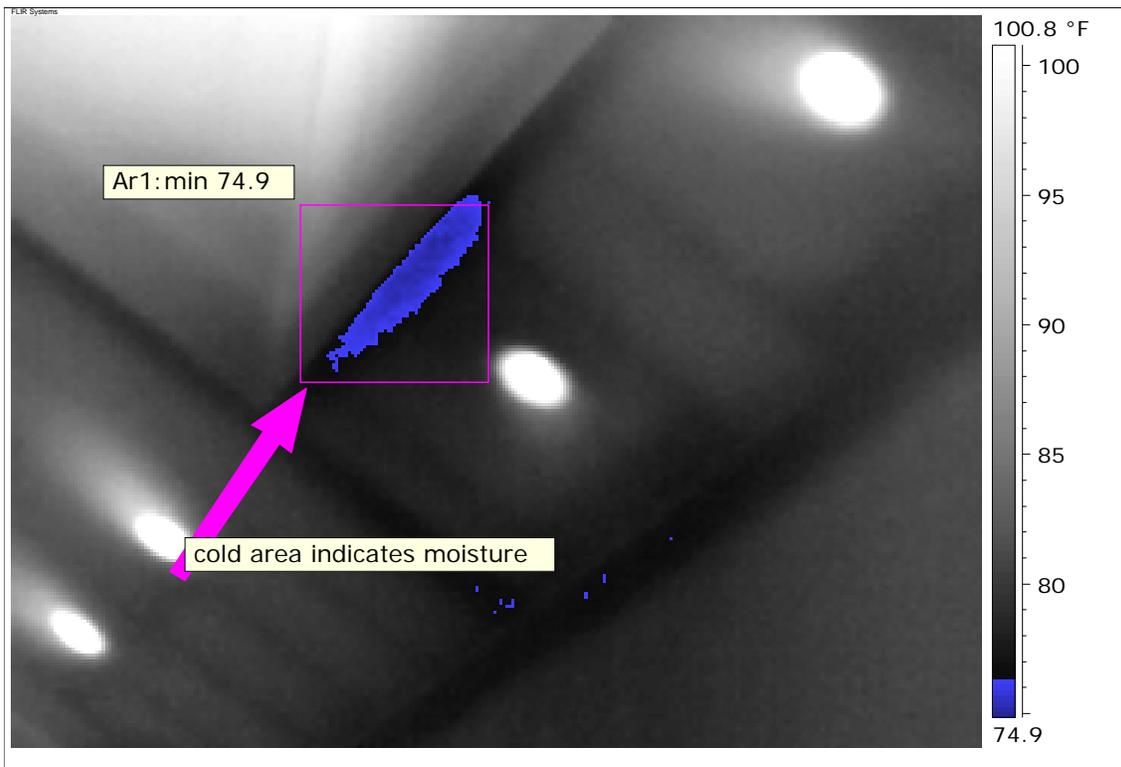
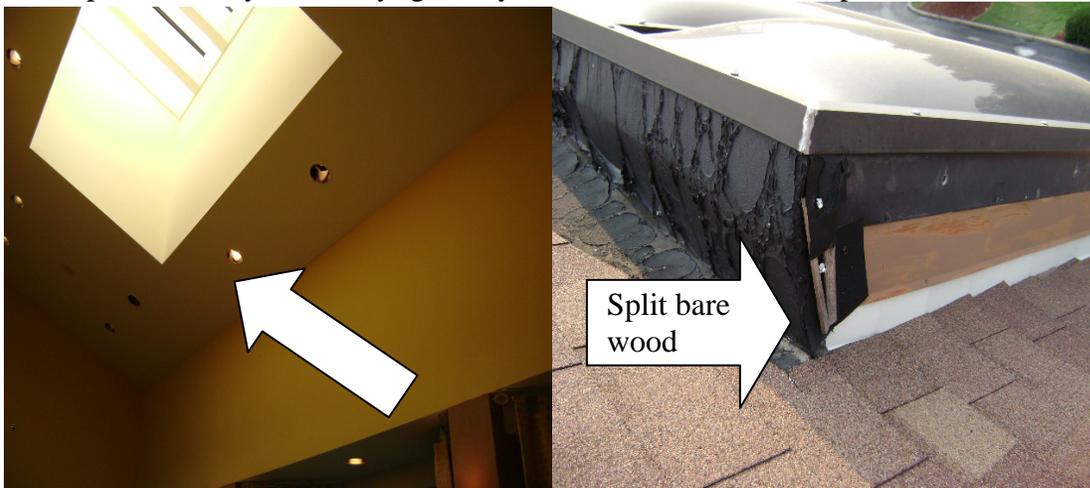
Description: Lobby under skylight may have leak outside air temp is in the low 100's

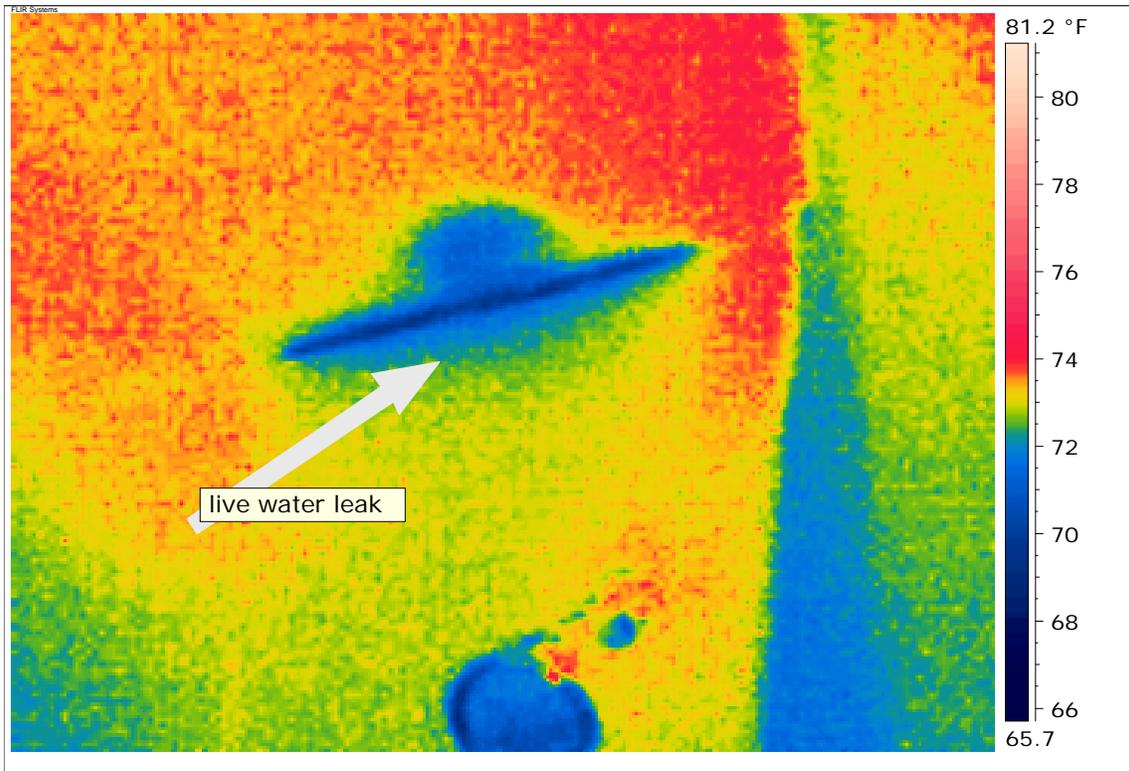
Description: Room 244 leak may be from above floor tub drain

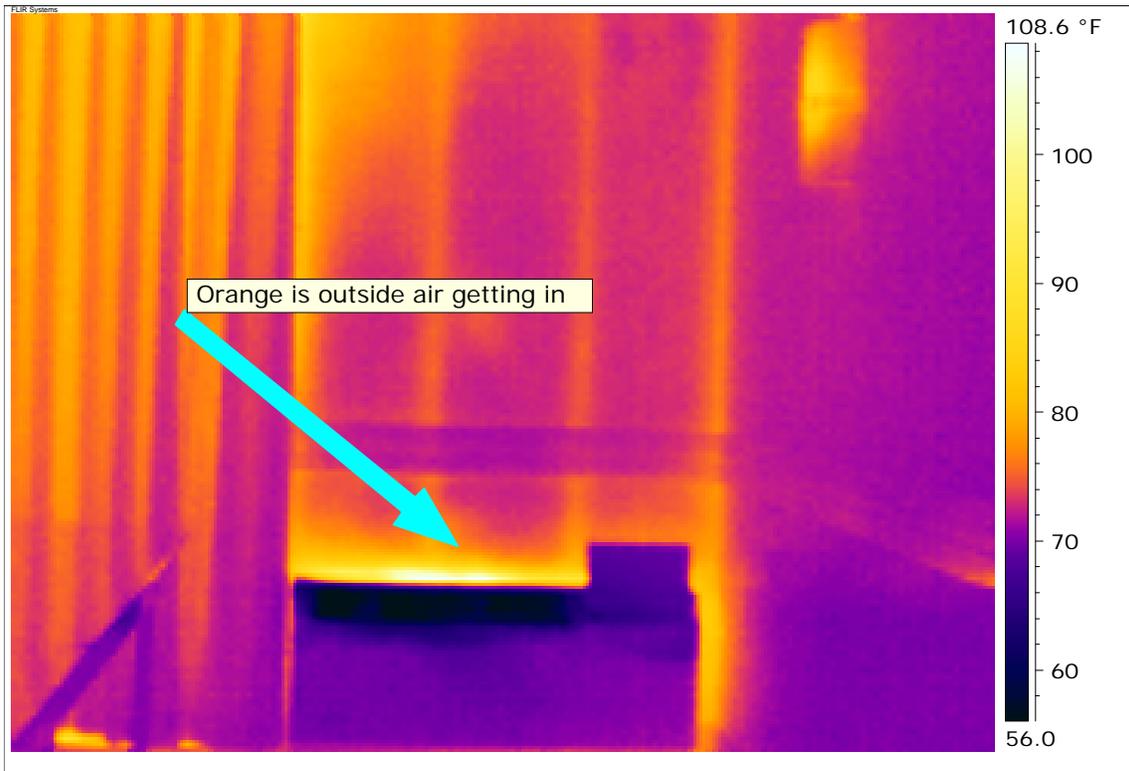
Description: Meeting room warm due too infiltration

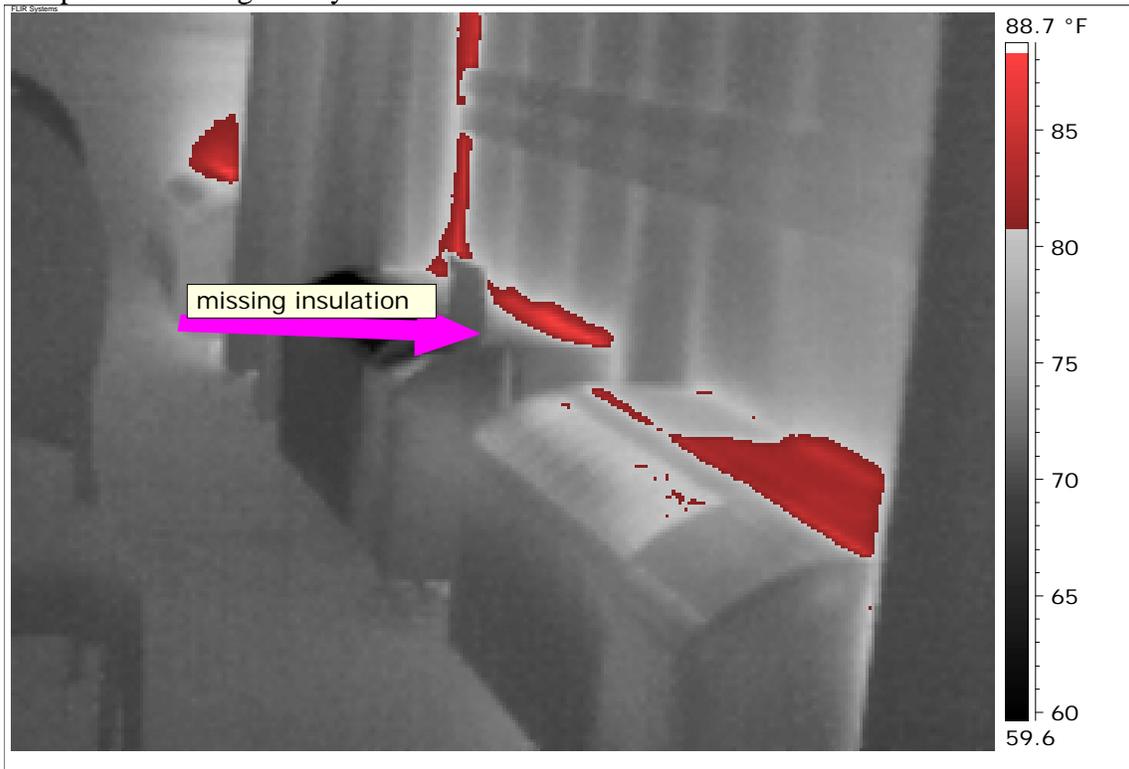
Description: Infiltration meeting rooms

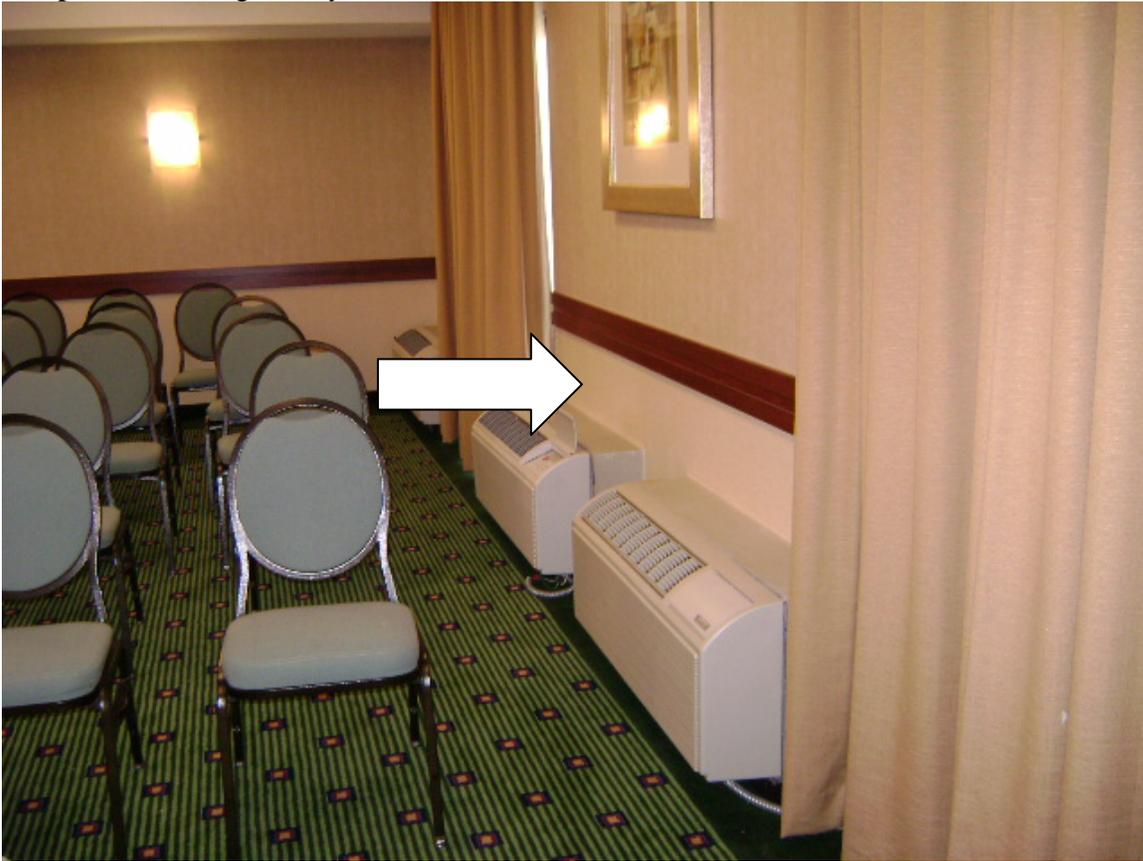
Description: missing insulation

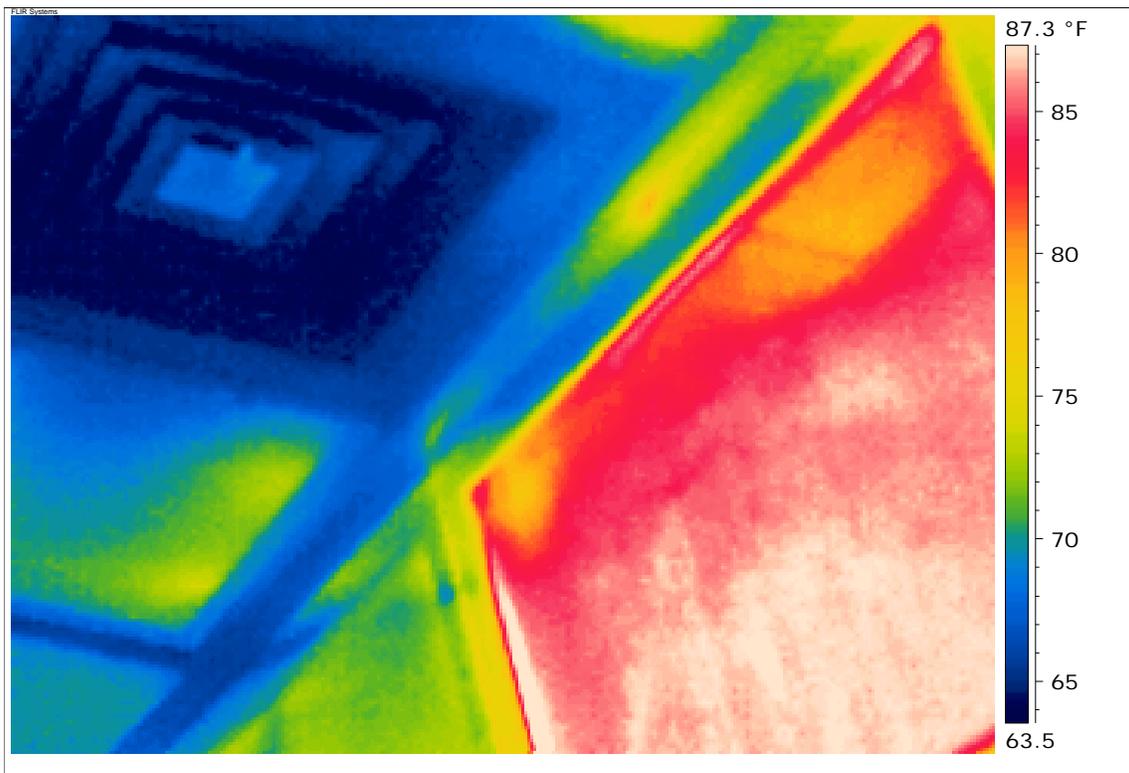
Description: Kitchen supply drawn into hood exhaust energy waste

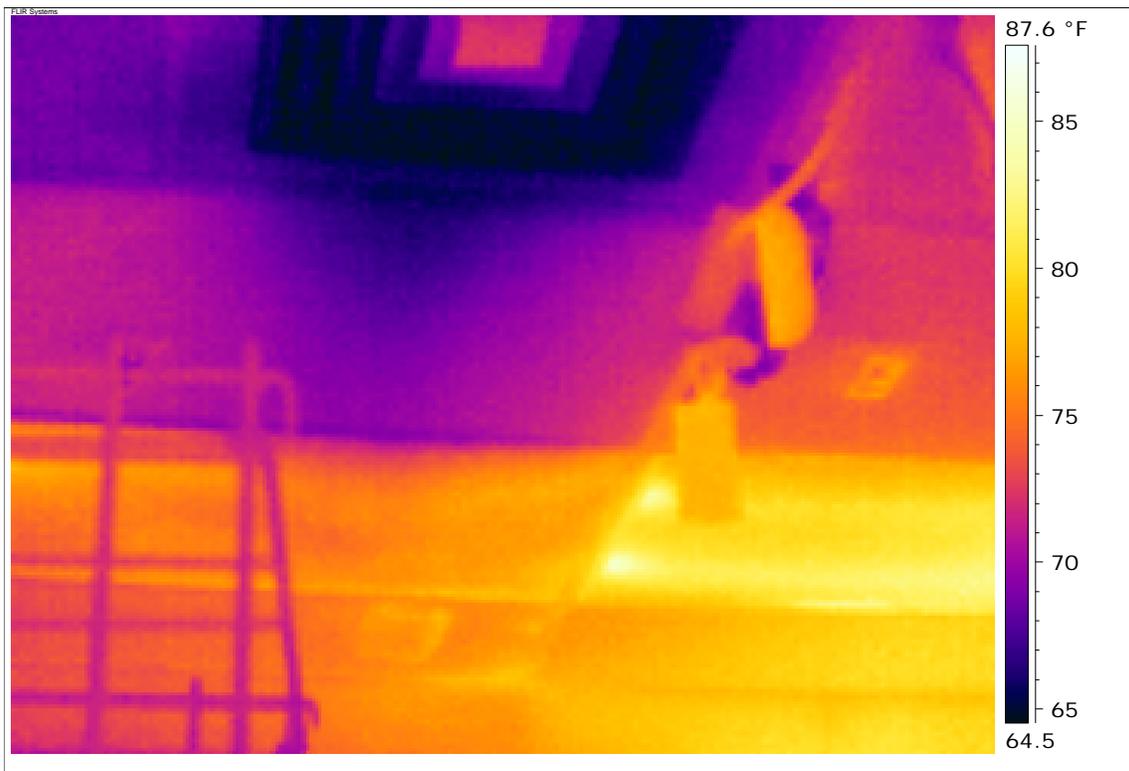
Description: Kitchen supply very close to return

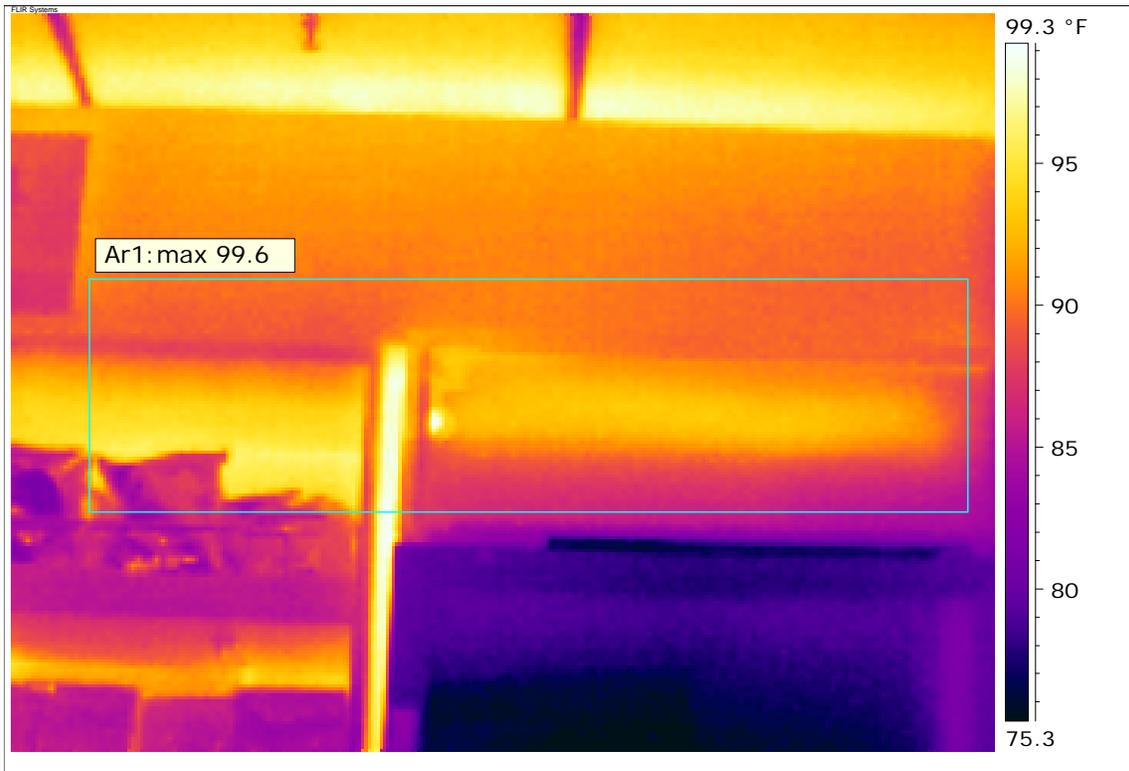
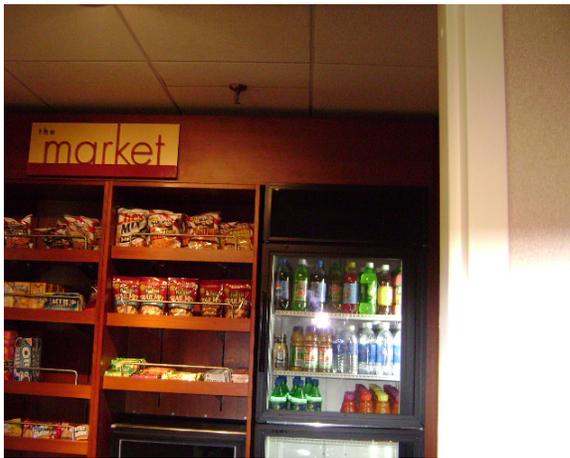
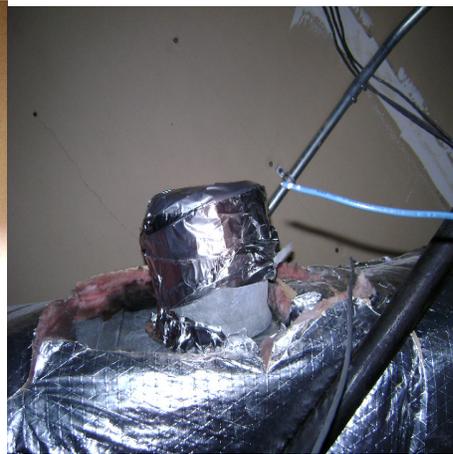
Description: Snack area not ventilated and Leslie's office is behind the wall

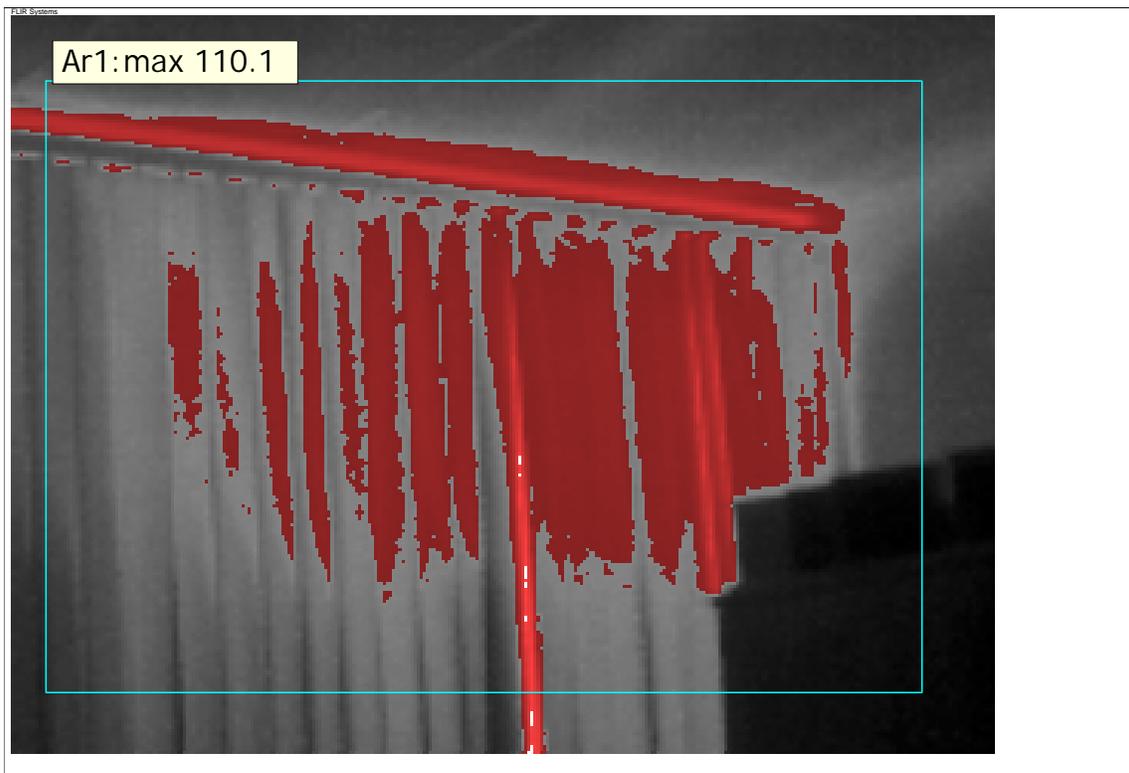
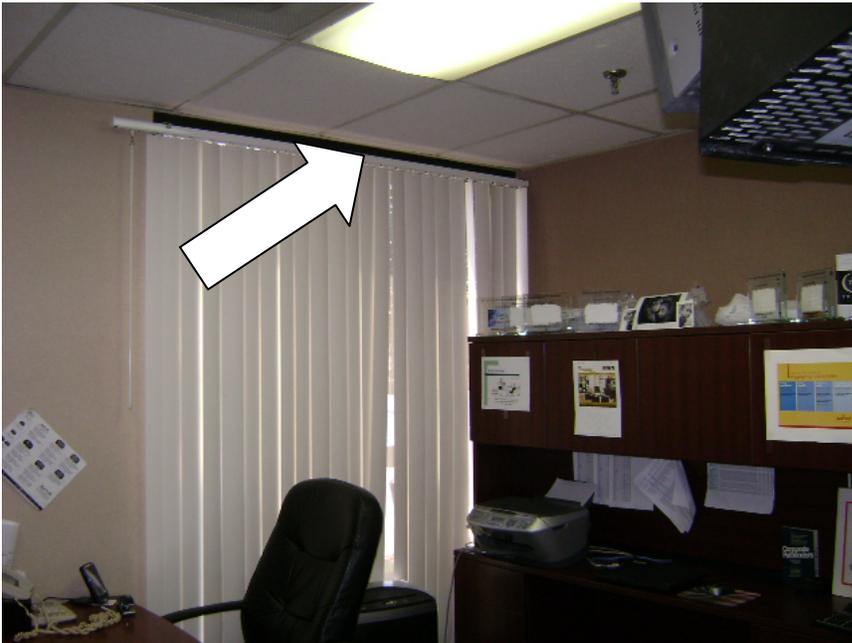
Description: Leslie's office large heat infiltration and lack of air flow due too leaking ductwork causes warm office

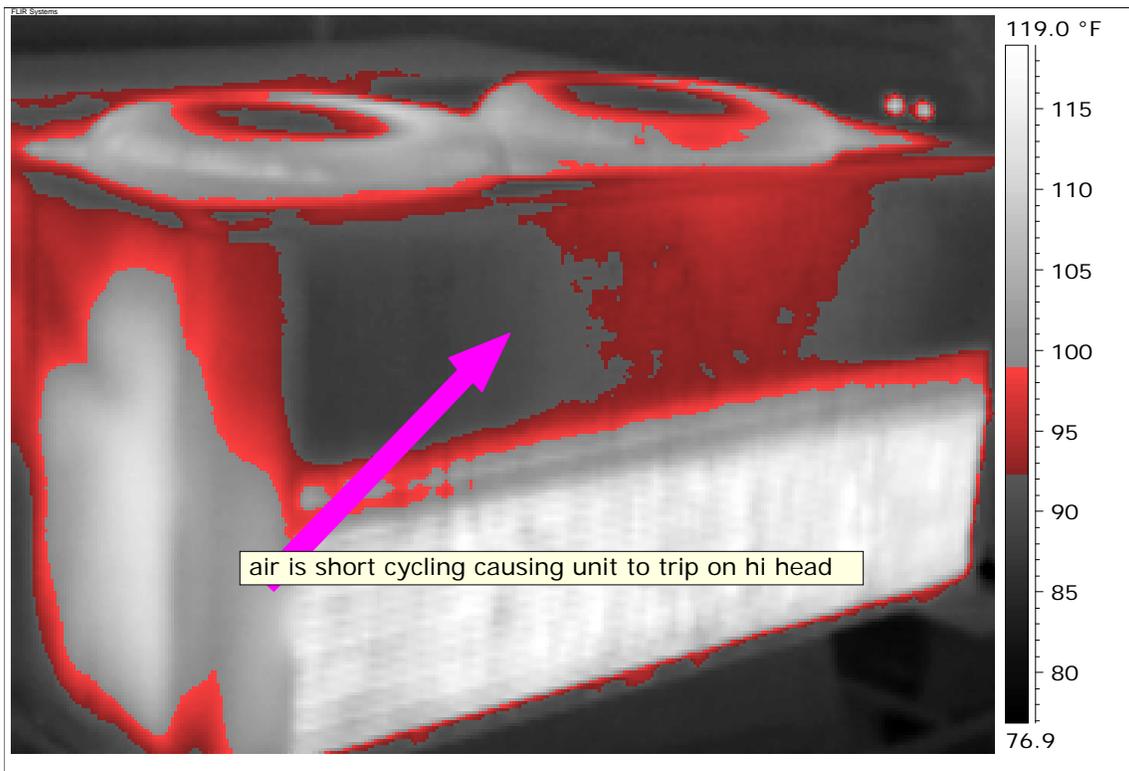
Description: Rtu 3rd floor east-cond fan air short cycling

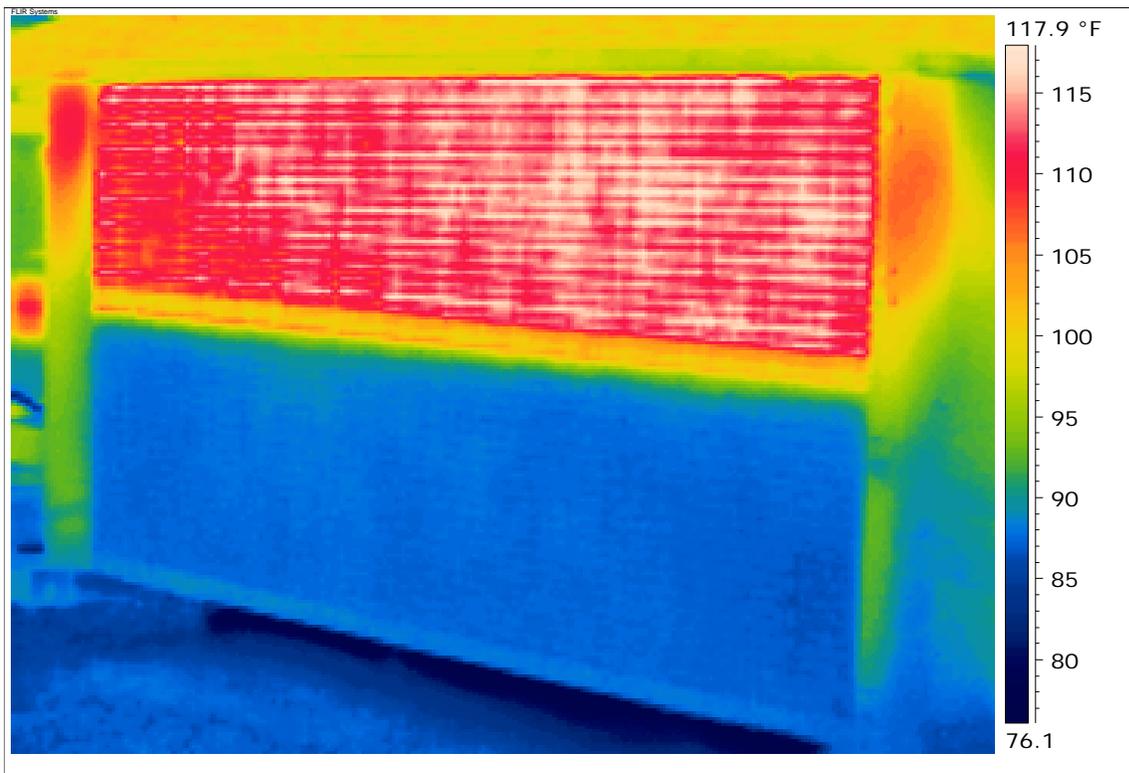
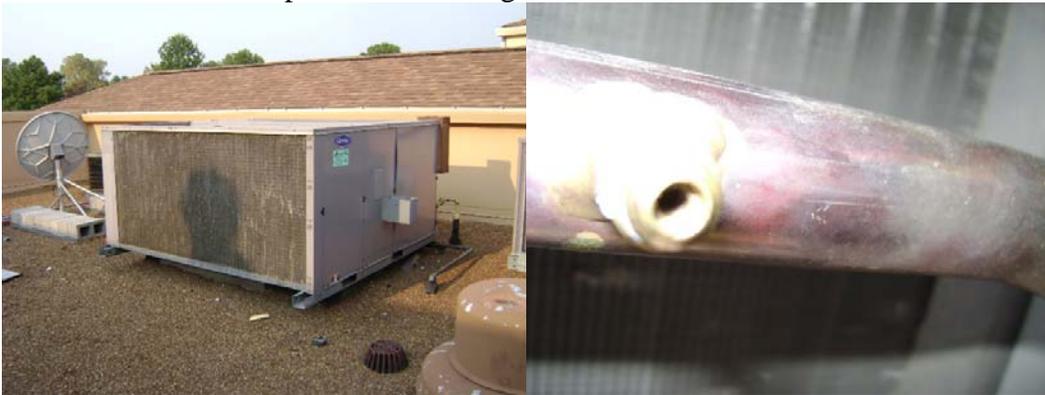
RTU 2 main lobby bad compressor- blown Schrader port- repaired and tried to charge unit but valves in compressor are damaged

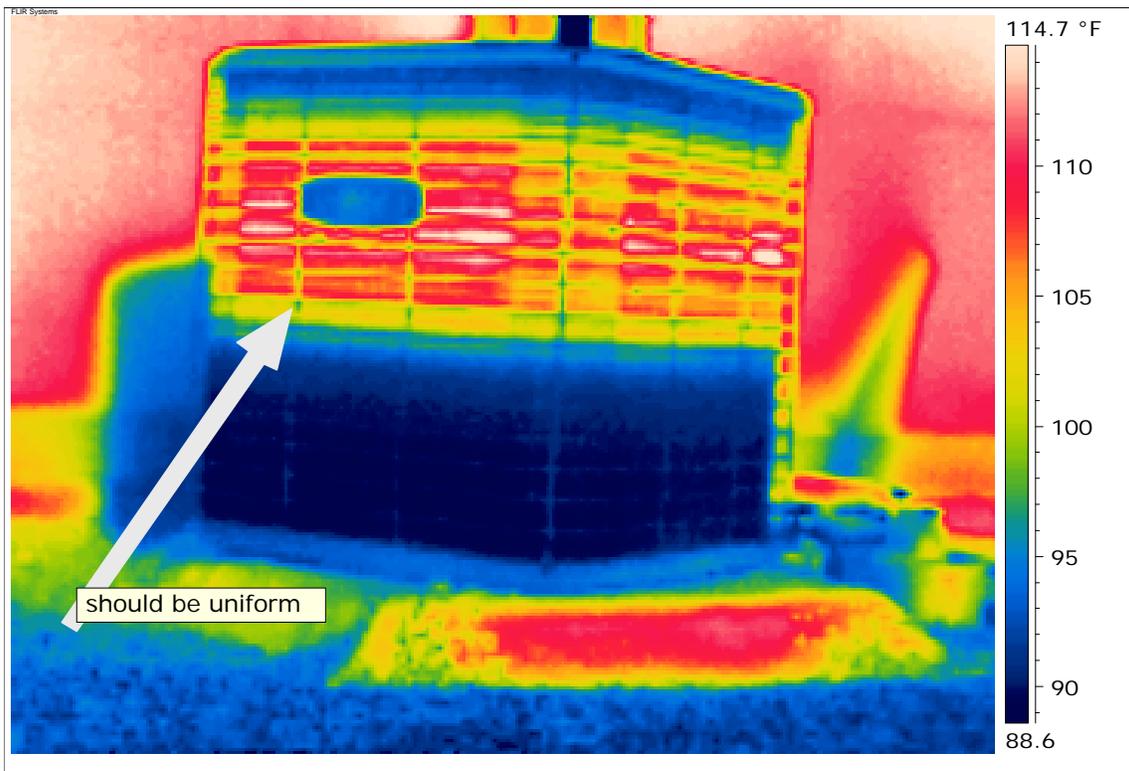
Description: Split system for computer room plugged condenser coil and is tripping

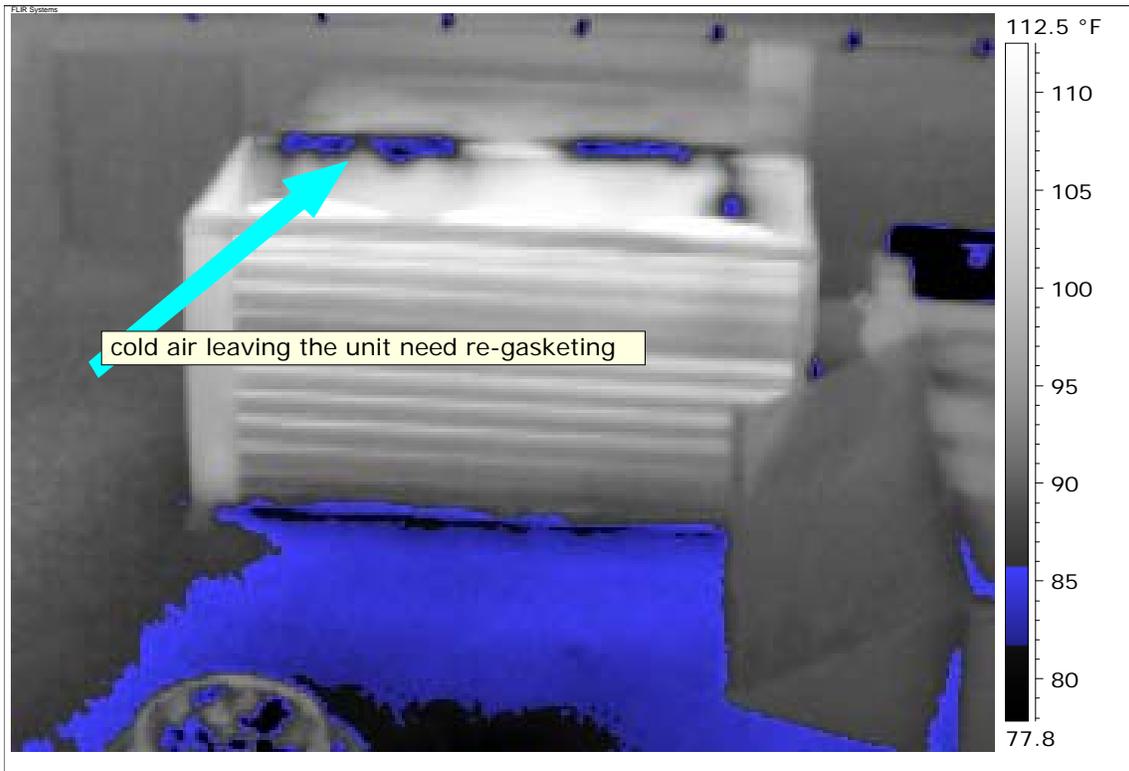
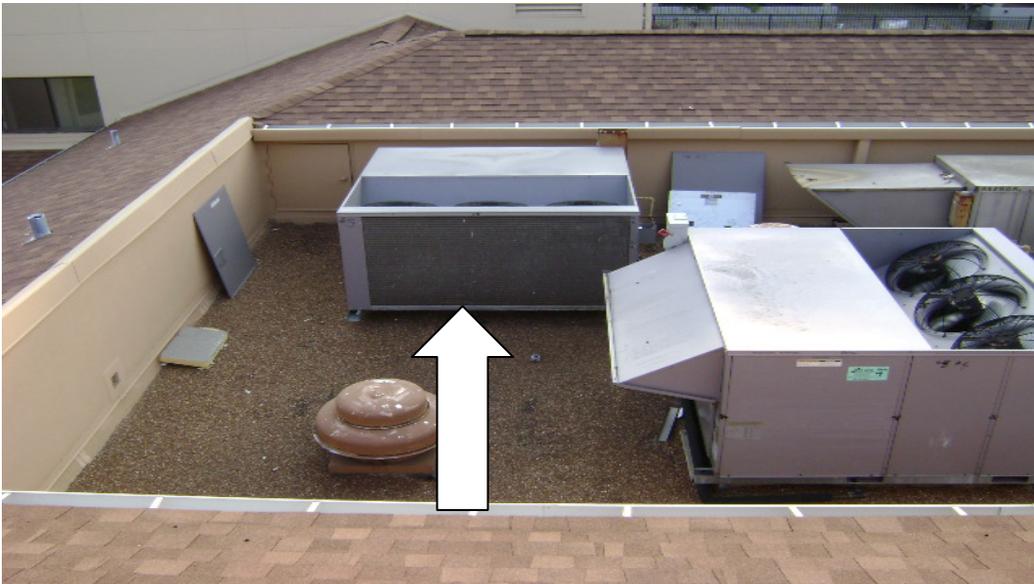
Description: energy loss in blue cold air leaking out instead of blowing into the space.

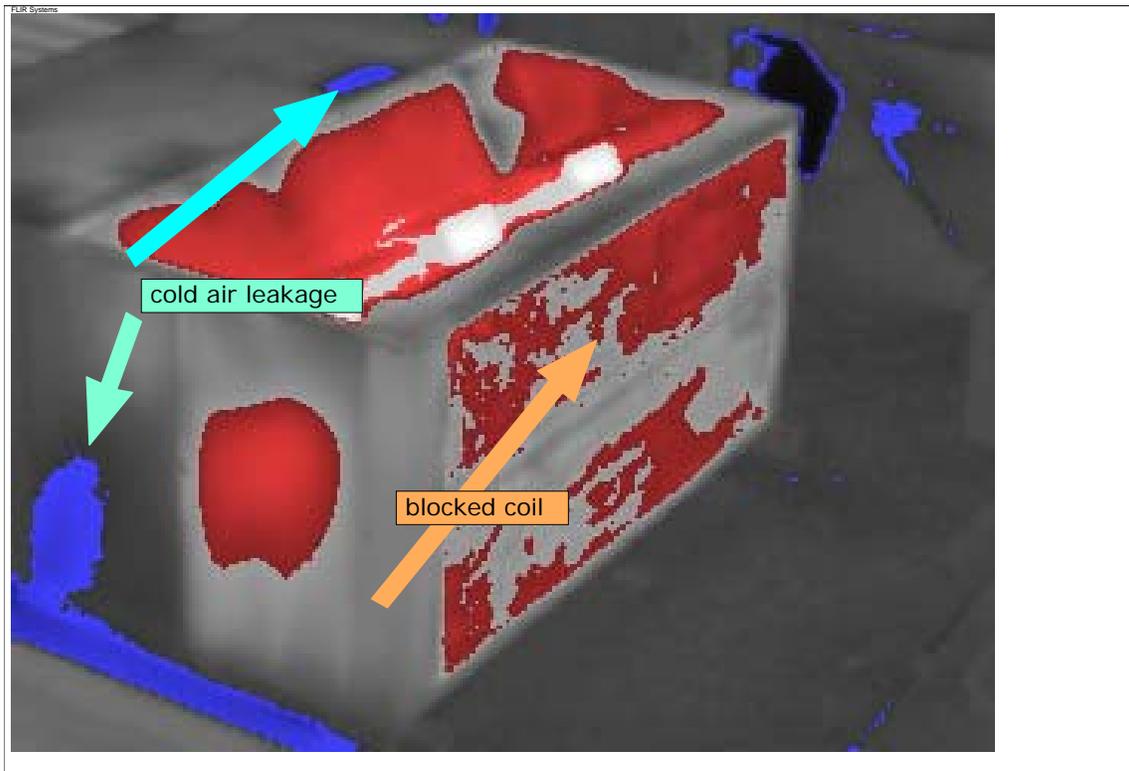
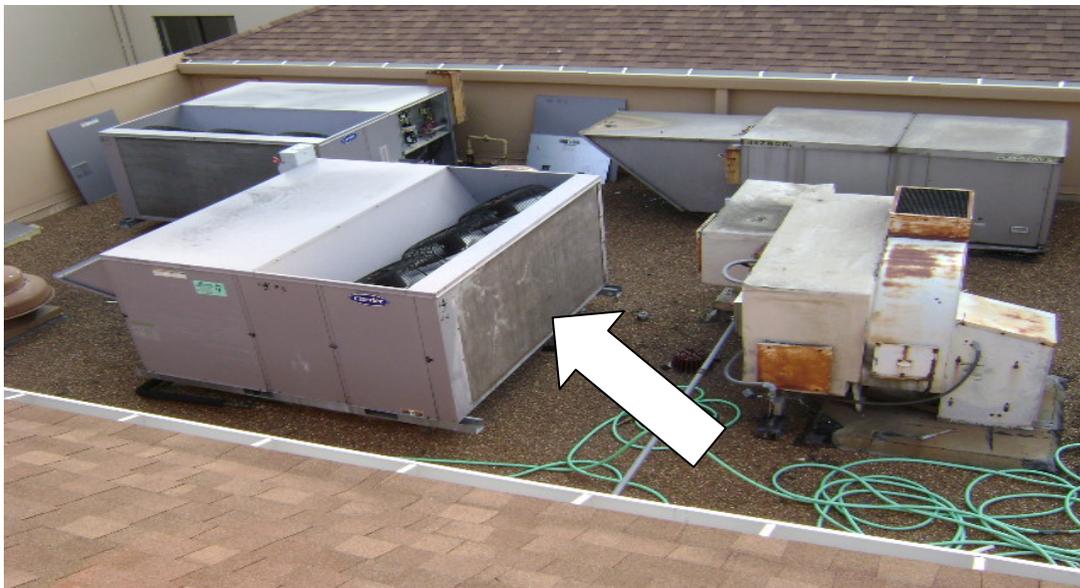
Description: Dirty coil blocked air flow in red will over work the compressors
Blue is air leakage

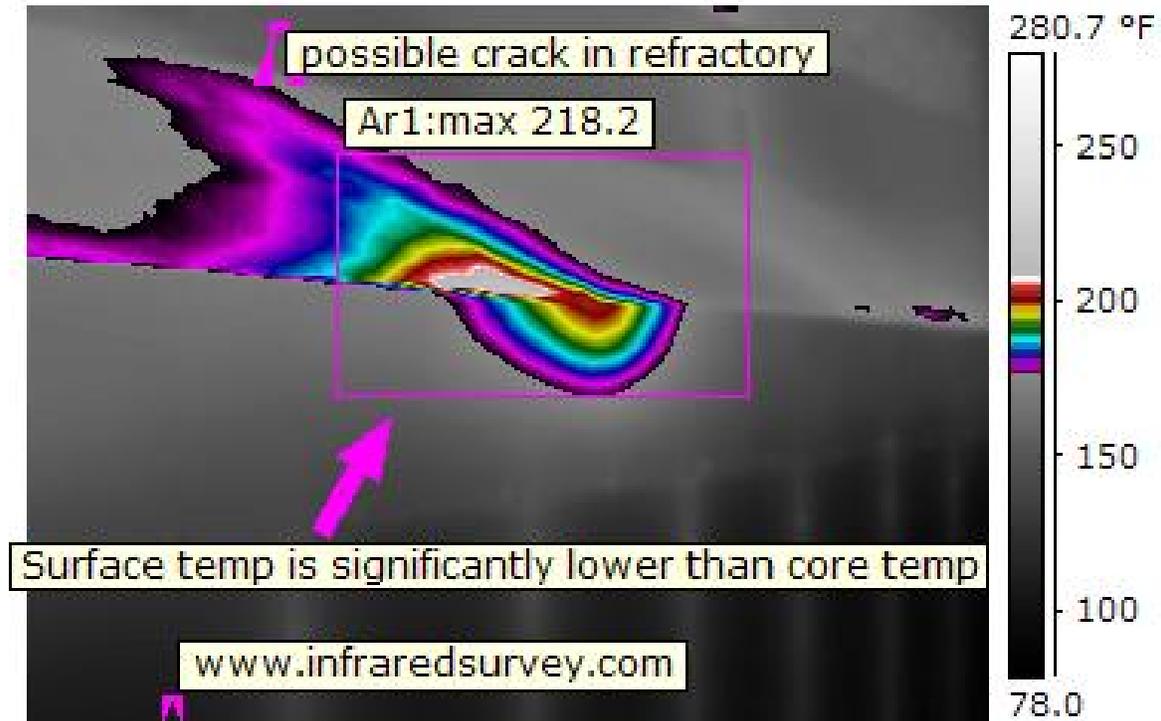
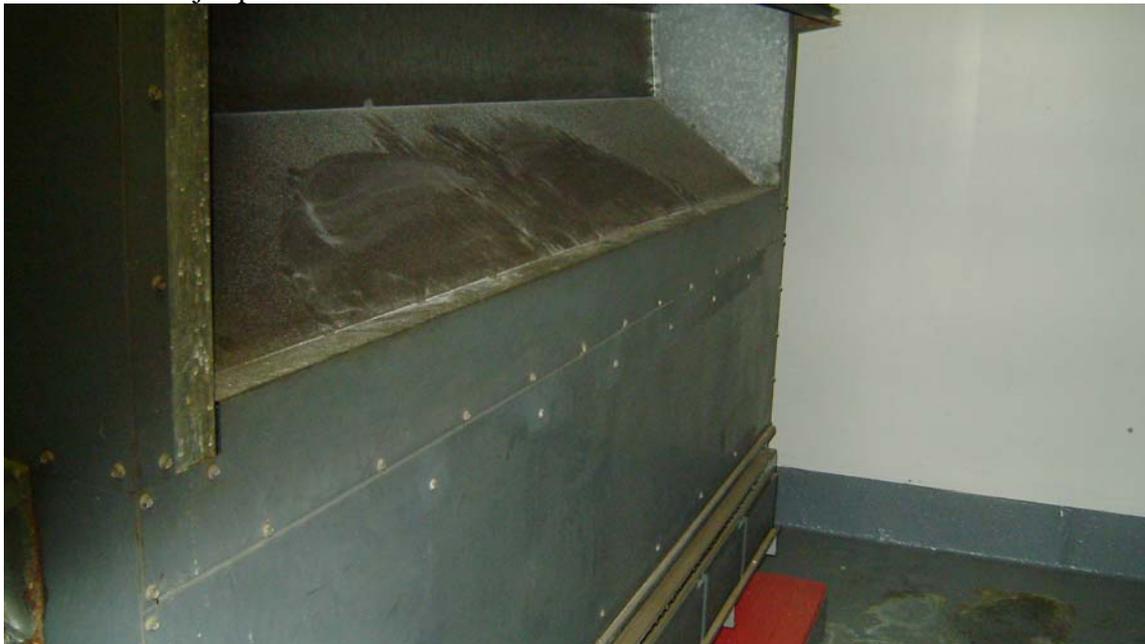
Boiler with major problem
