Infrared Thermographic Report
For

Report done by
John Cannamela
Level II Thermographer

Data floor12-18-08 supply air 110 degrees F @ 0.45 in Wg
www.infraredsurvey.com Level II Thermographer John Cannamela

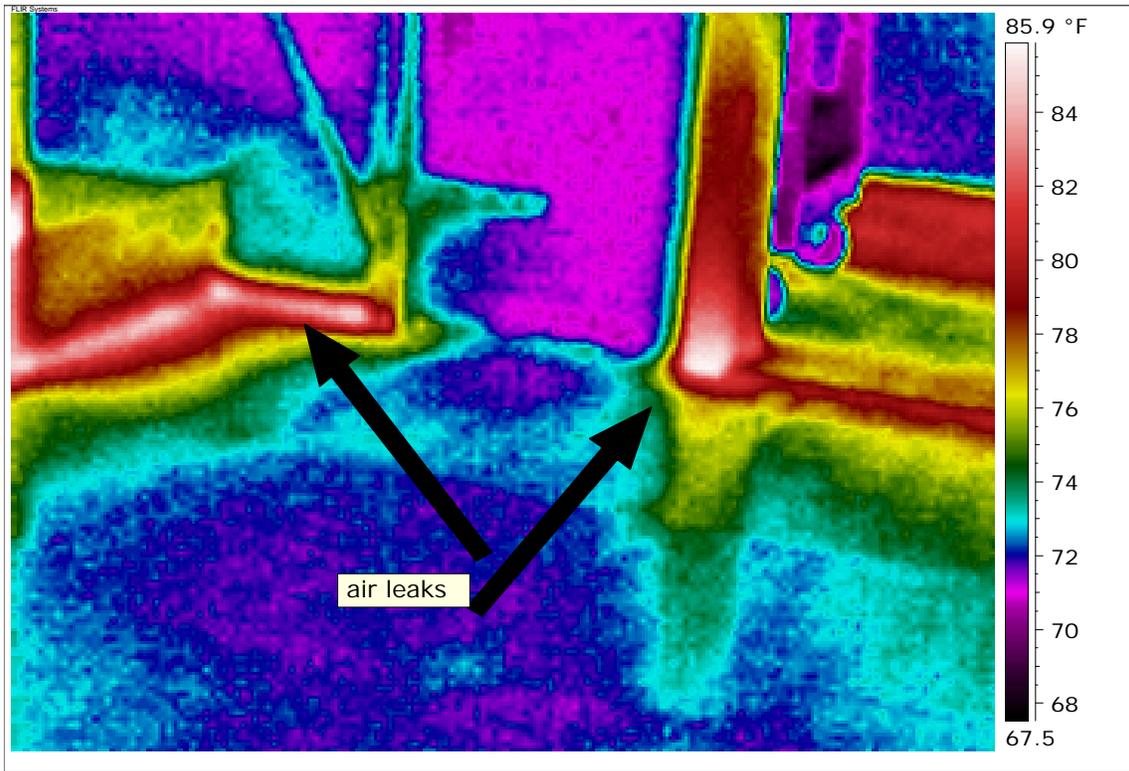
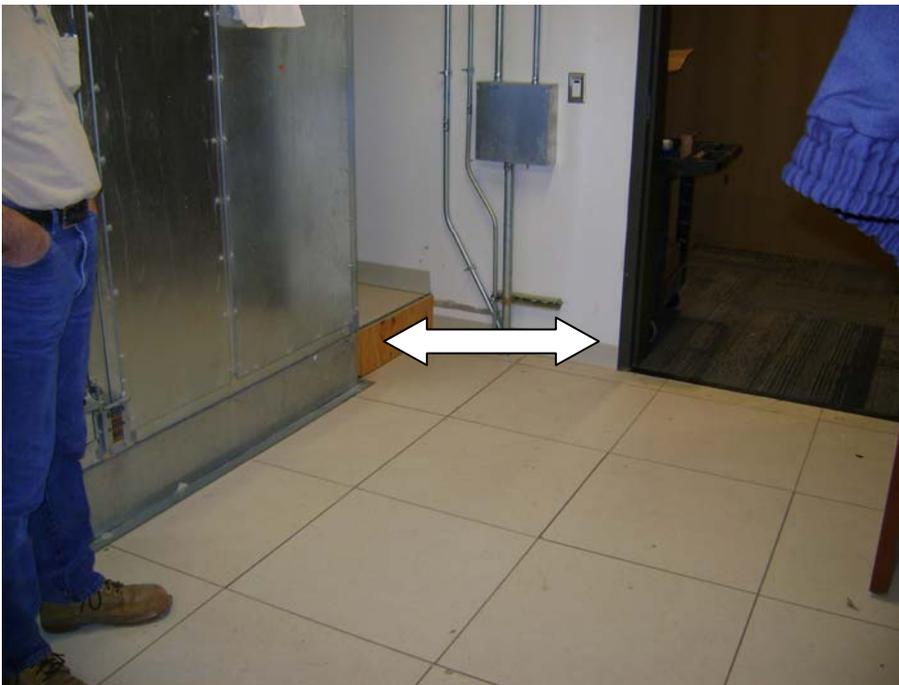
Description: Mechanical room anomaly at door jam and discharge

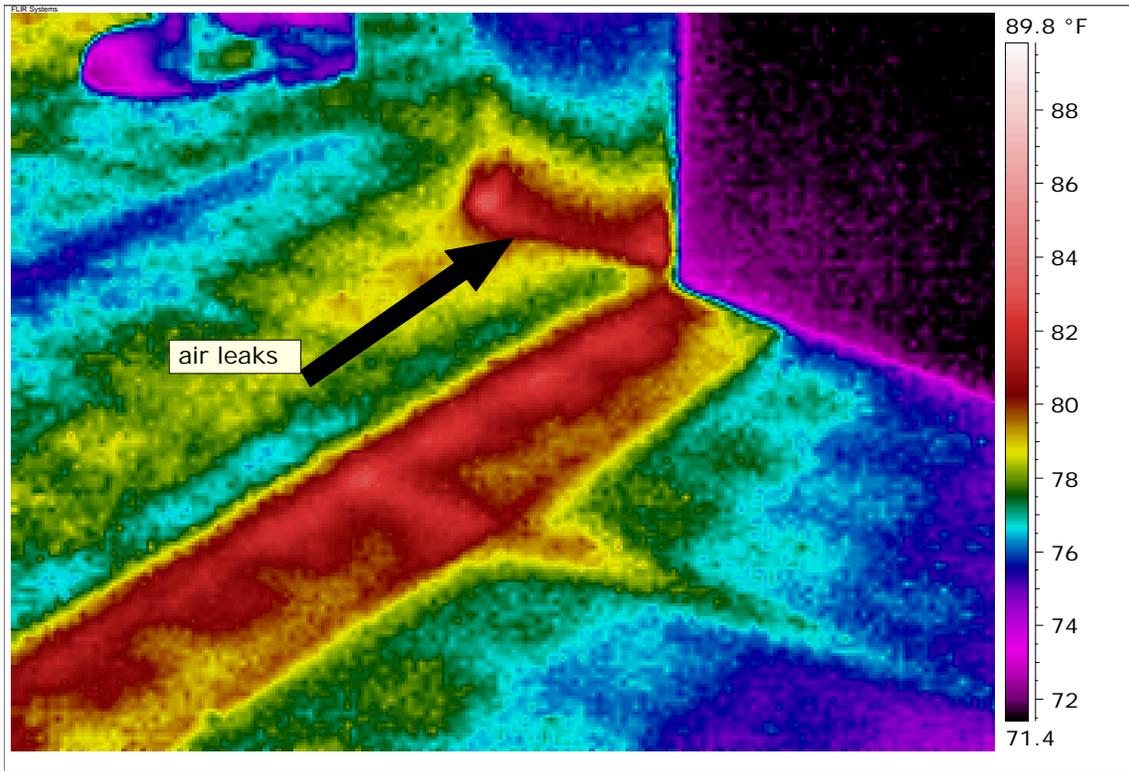
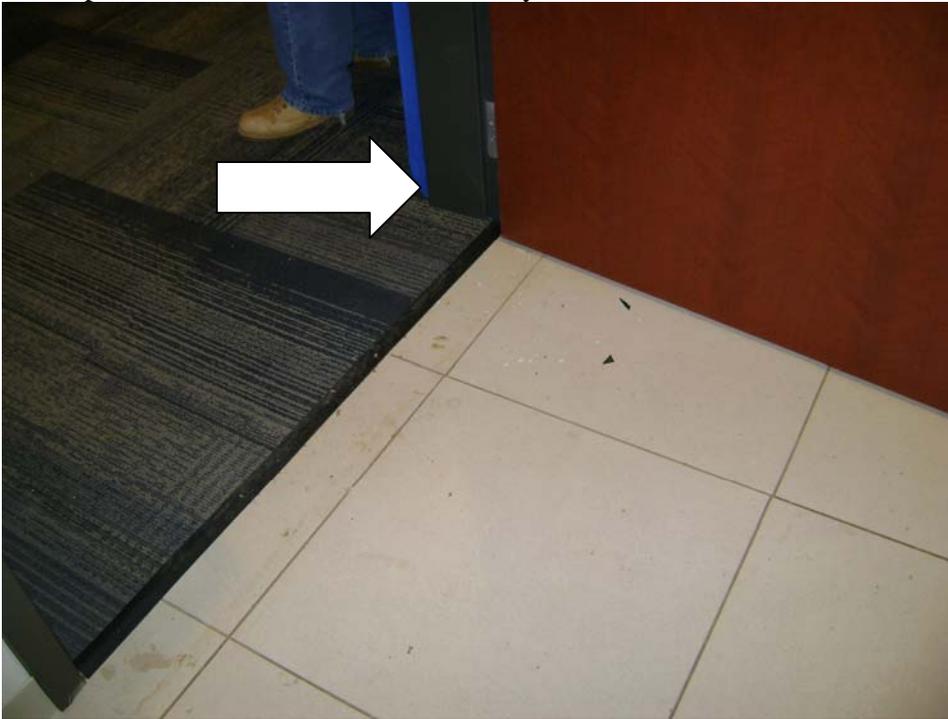
Description: Mechanical room door entry

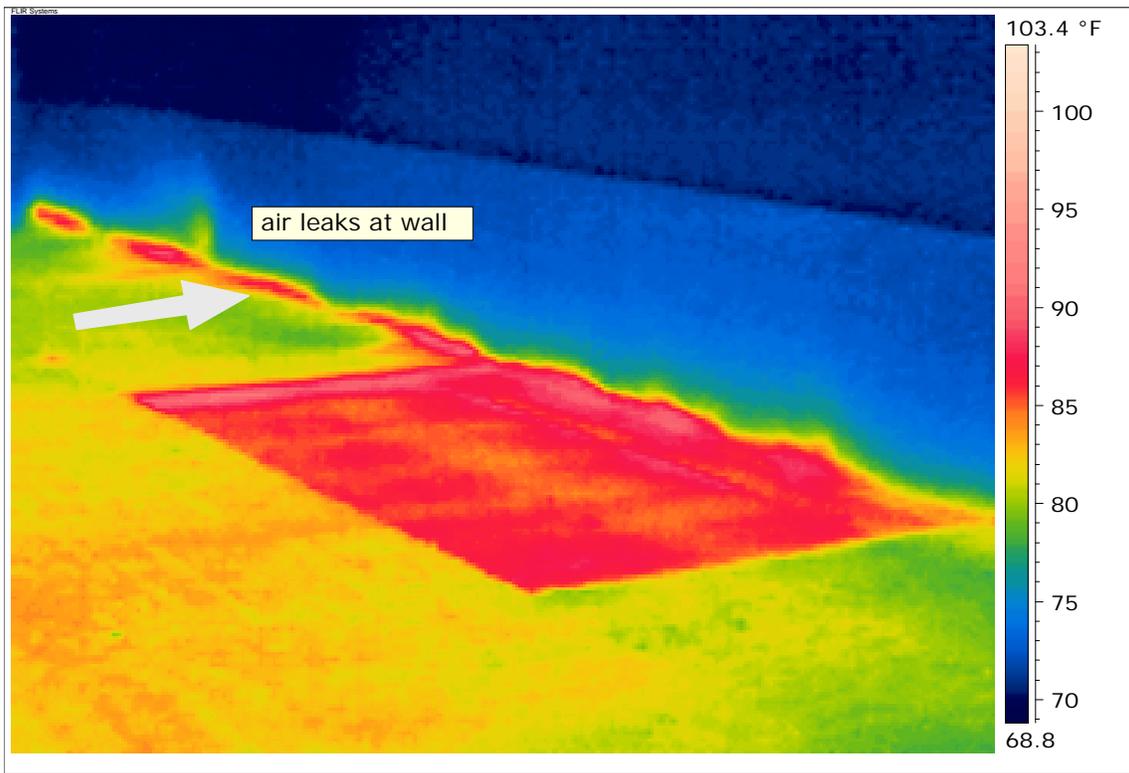
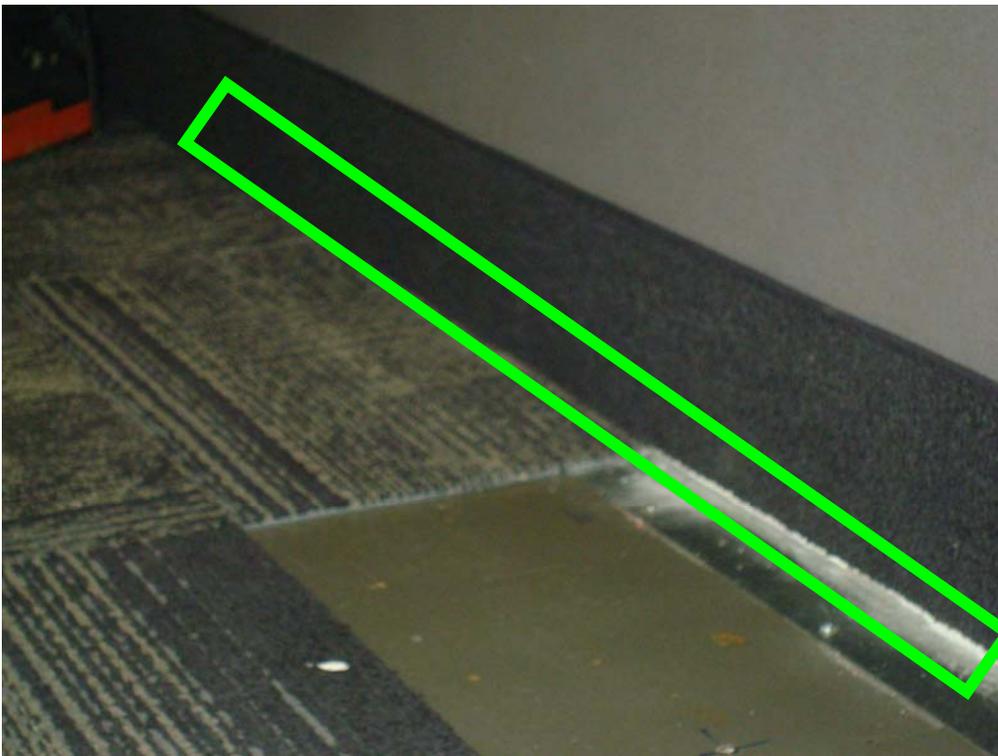
Description: anomaly at wall in hallway in front of AHU highway

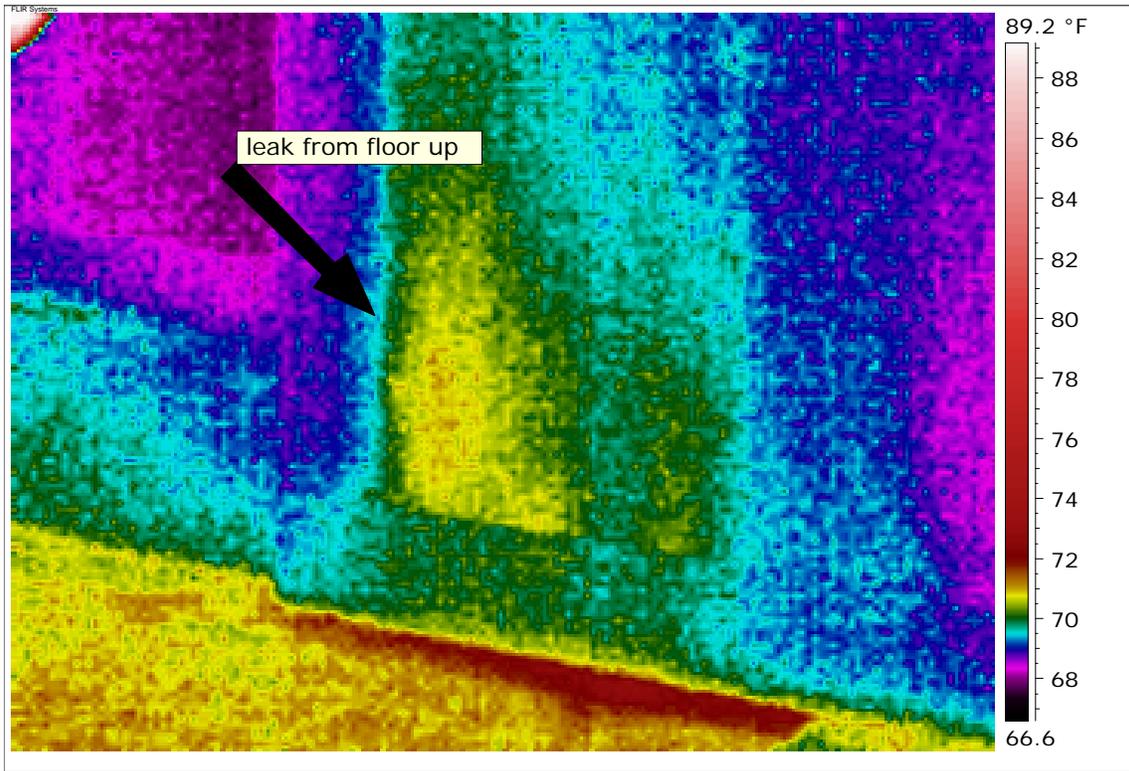
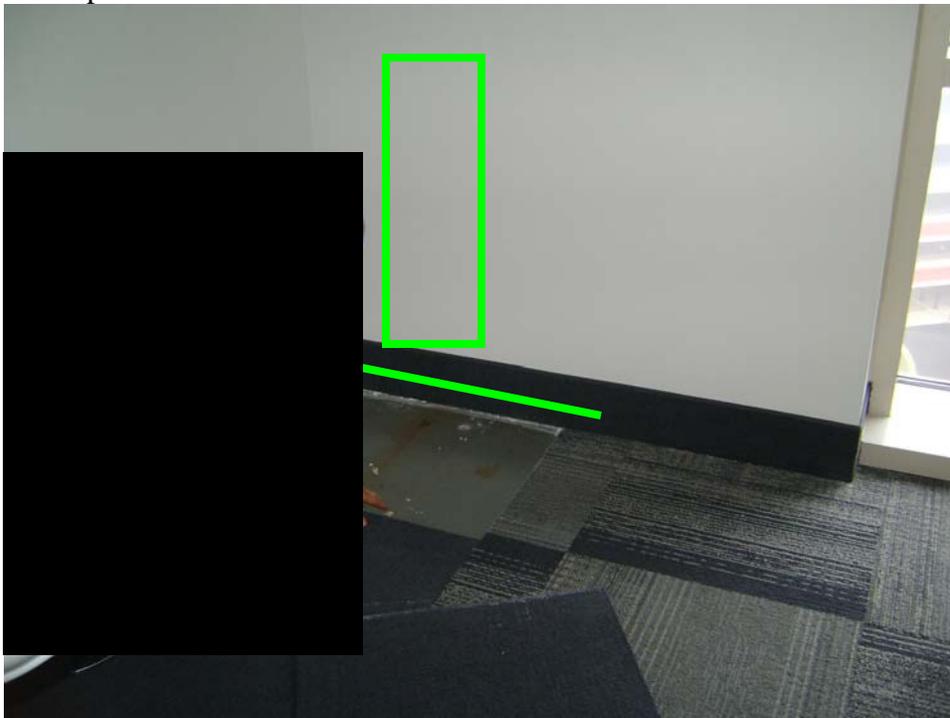
Description: Conference room outside of Mechanical room

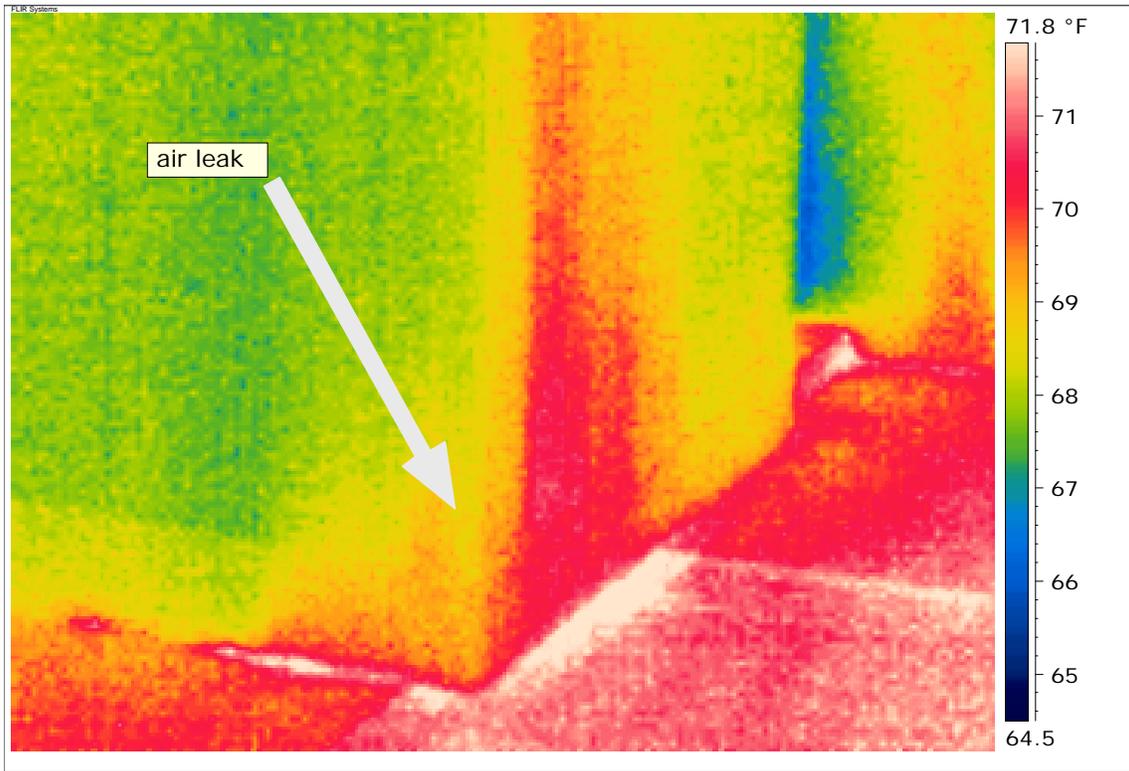
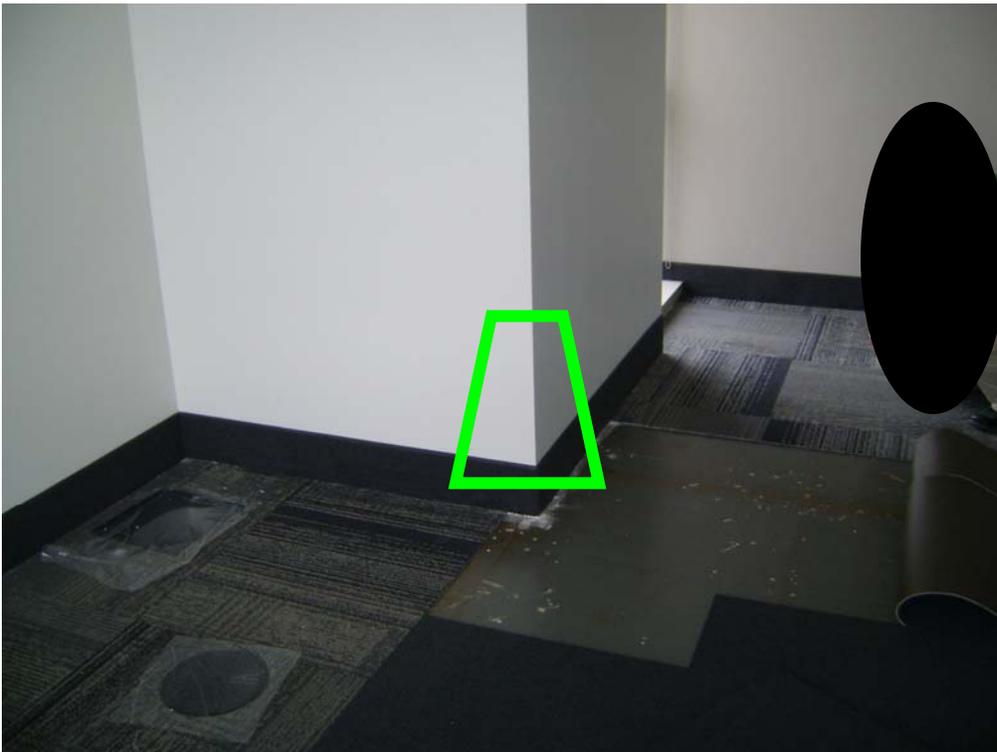
Description: Conference room at a different angle. The hot floor air is causing an anomaly at the wall and floor joint

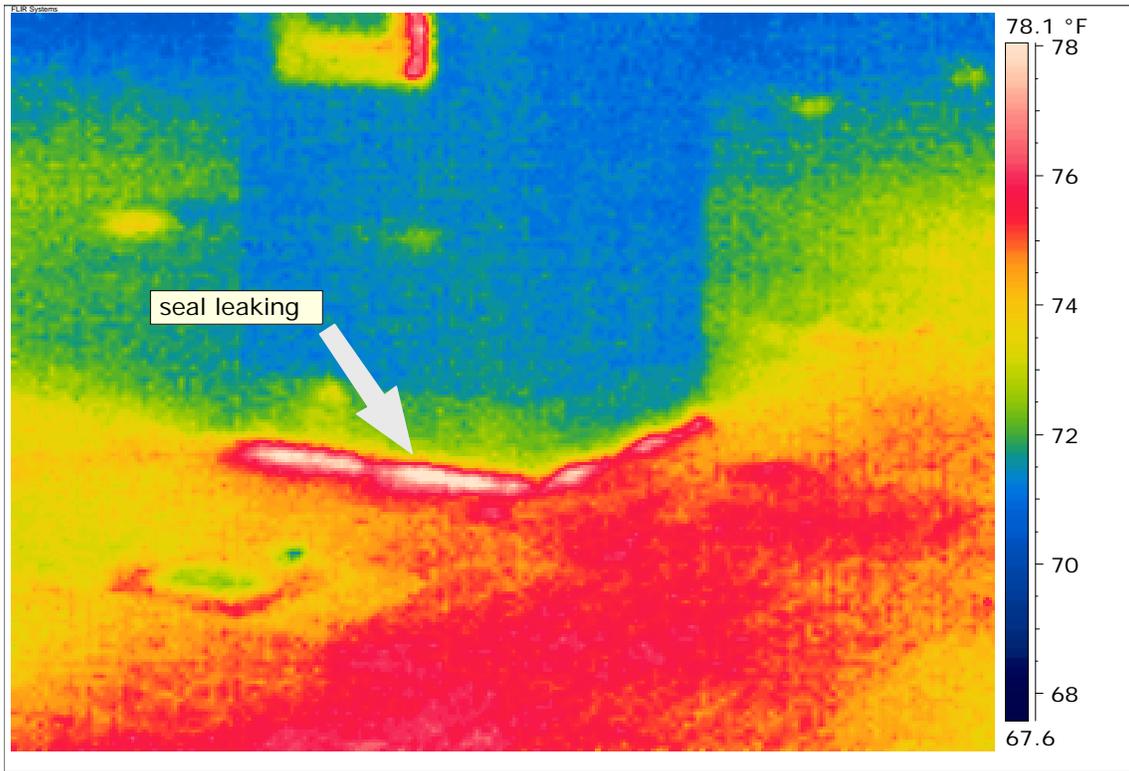
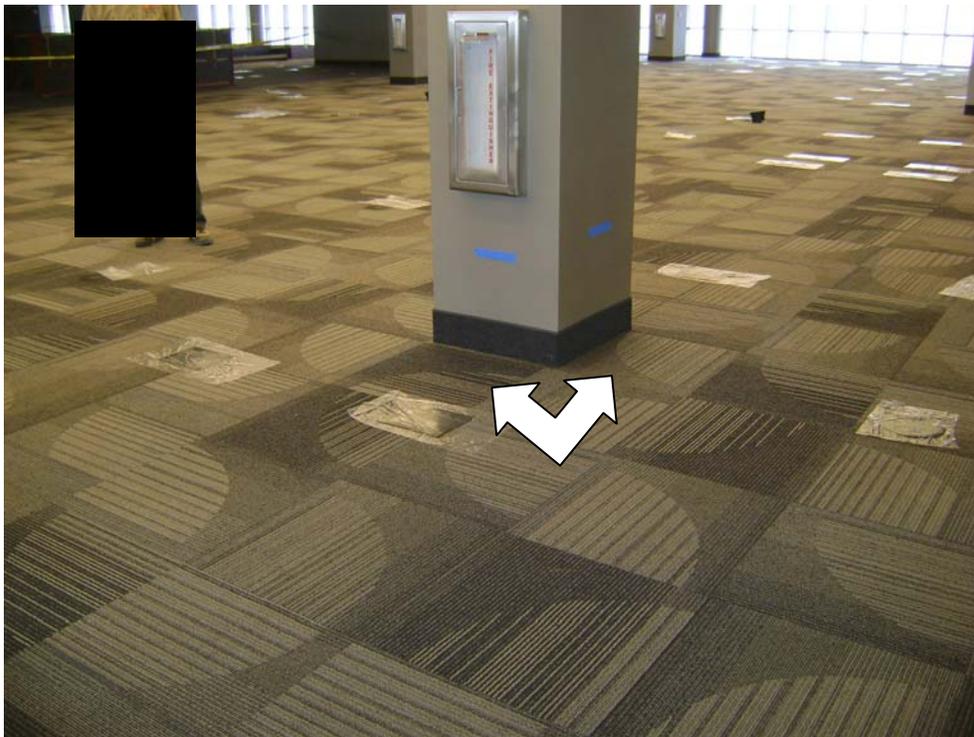
Description: Column, anomaly from floor base in red

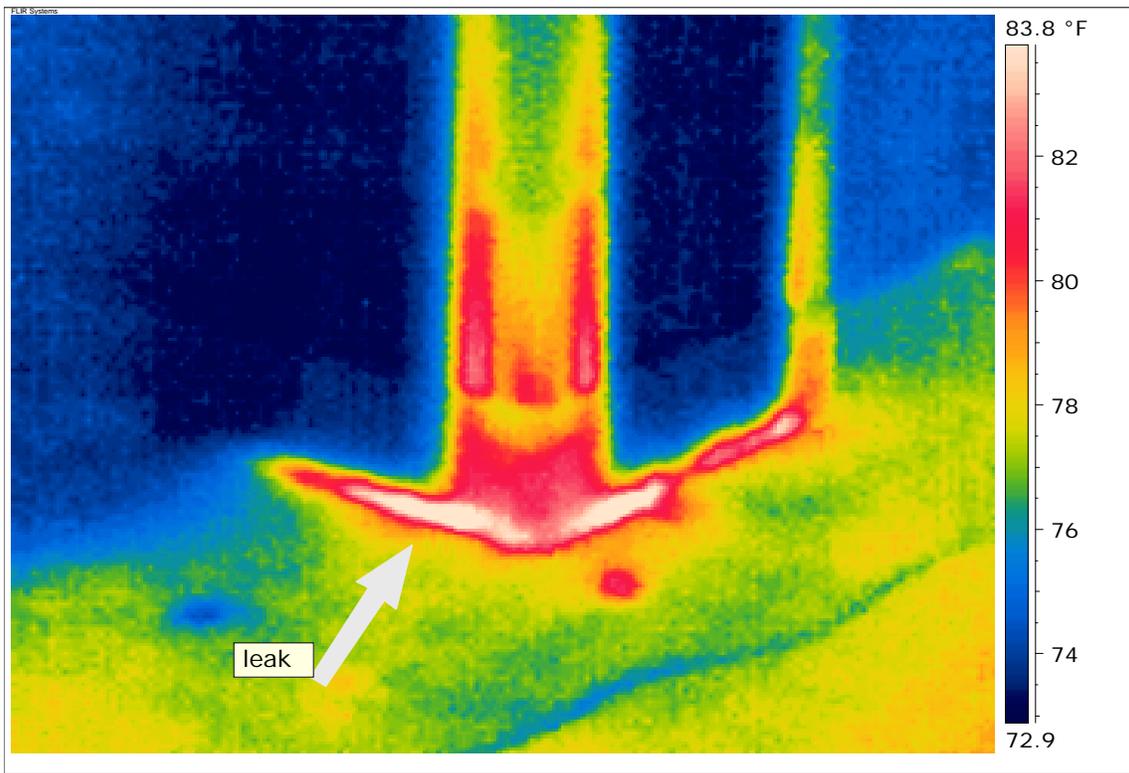
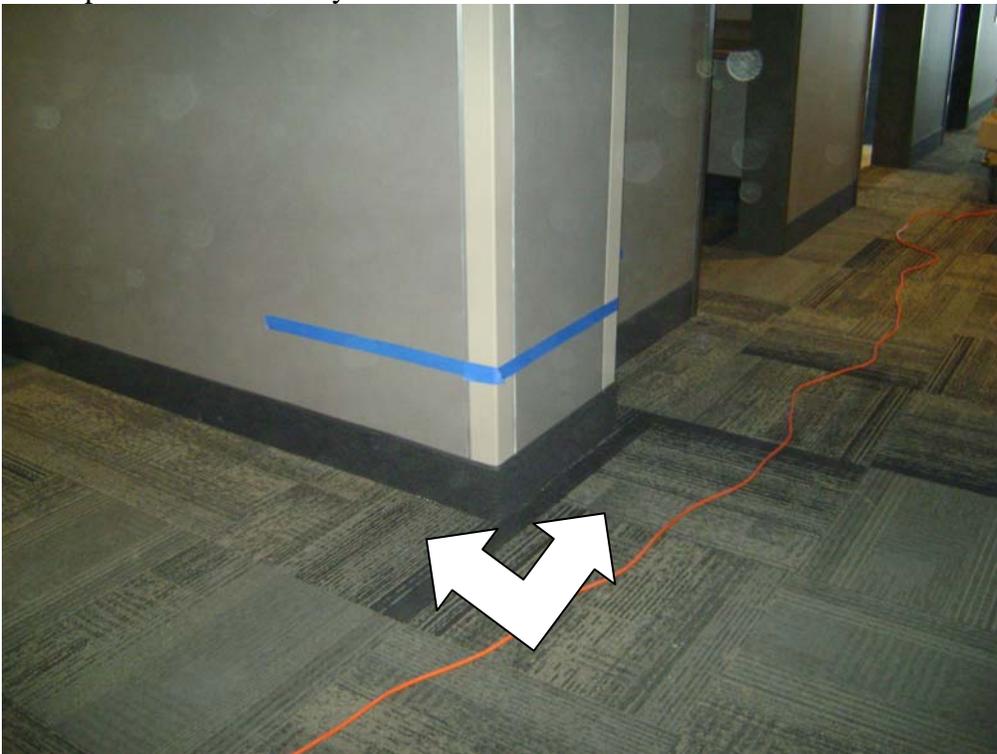
Description: wall anomaly at floor base

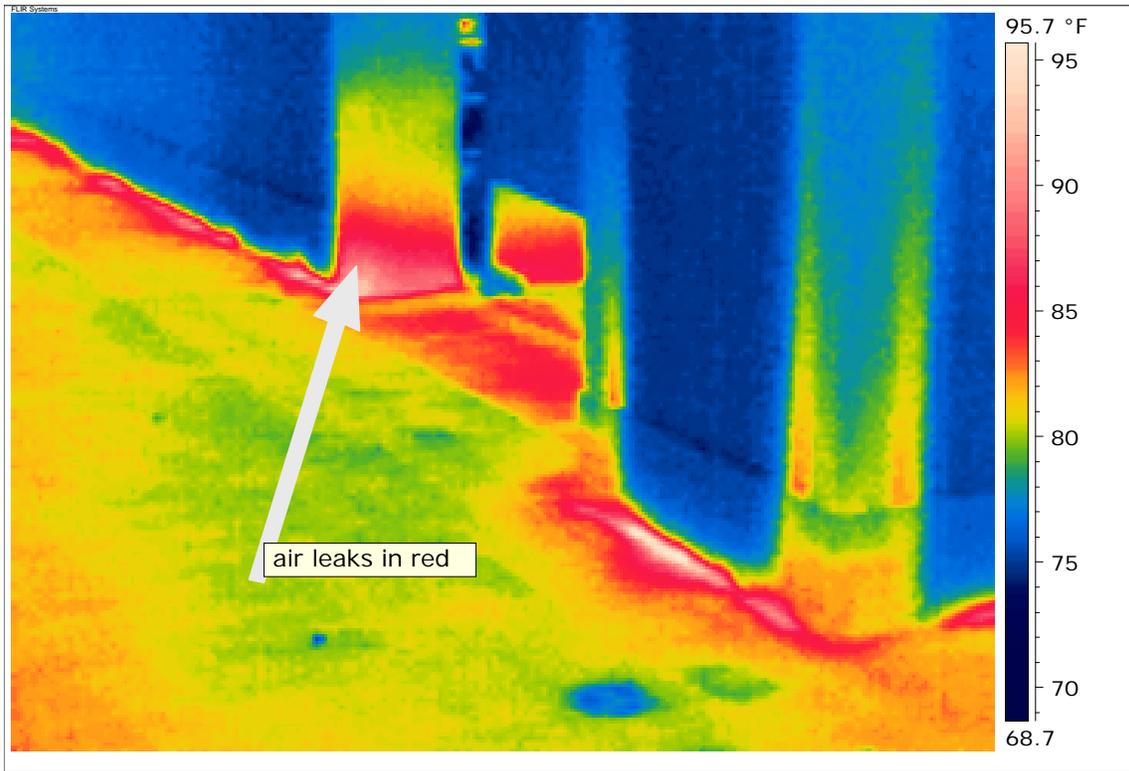
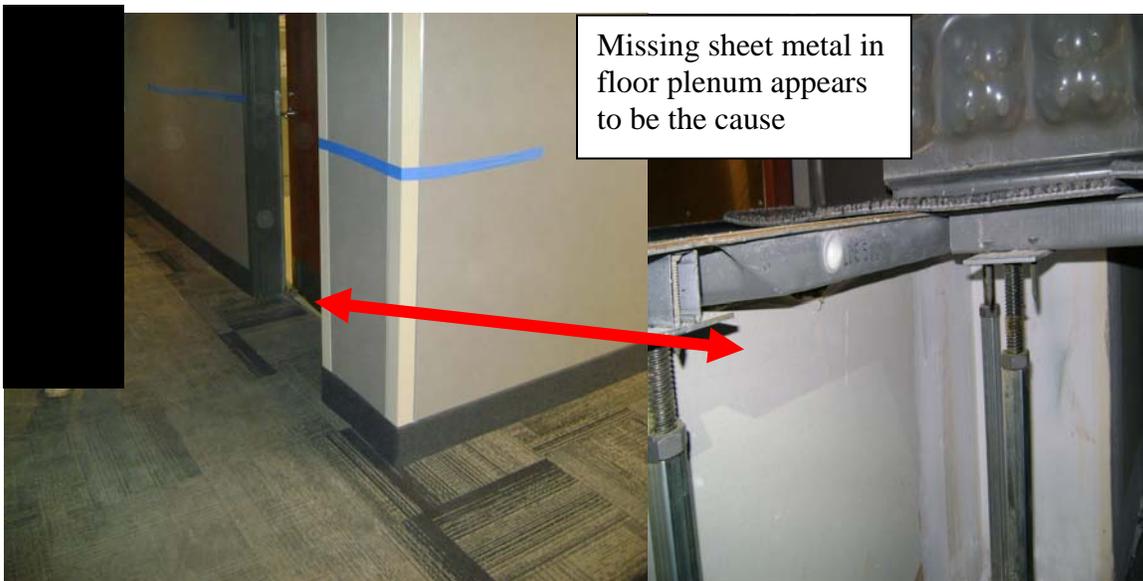
Description: Major anomaly across from electrical and bathrooms at door jam

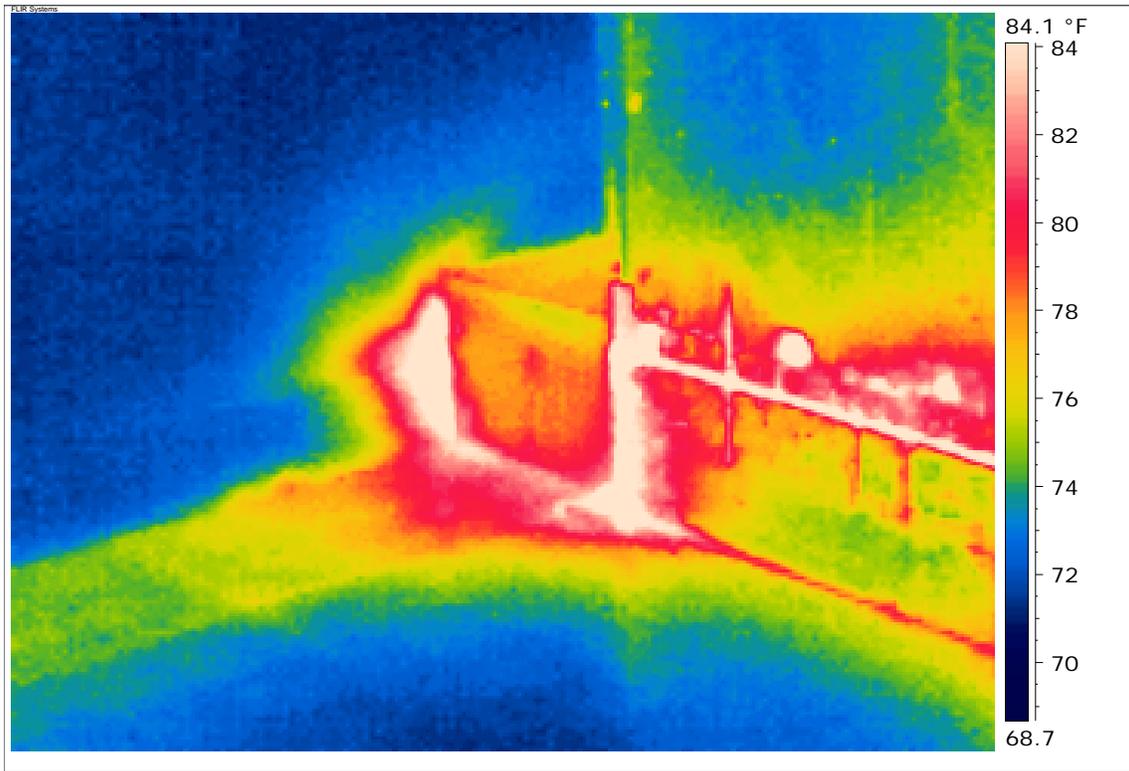
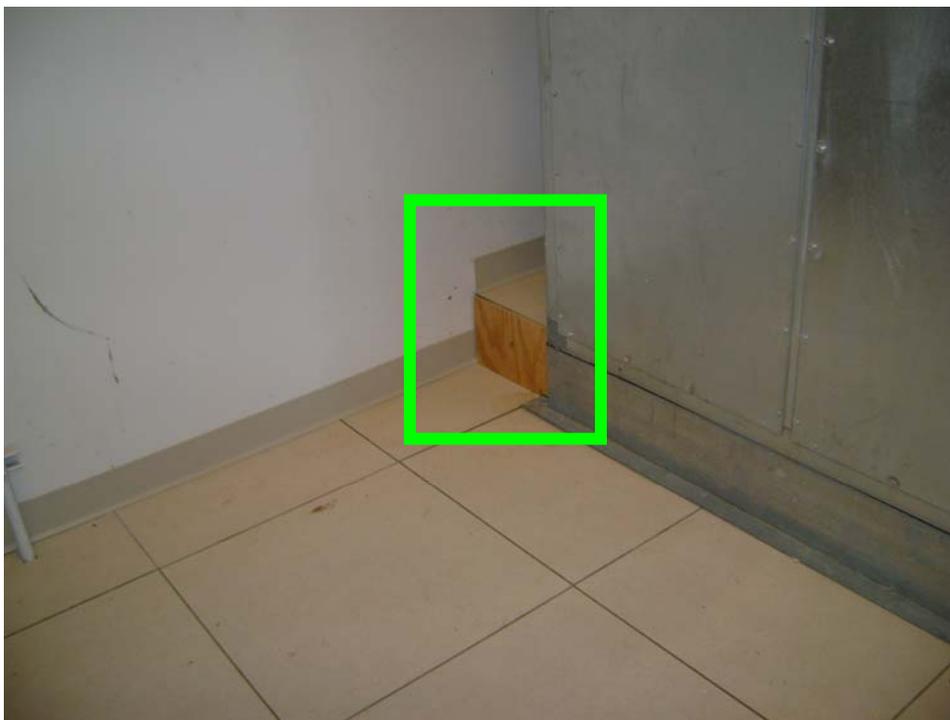
Description: Mechanical room anomaly at discharge of air handler

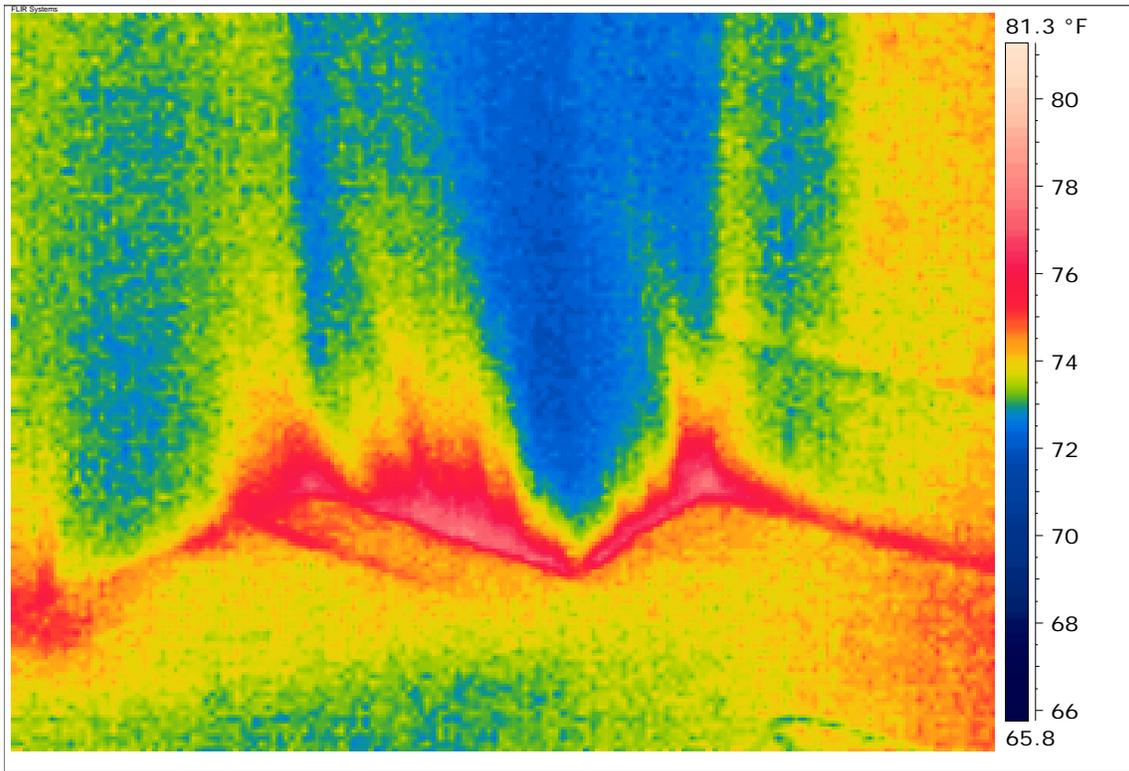
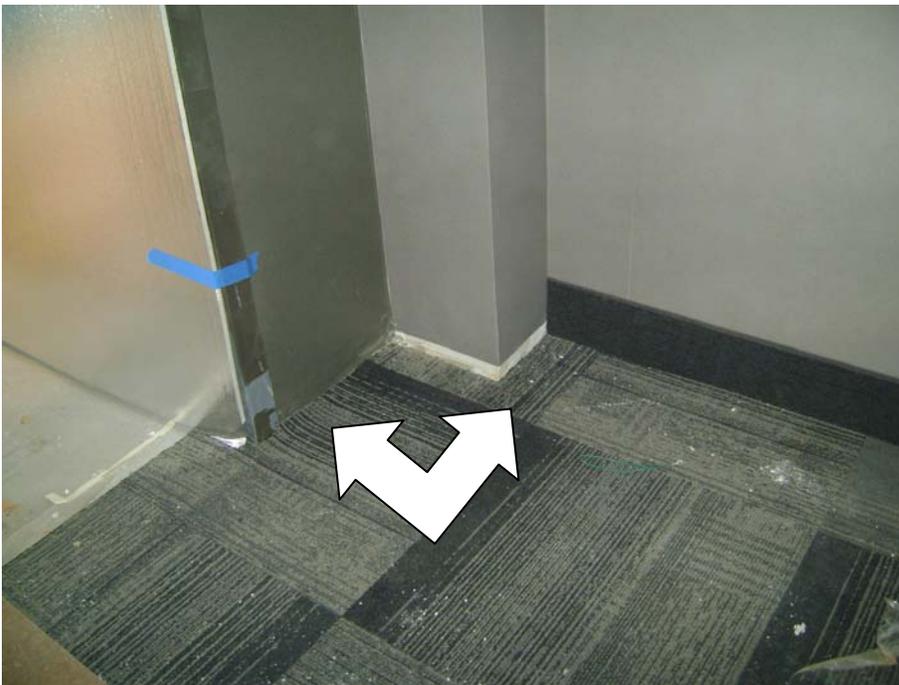
Description: Anomaly at wall base near south mech room hallway

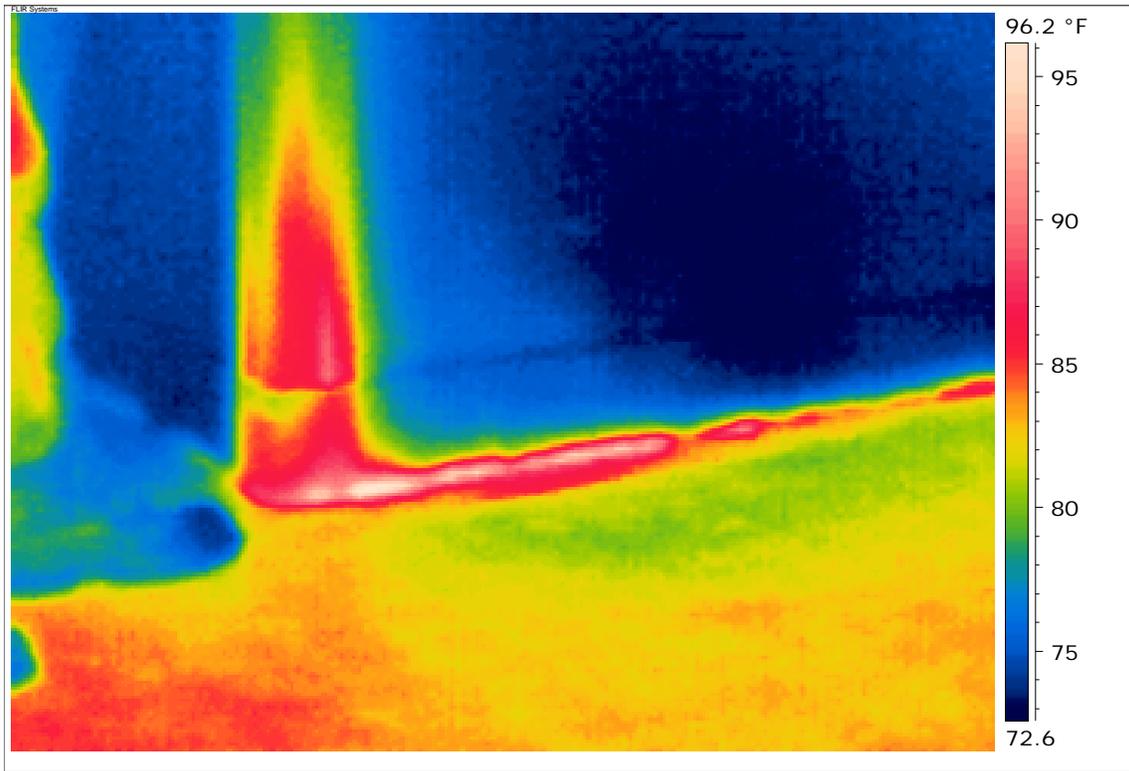
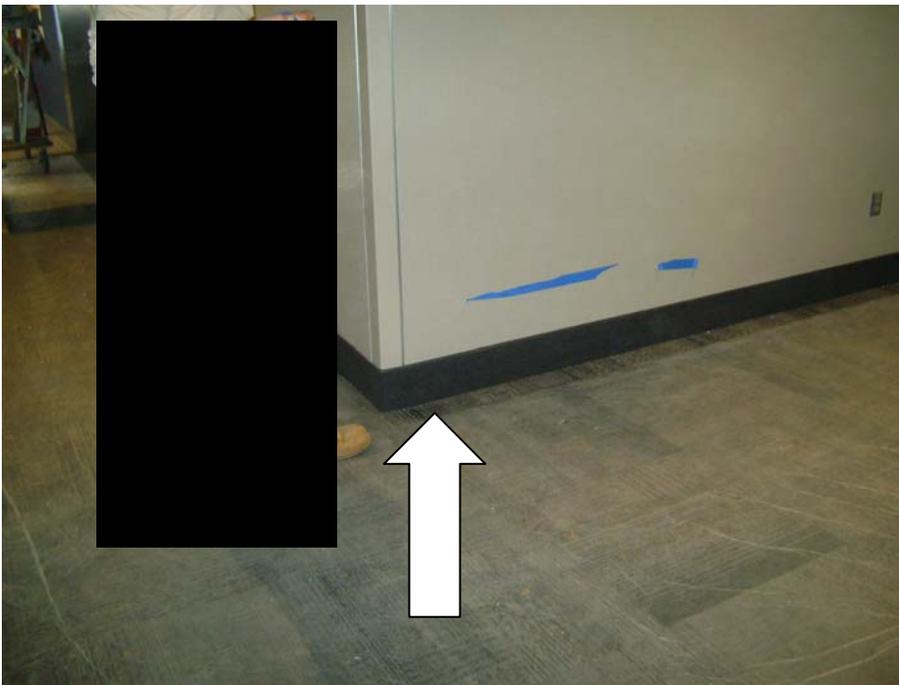
Description: Southeast hallway anomaly at wall base
