Infrared Thermographic Report
For

Report done by
John Cannamela
Level II Thermographer

Sample Customer

ELECTRICAL SURVEY

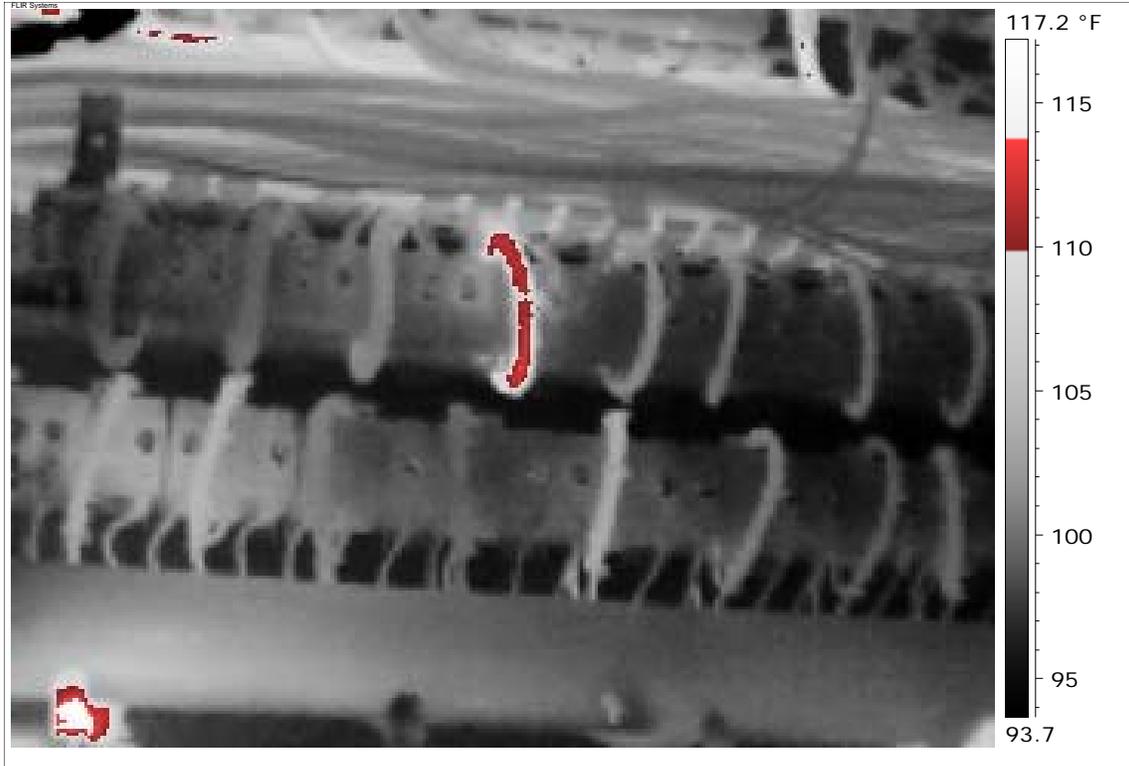
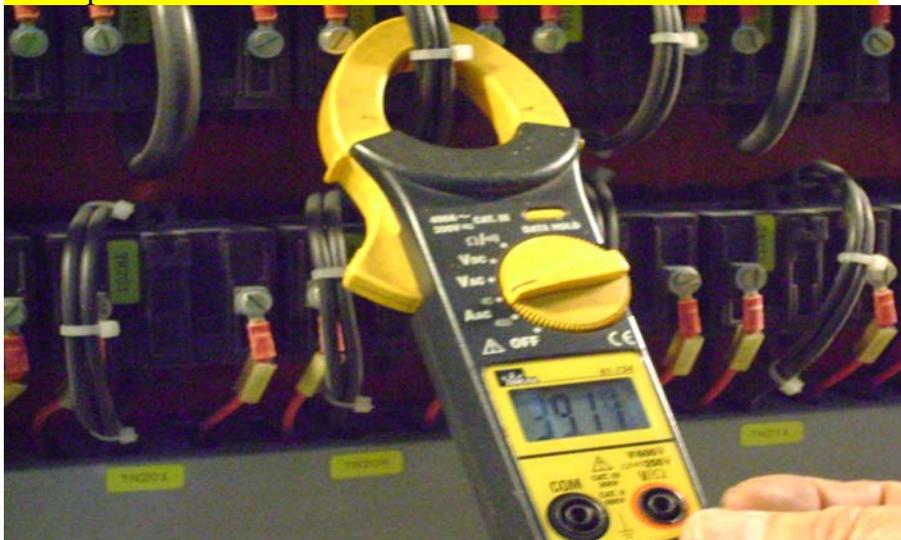
Description: CAB 105 CHECK LOAD TN162 CURRENT TRANS

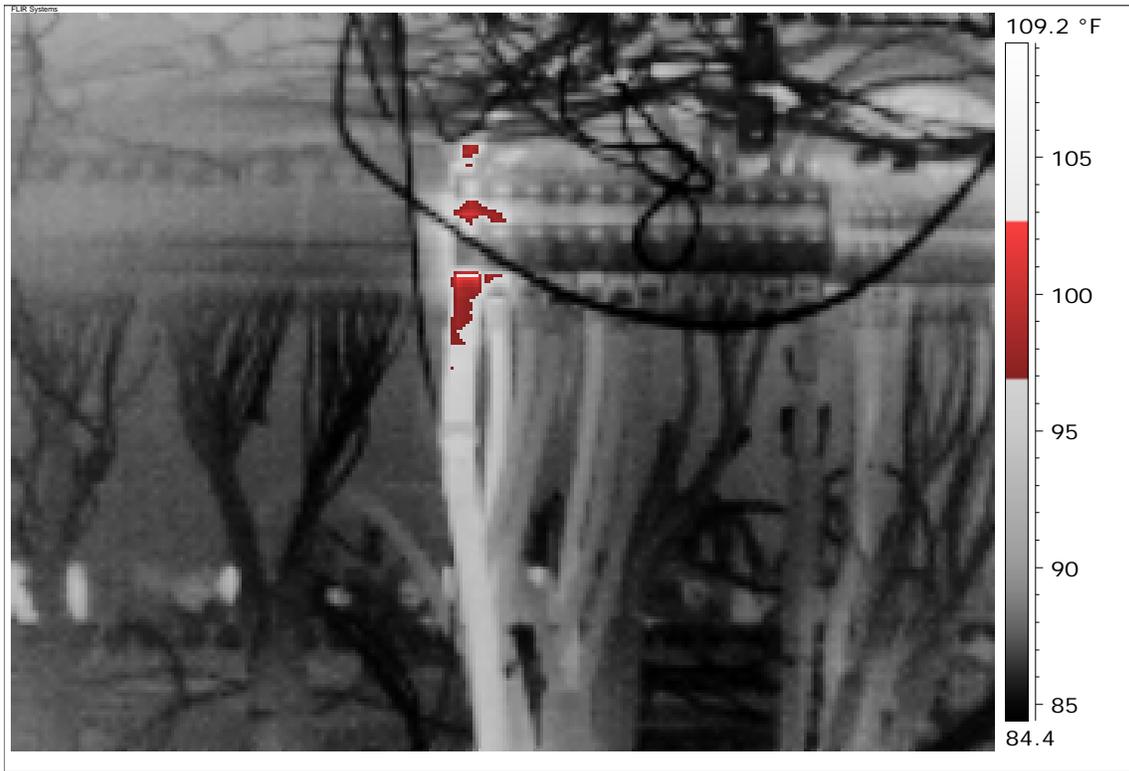
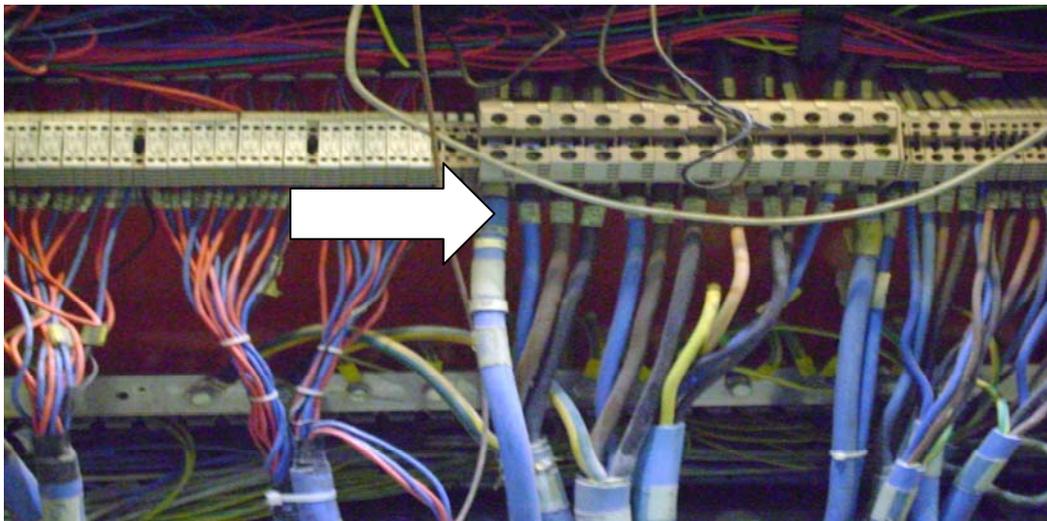
Description: CAB 106 CHECK NEUTRAL CONNECTION

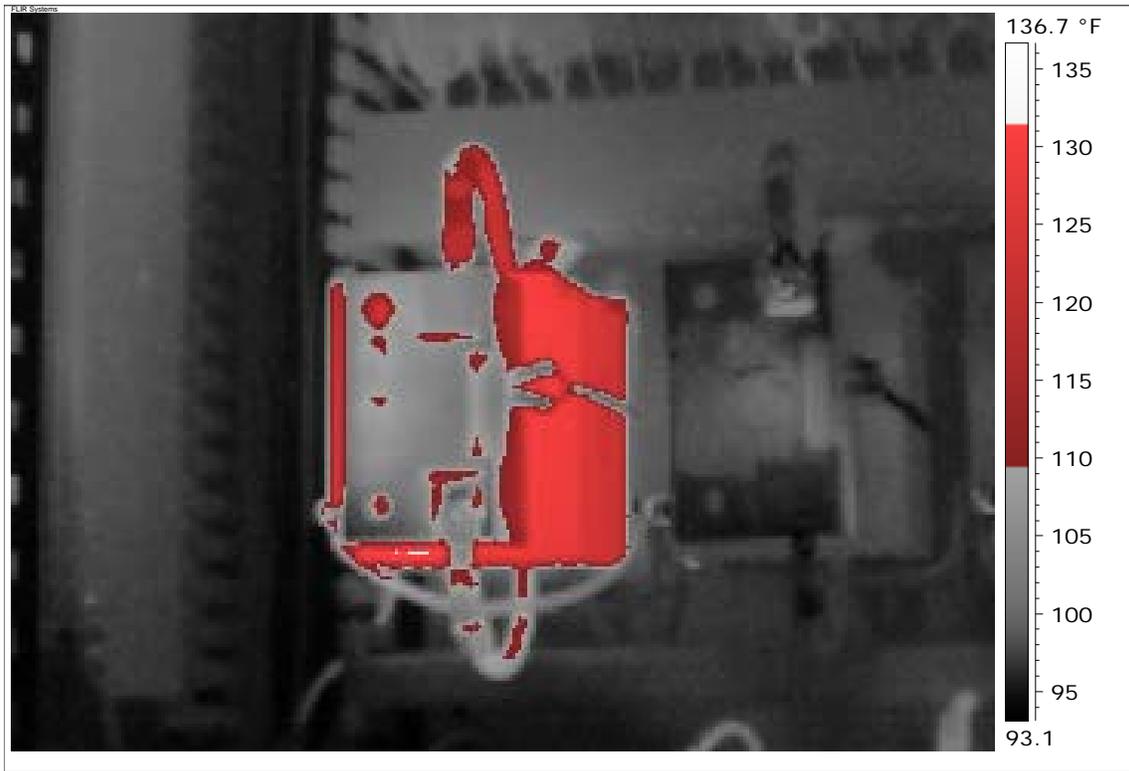
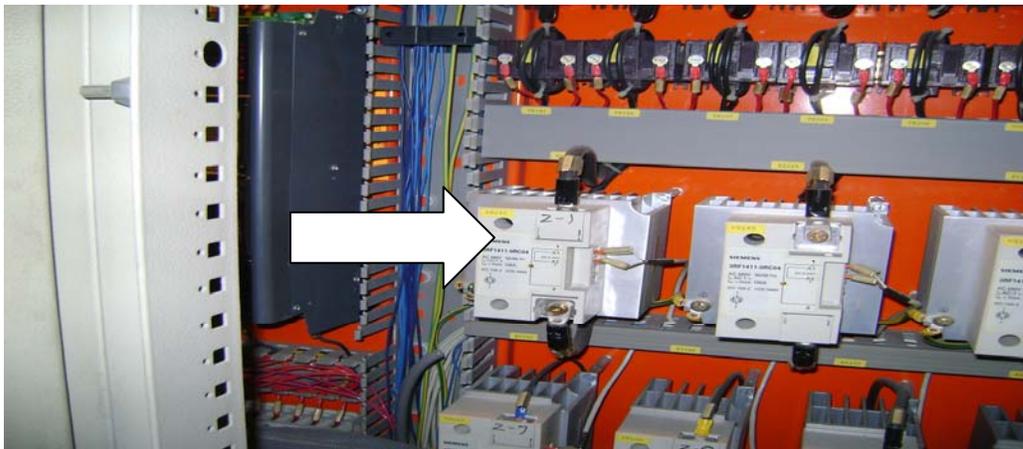
Description: CAB 205 CHECK HEATER BLOC CONNECTIONS

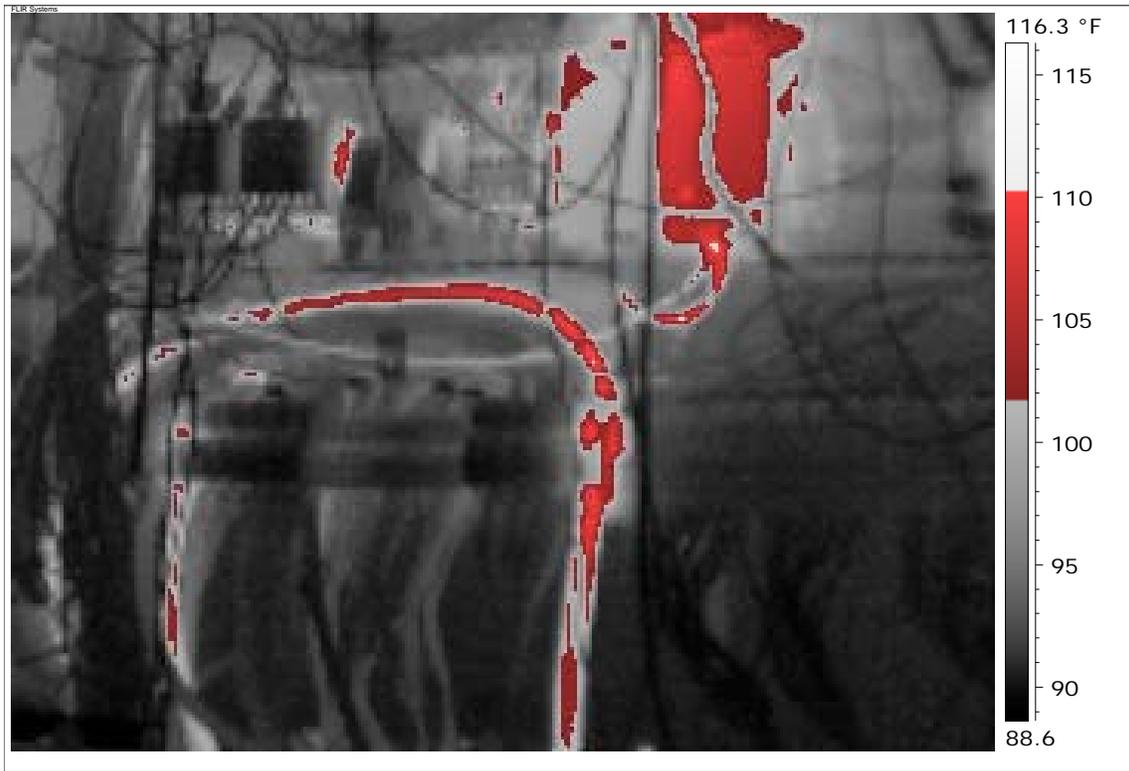
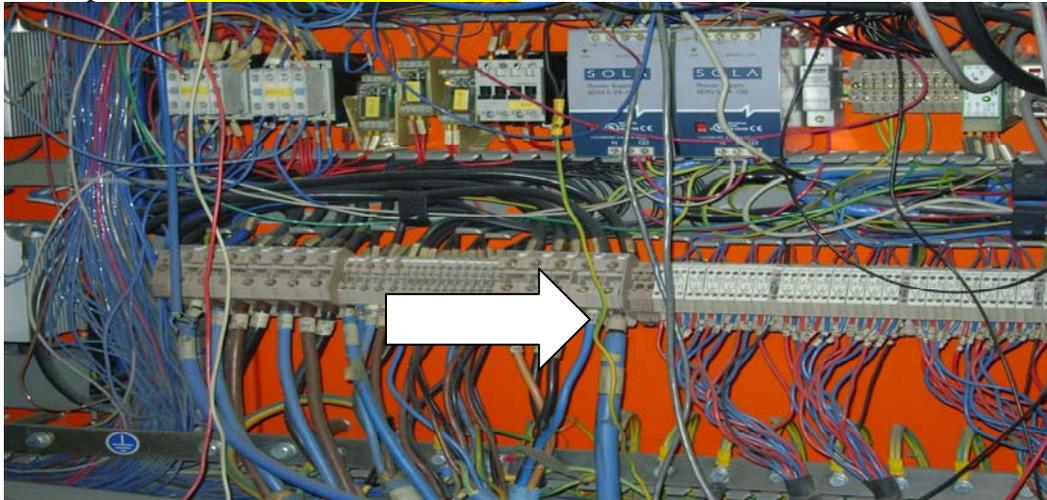
Description: CAB 206 CHECK LOAD

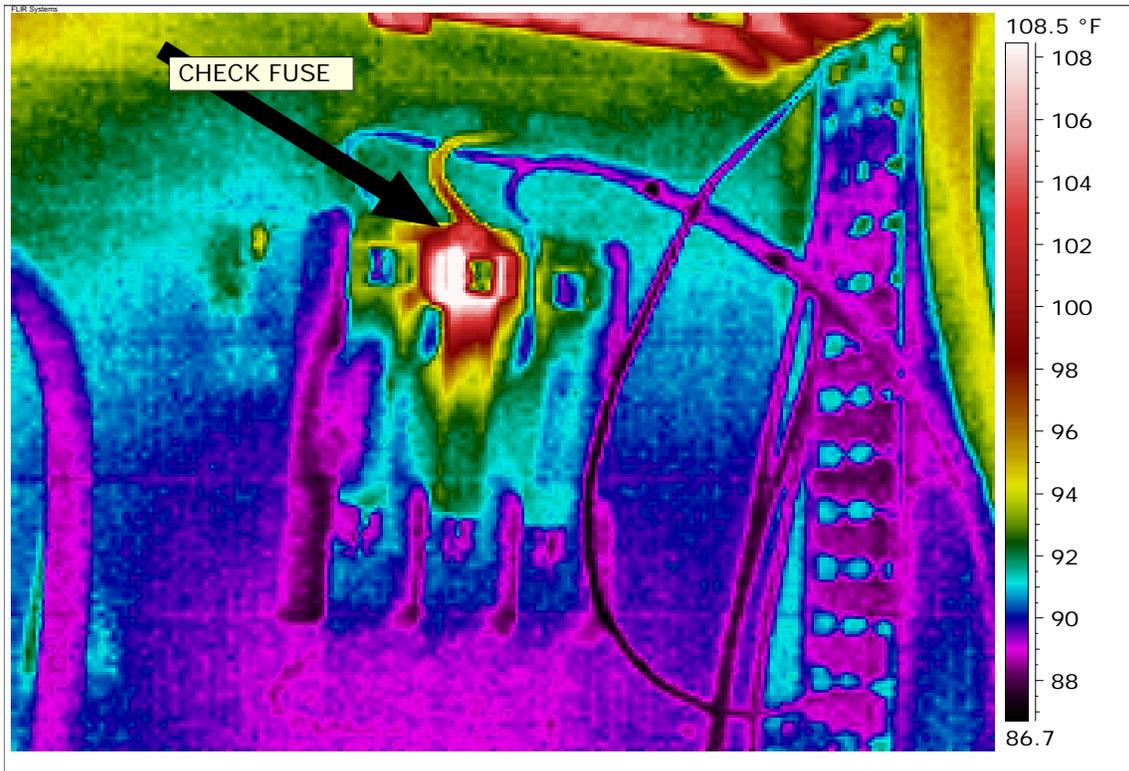
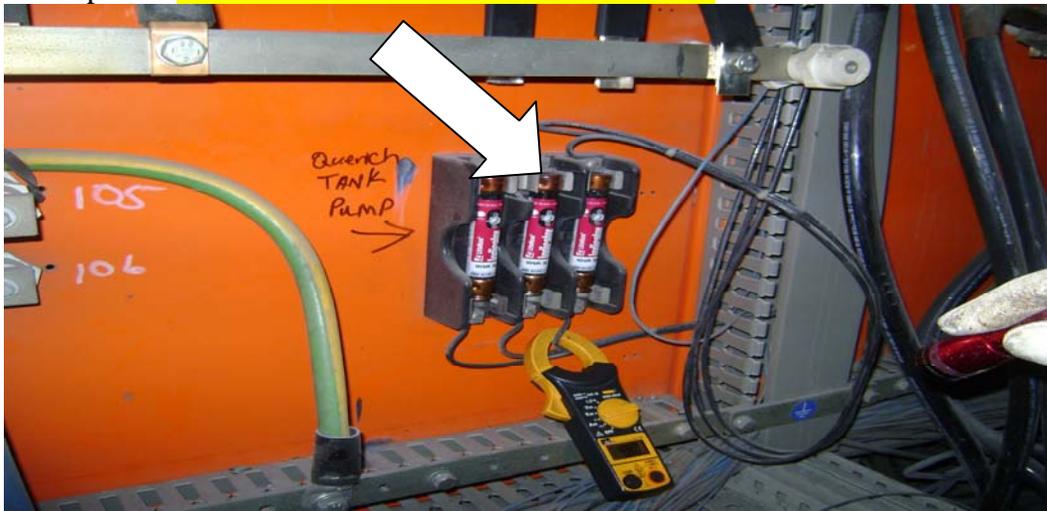
Description: CAB 304 CHECK FUSE CONNECTION

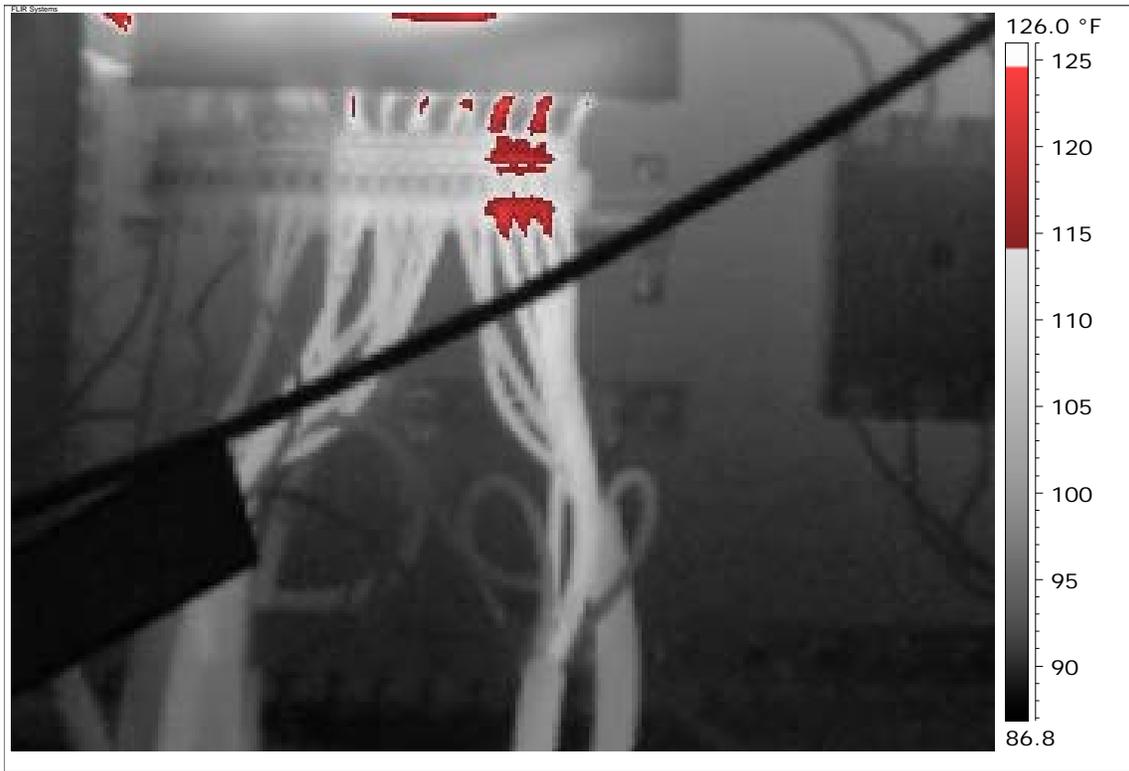
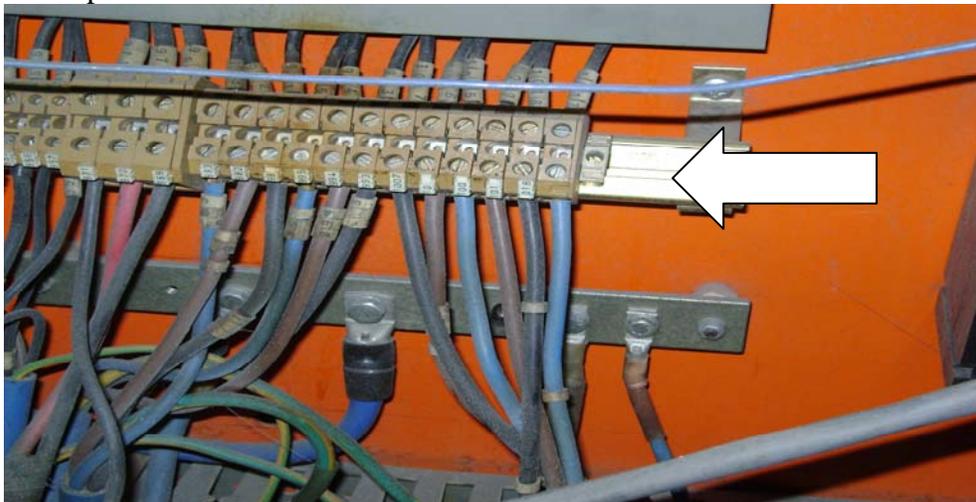
Description: CAB 8 CHECK CONNECTIONS

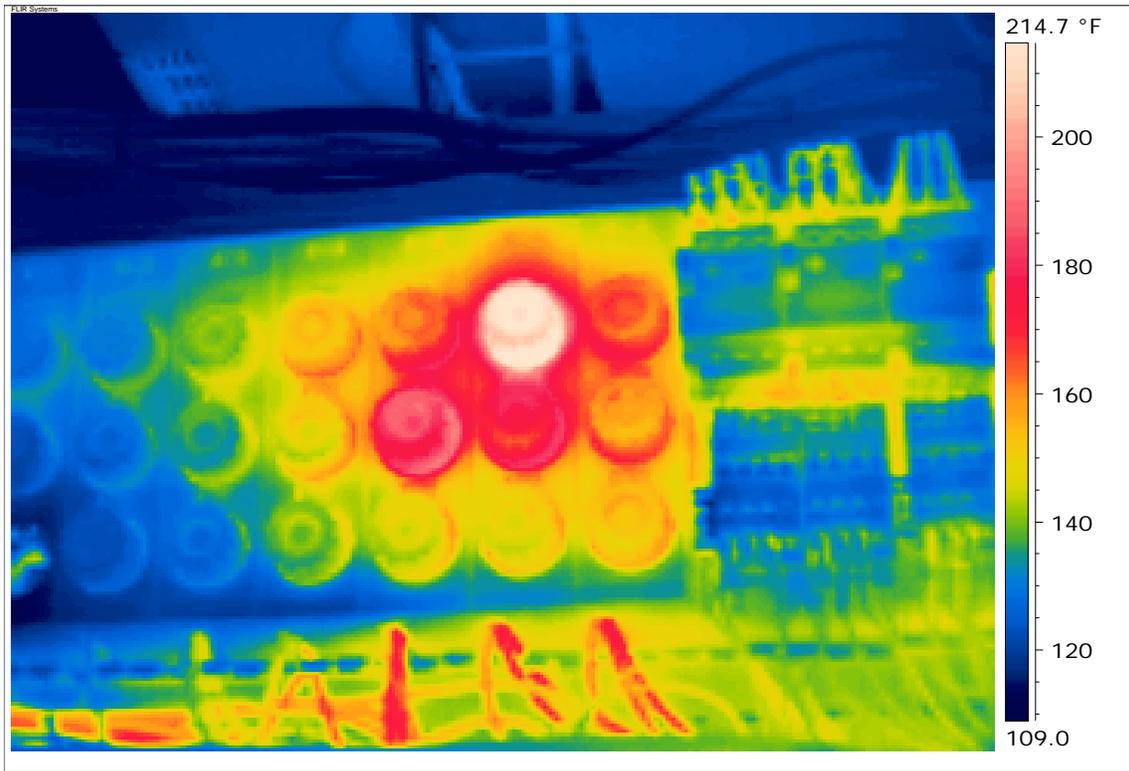
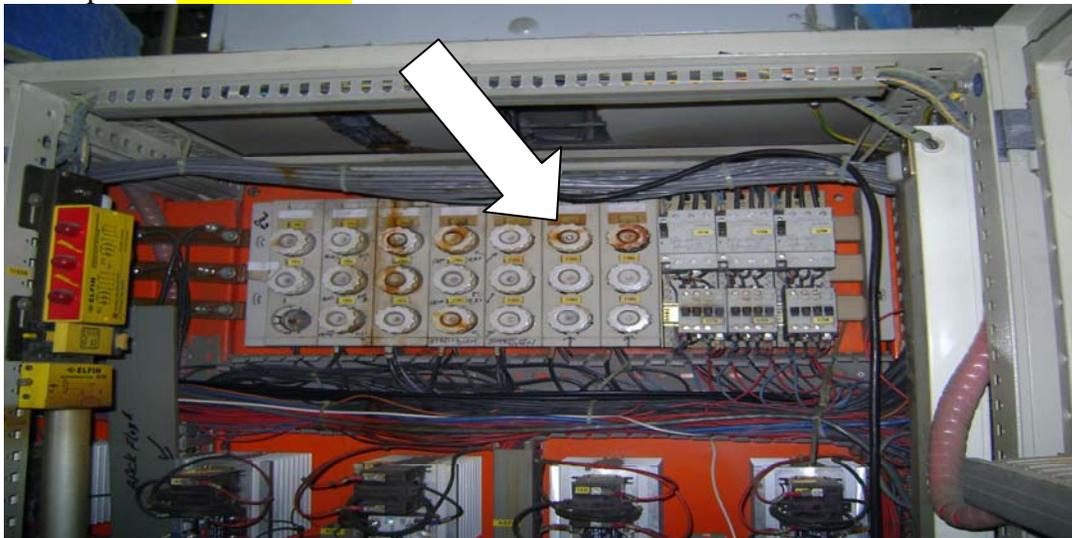
Description: CAB 8 FUSE

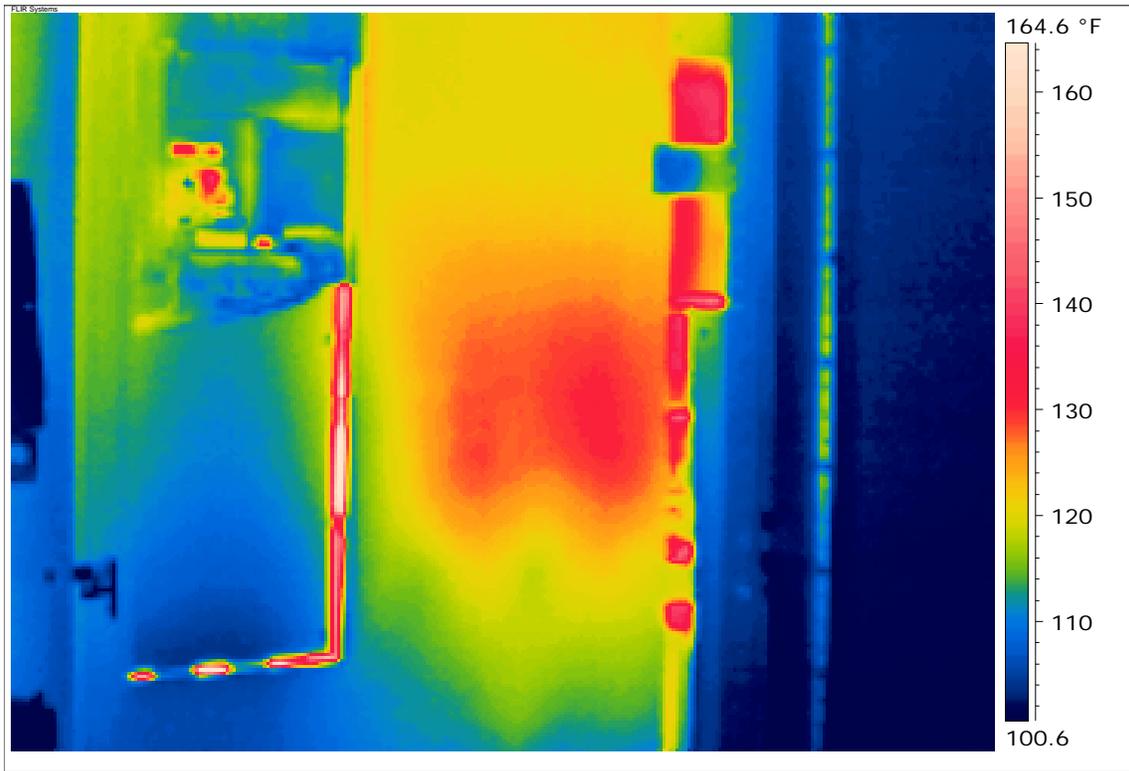
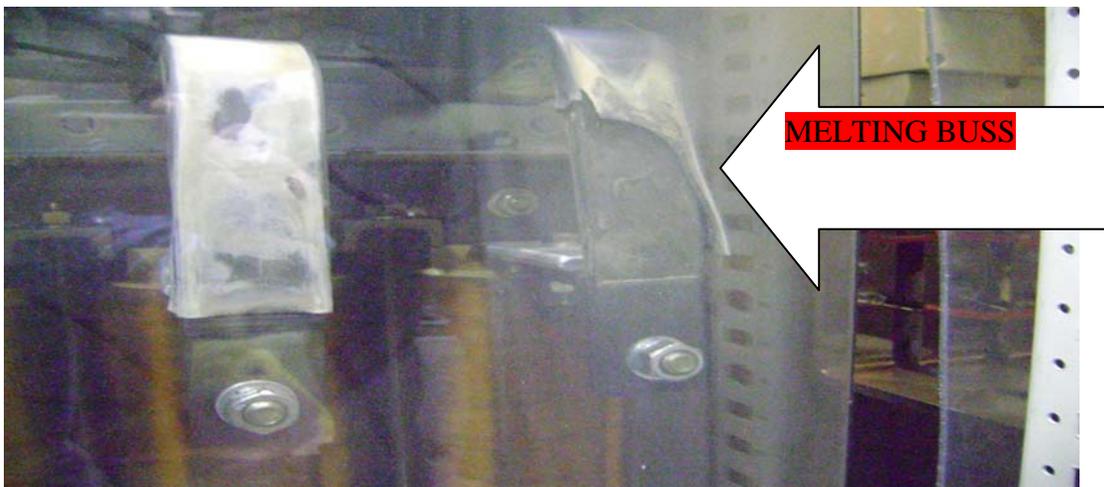
Description: CAB 401 MAJOR PROBLEM CORRECT IMMEDIATLY

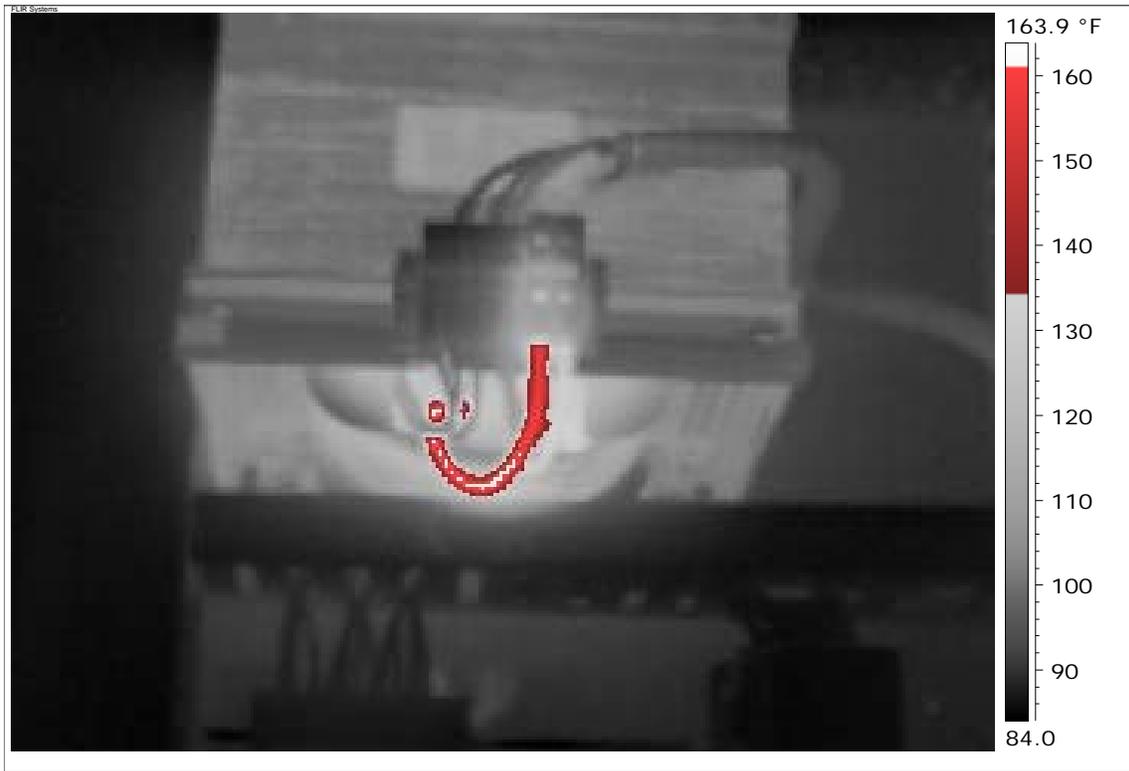
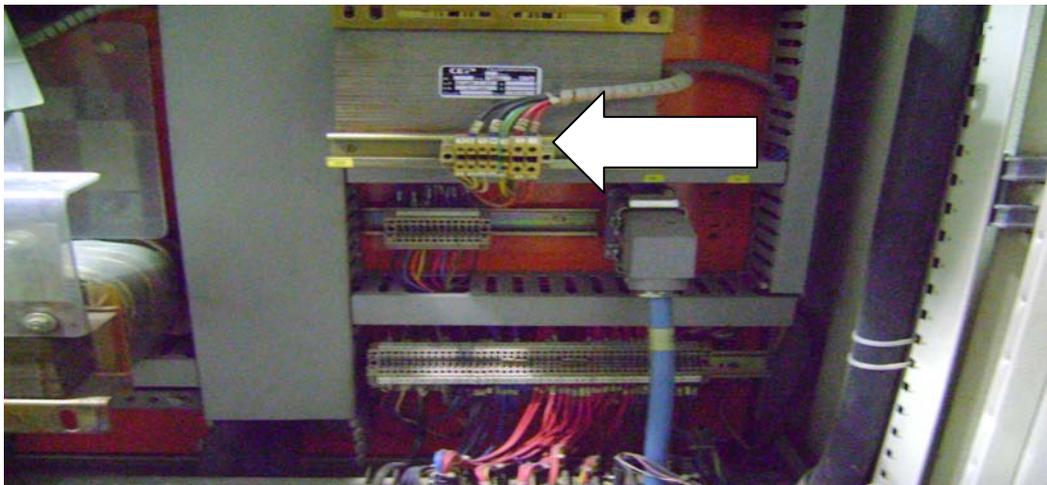
Description: CAB 115 TRANSFORMER CHECK LOAD

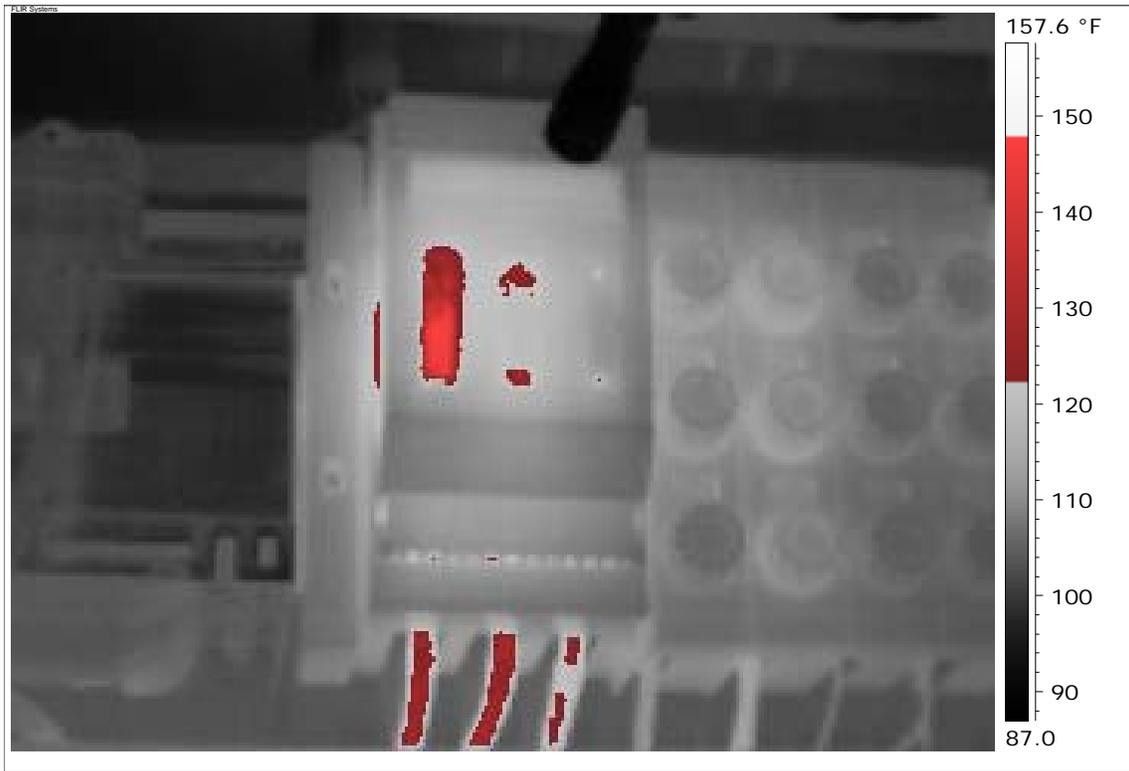
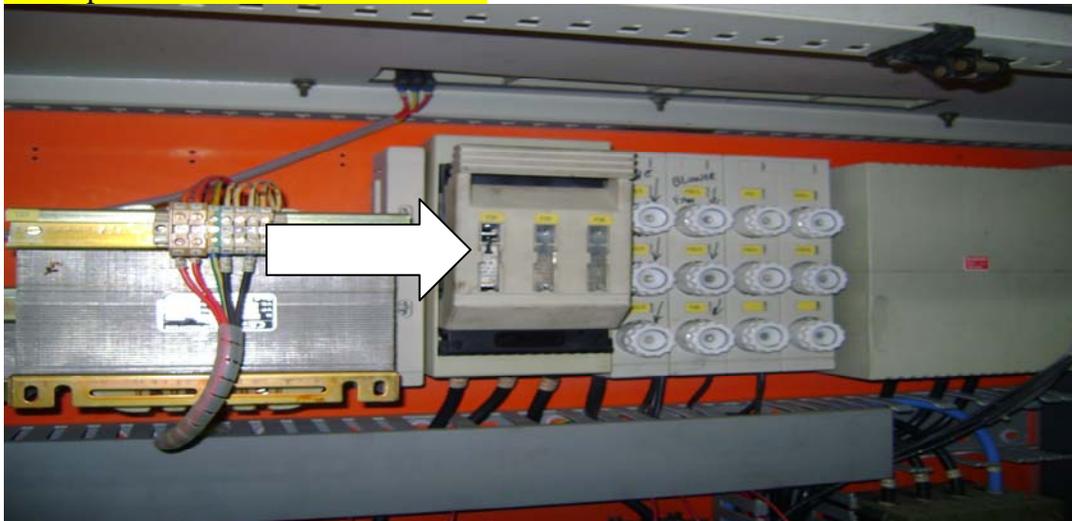
Description: CHECK FUSE BLOCK

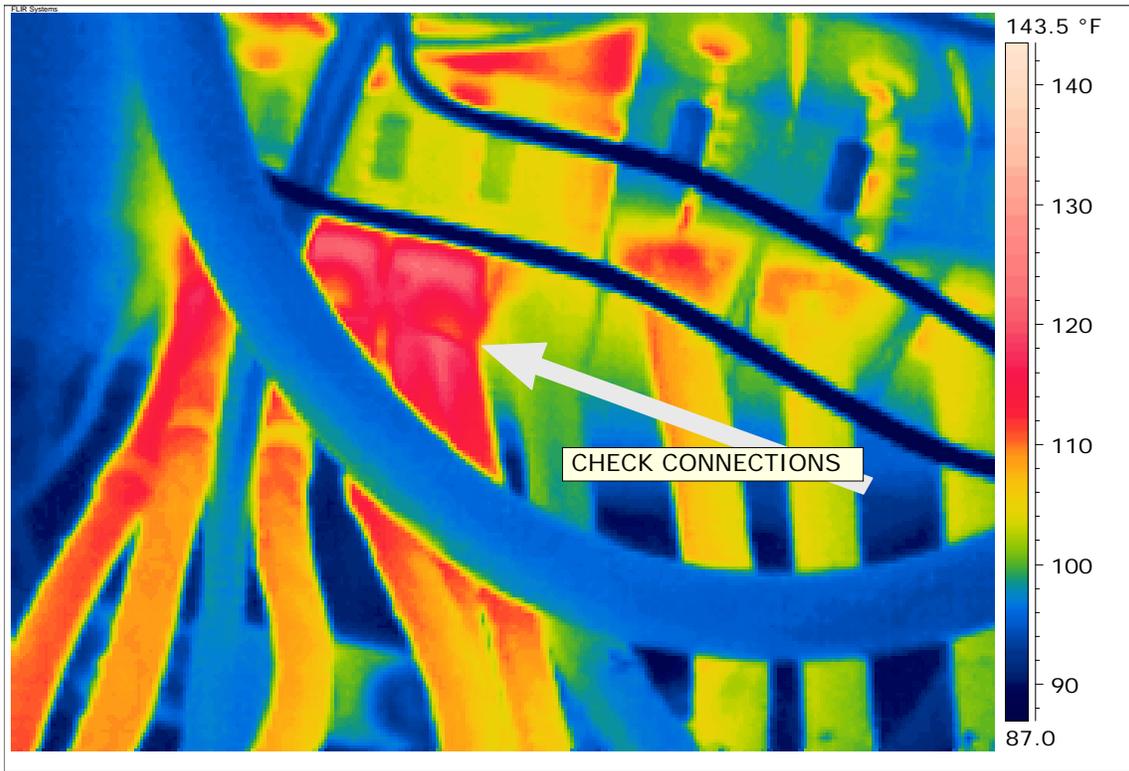
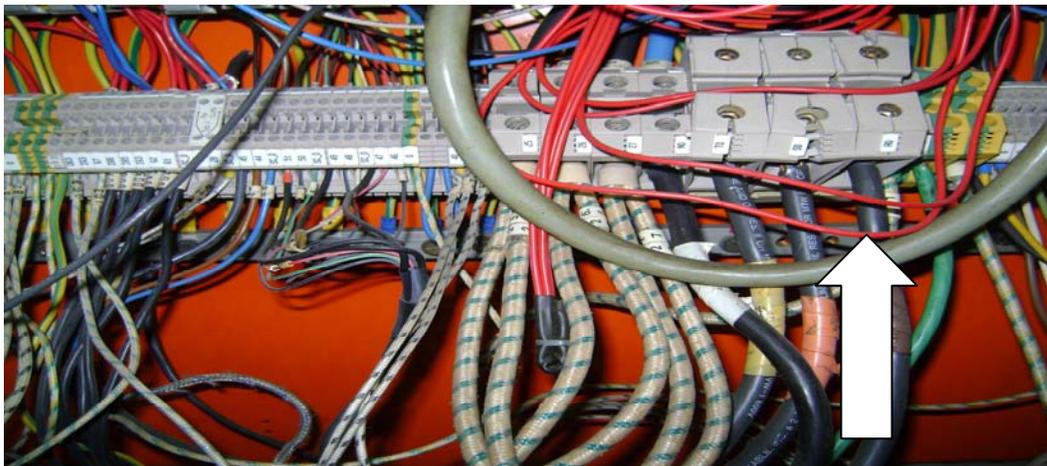
Description: PANEL NEXT TO CAB 118 CHECK CONNECTIONS

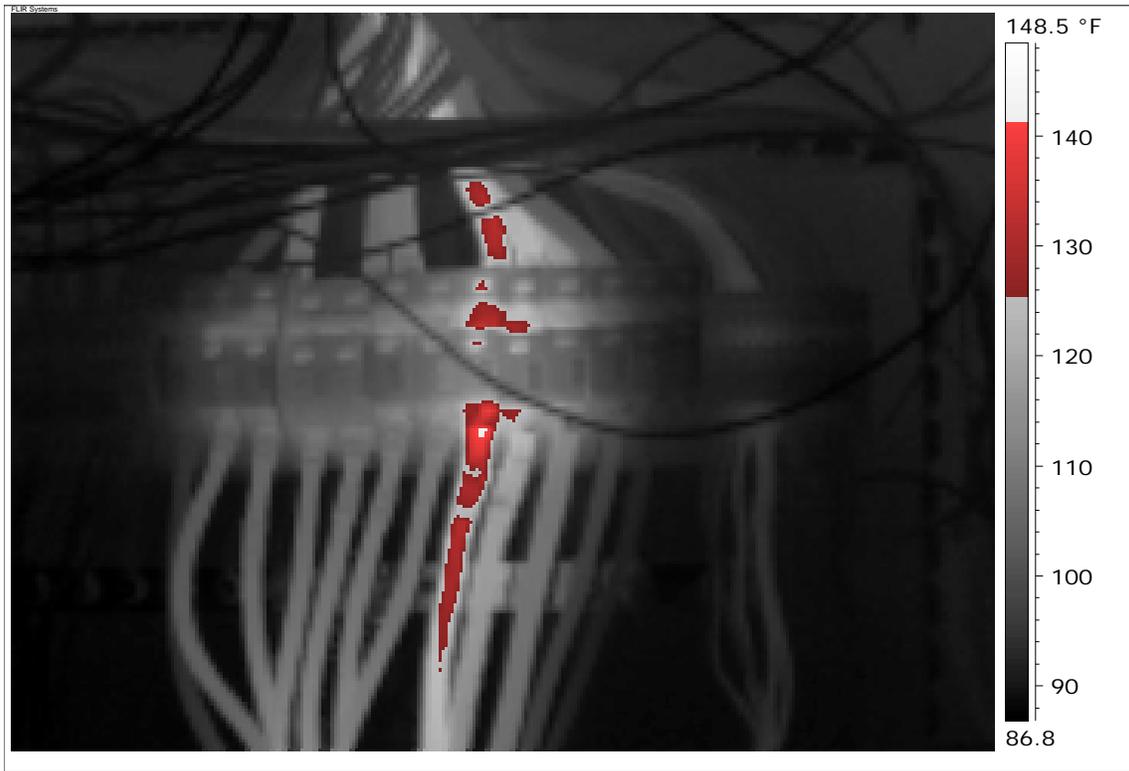
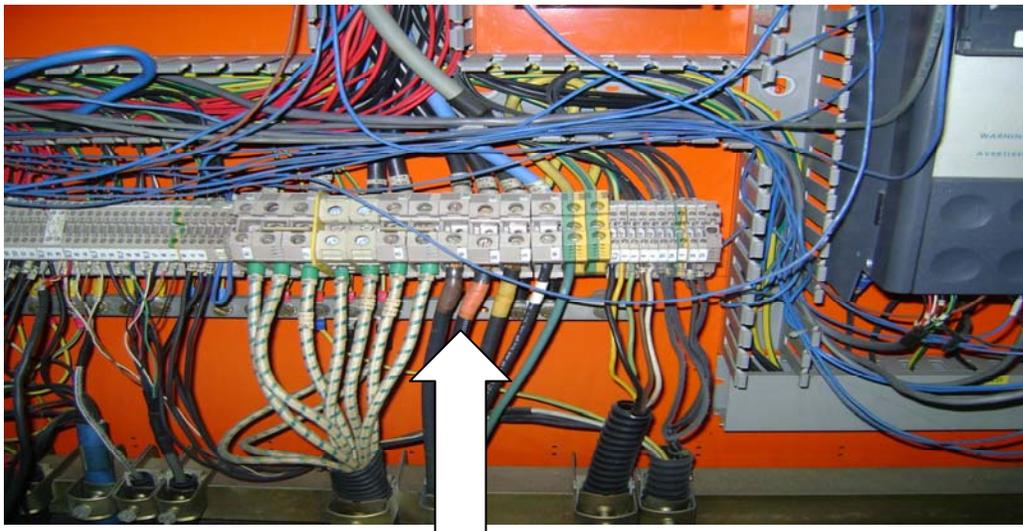
Description: **LINE 2 ANNEALING OVEN CHECK CONNECTIONS**

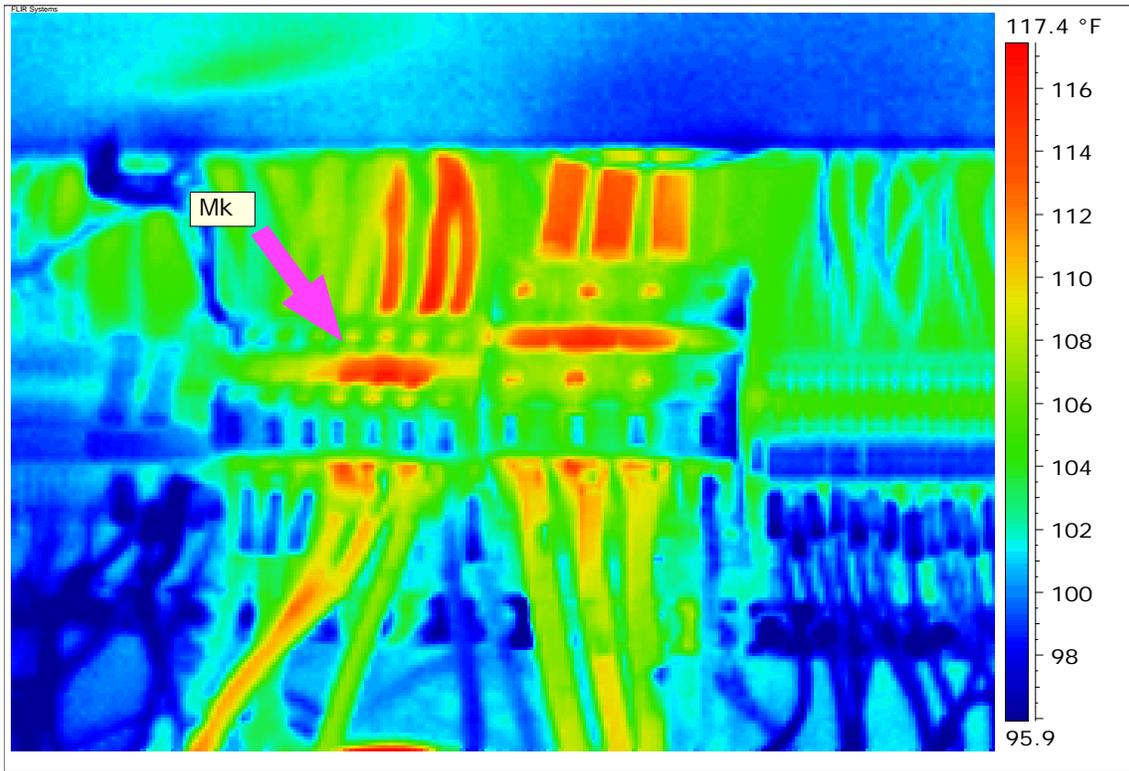
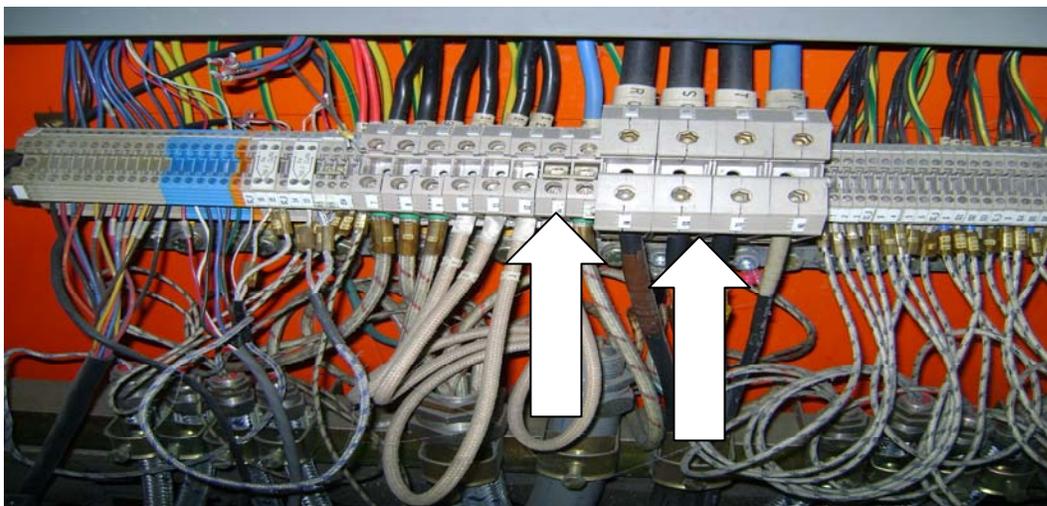
Description: CAB 214 CHECK CONNECTIONS

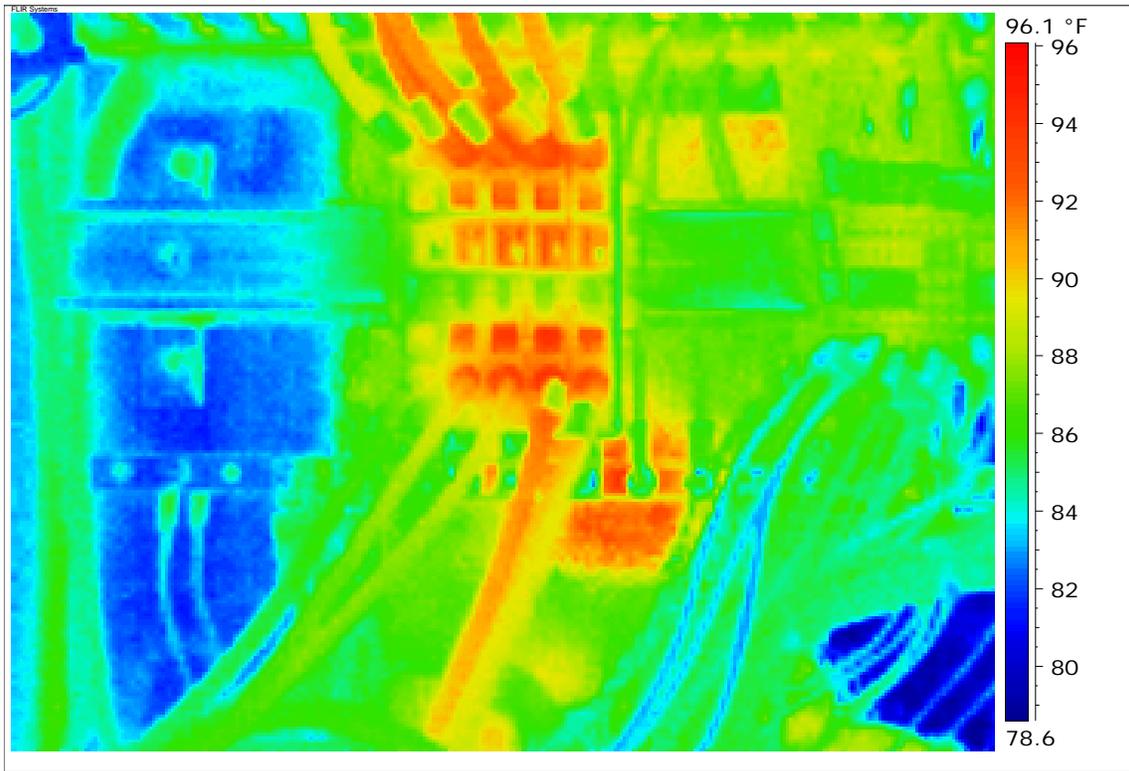
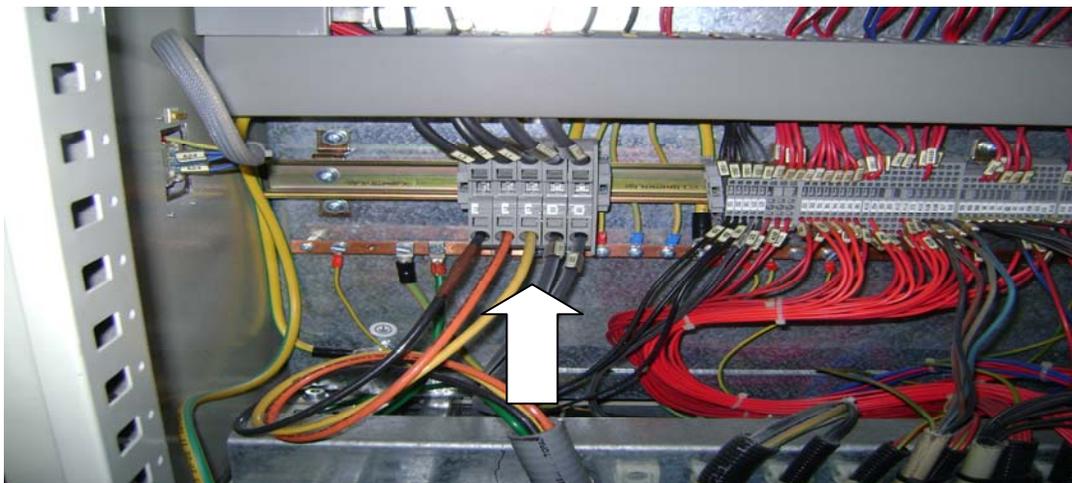
Description: **LINE 4 GODET 5 CHECK CONNECTIONS**

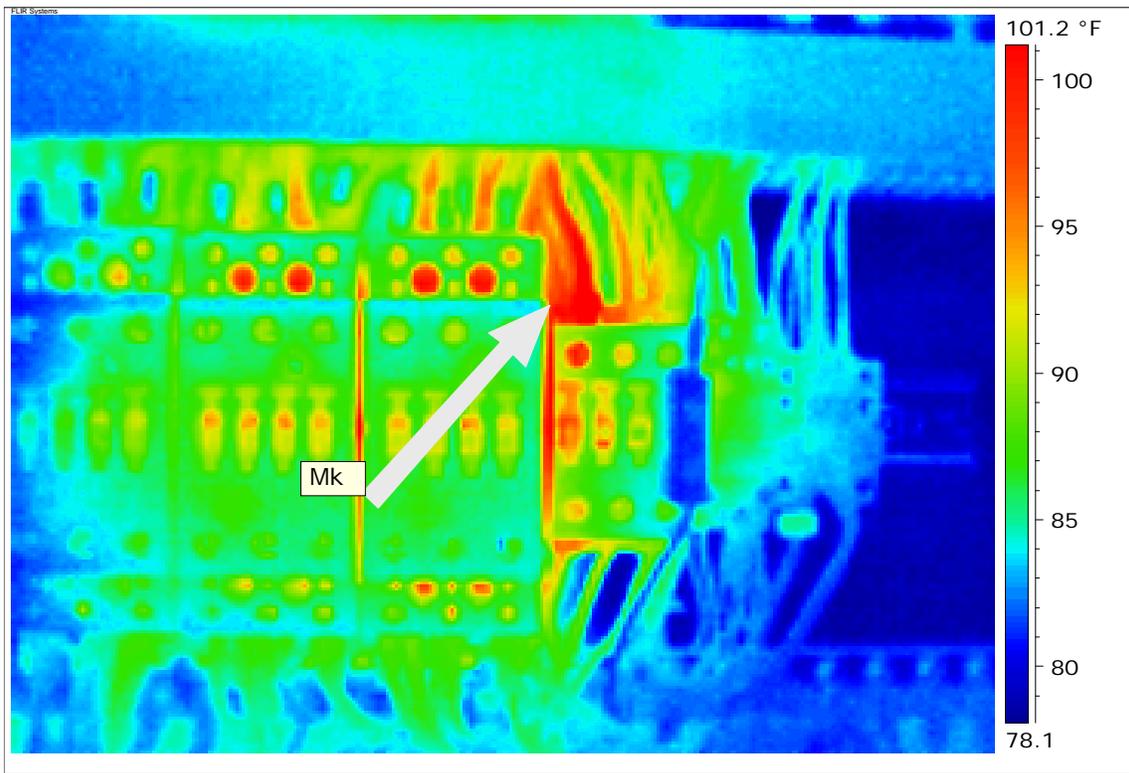
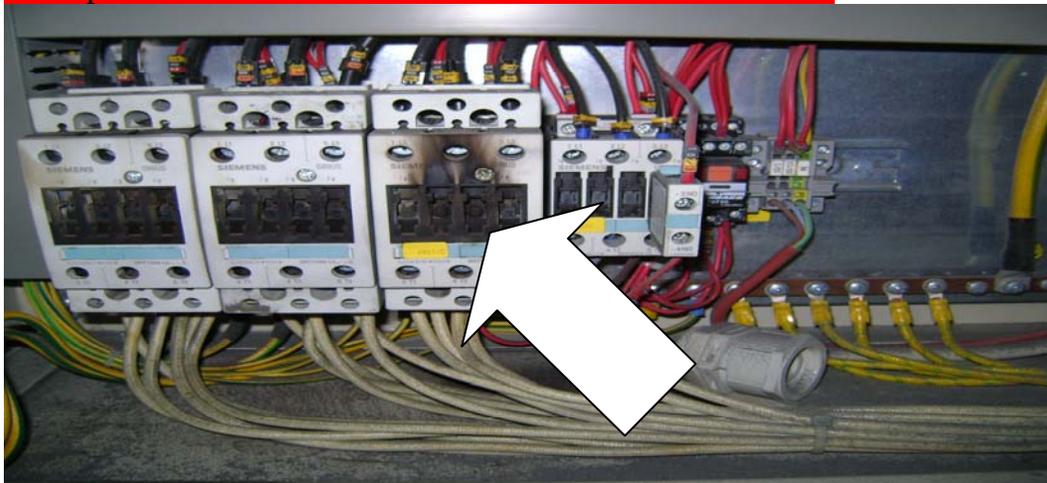
Description: LINE 4 GODET 3 OIL HEATER VISIBLE BURN

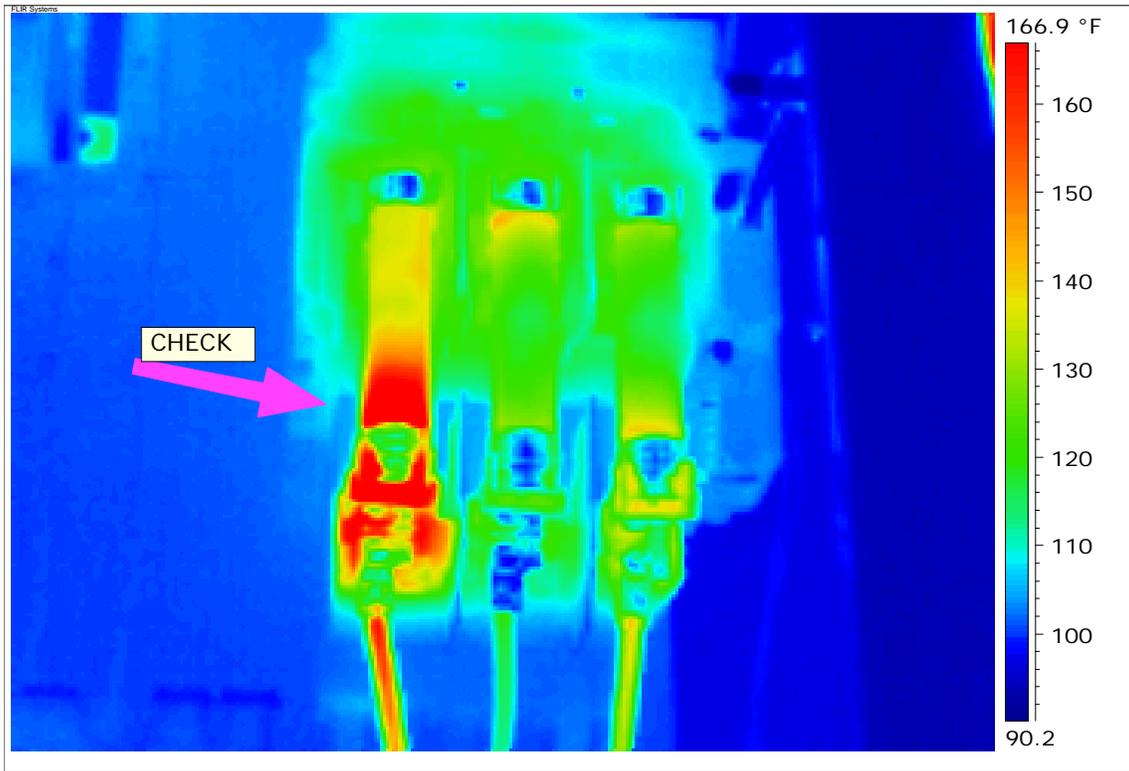
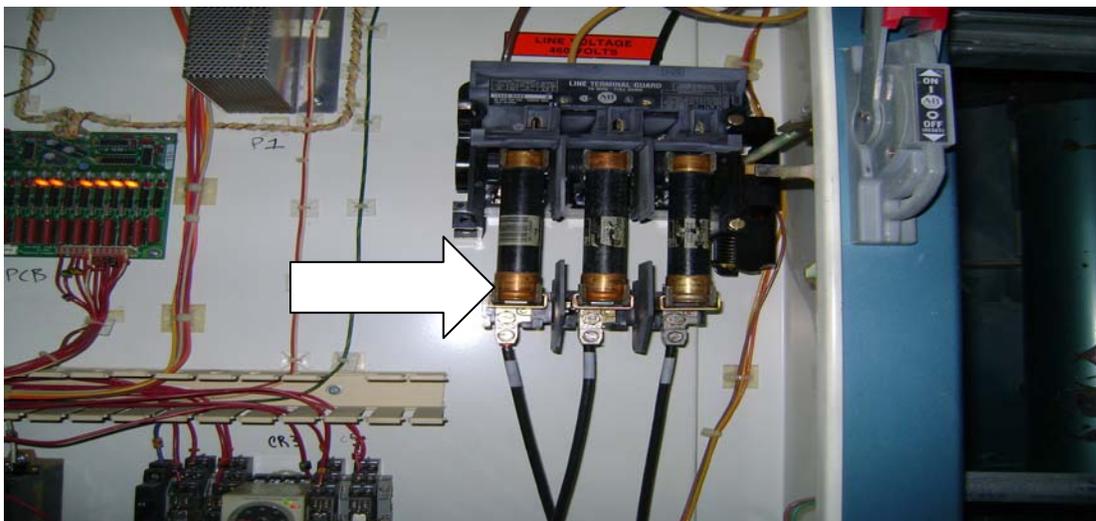
Description: **LINE 3 DRYER MAIN PANEL FUSE CLIP**
