Infrared Thermographic Report
For

Report done by
John Cannamela
Level II Thermographer

Sample Customer

ELECTRICAL SURVEY

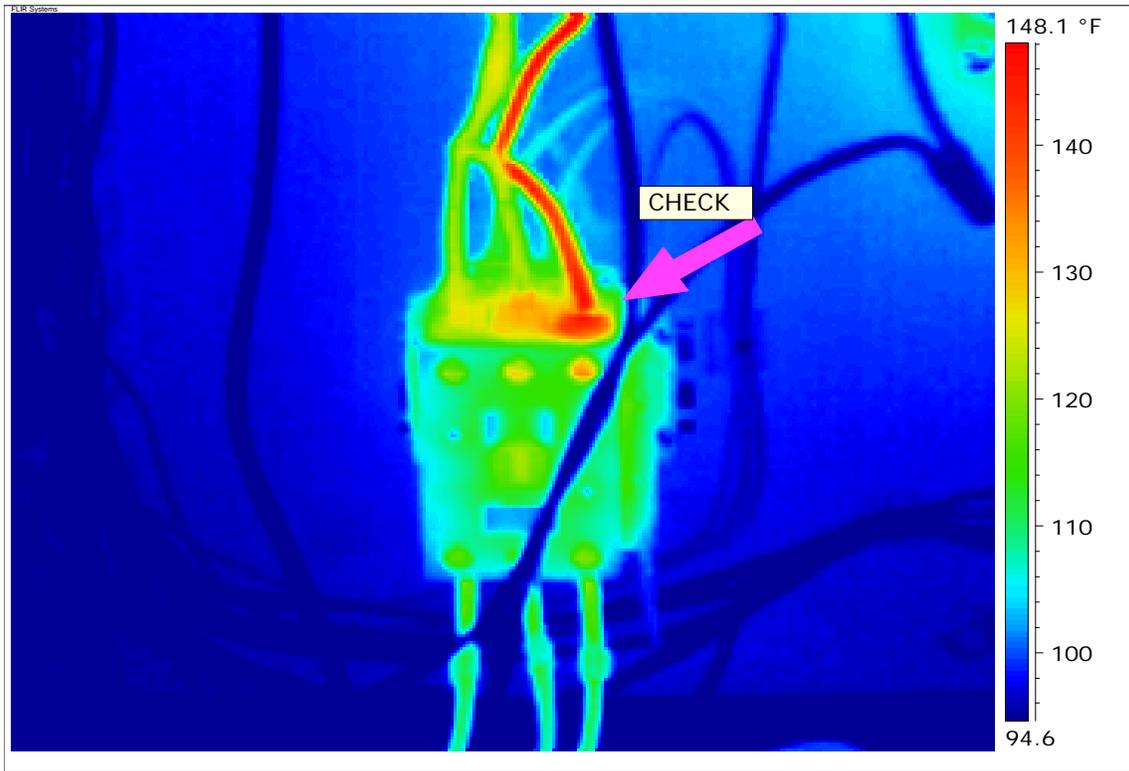
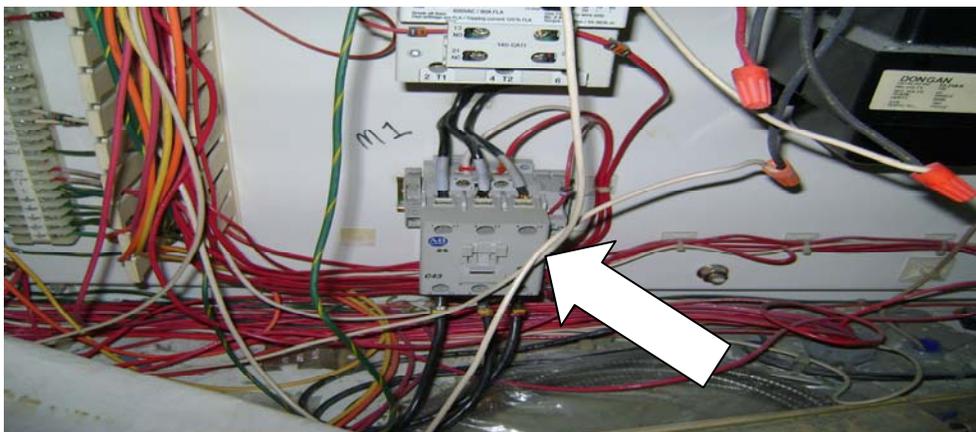
Description: **LINE 3 DRYER MAIN CHECK CONNECTION**

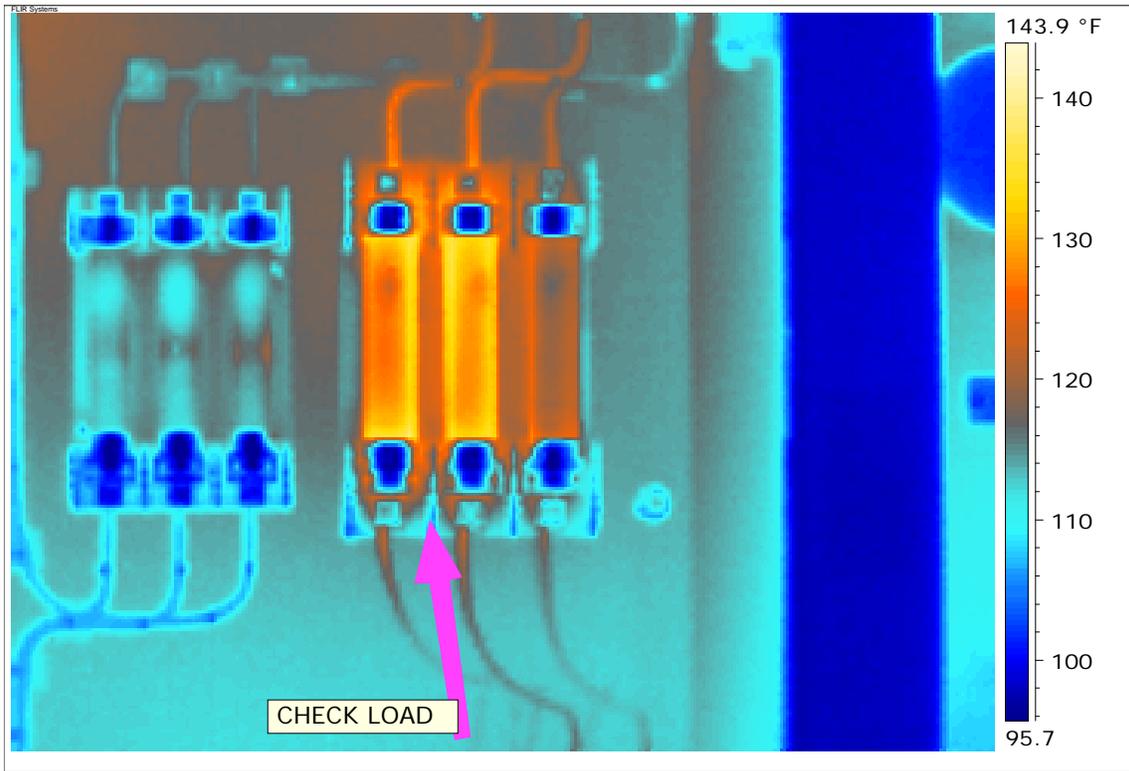
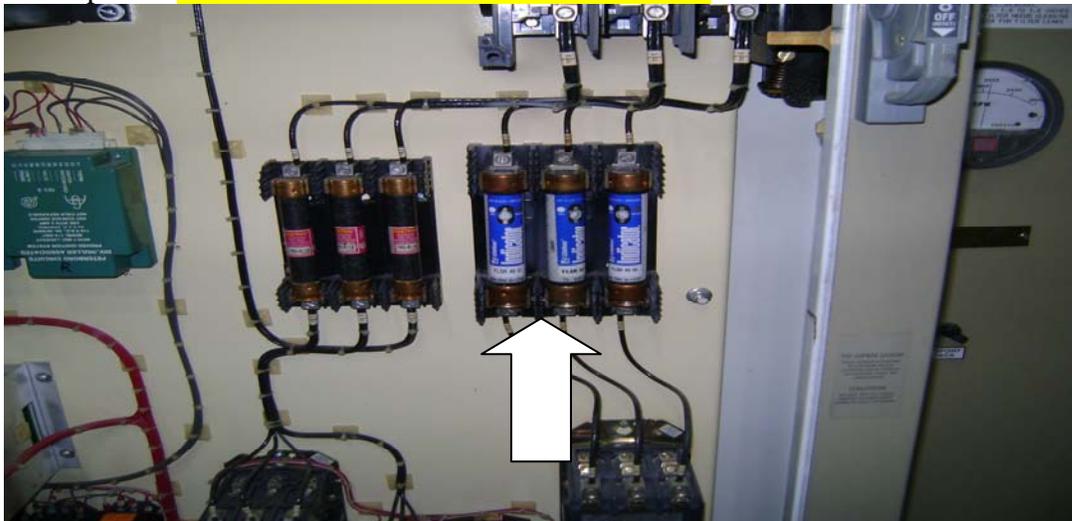
Description: **LINE 2 DRYER 2 FUSE CHECK LOAD**

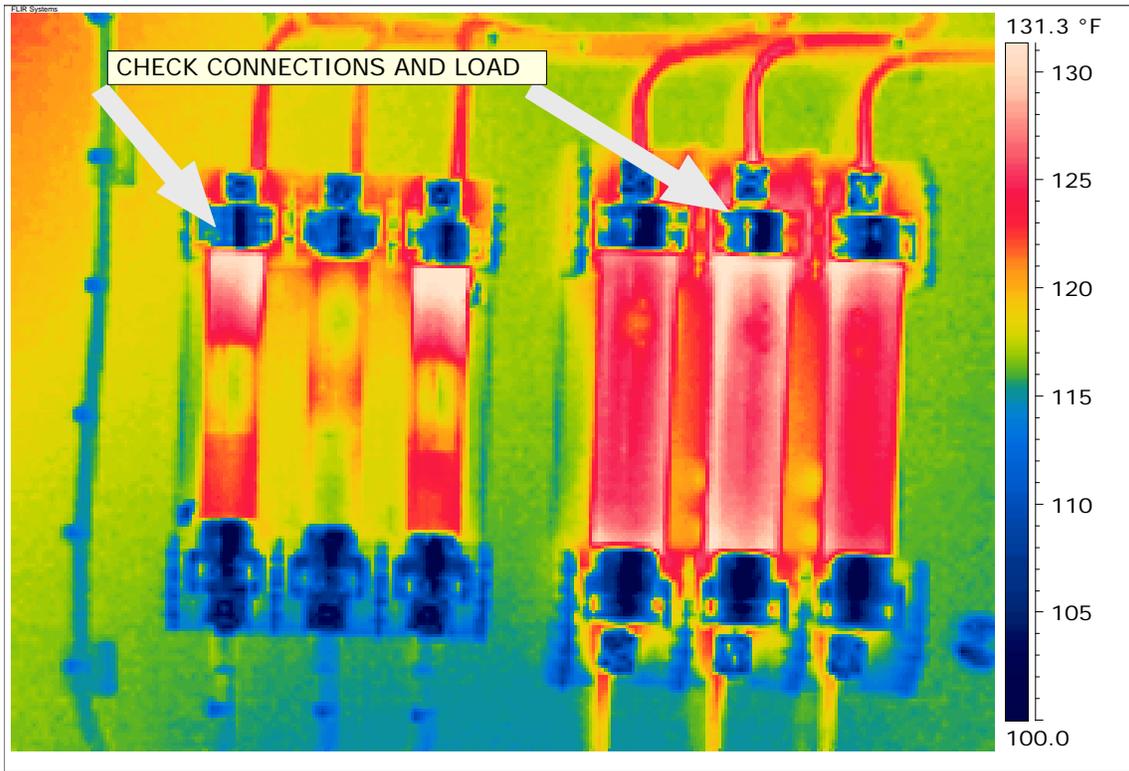
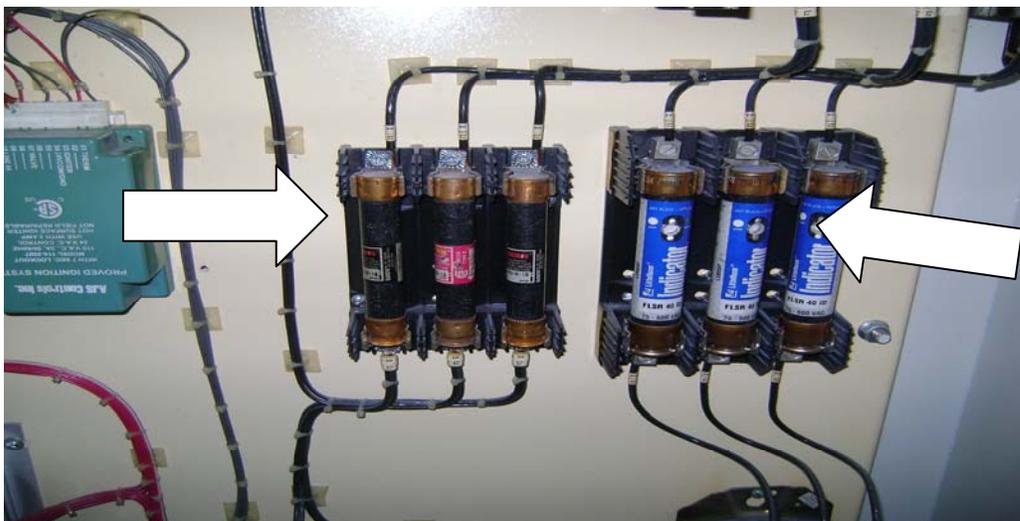
Description: LINE 1 DRYER 1 CHECK LOAD AND CONNECTIONS

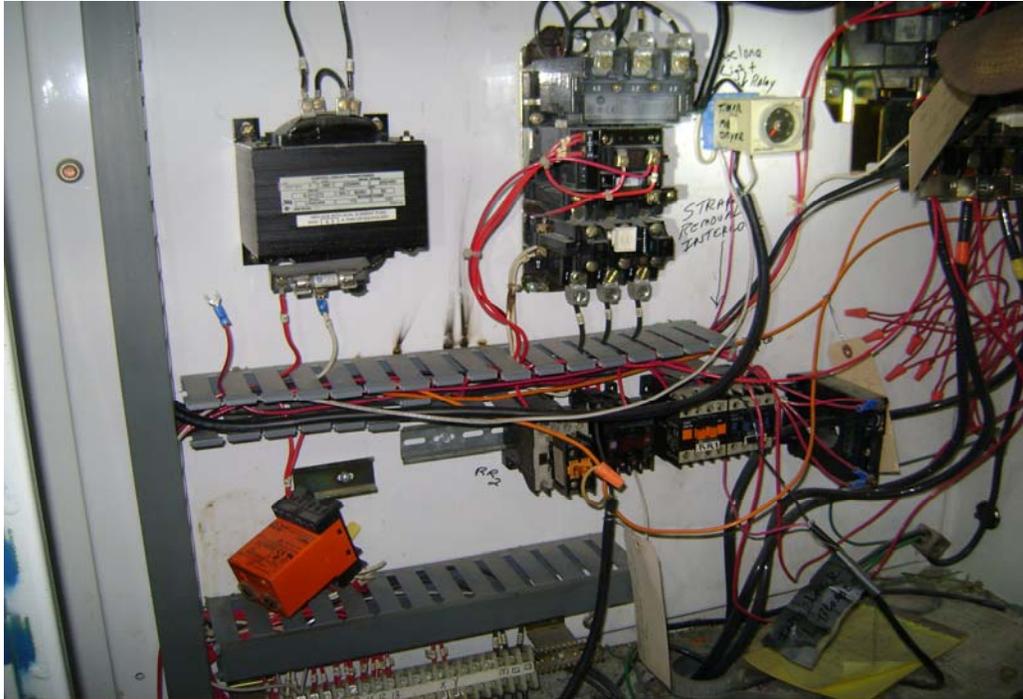
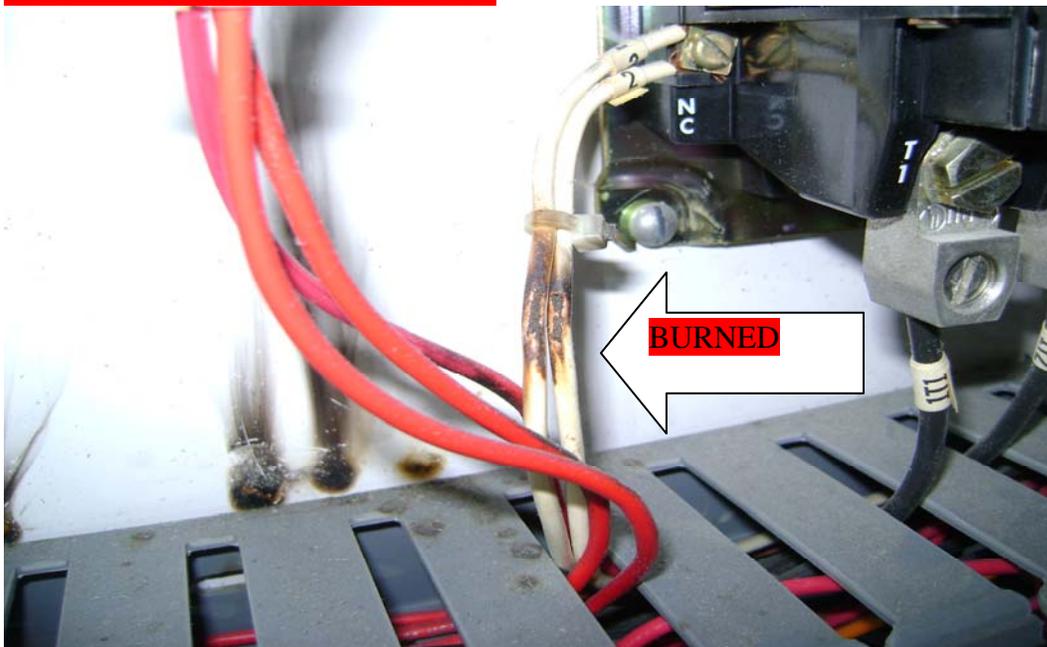
LINE 3 GRINDER BURNED WIRES

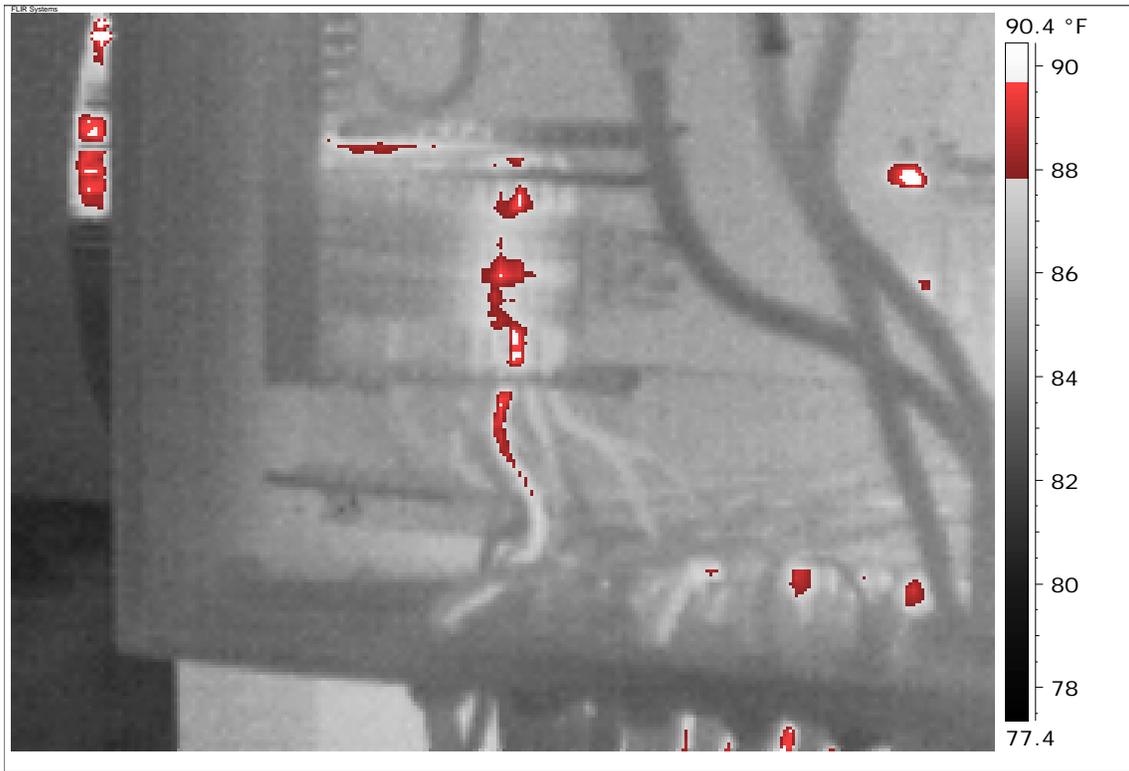
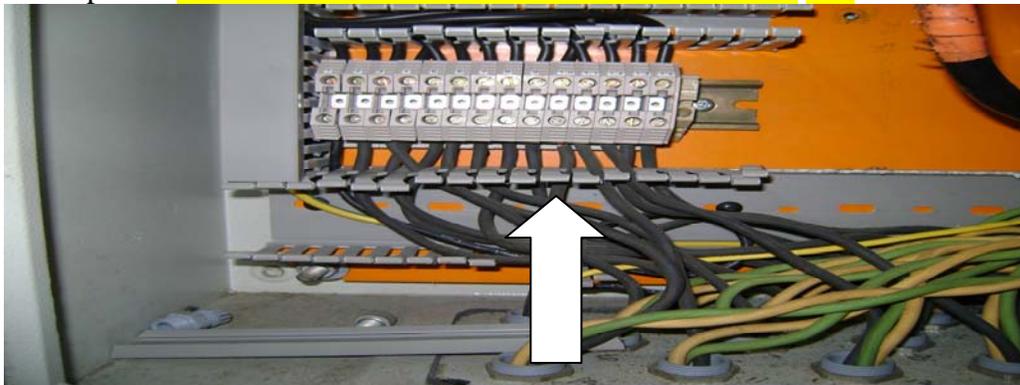
Description: CAB 122 WINDER WIRE OR CONNECTION #10

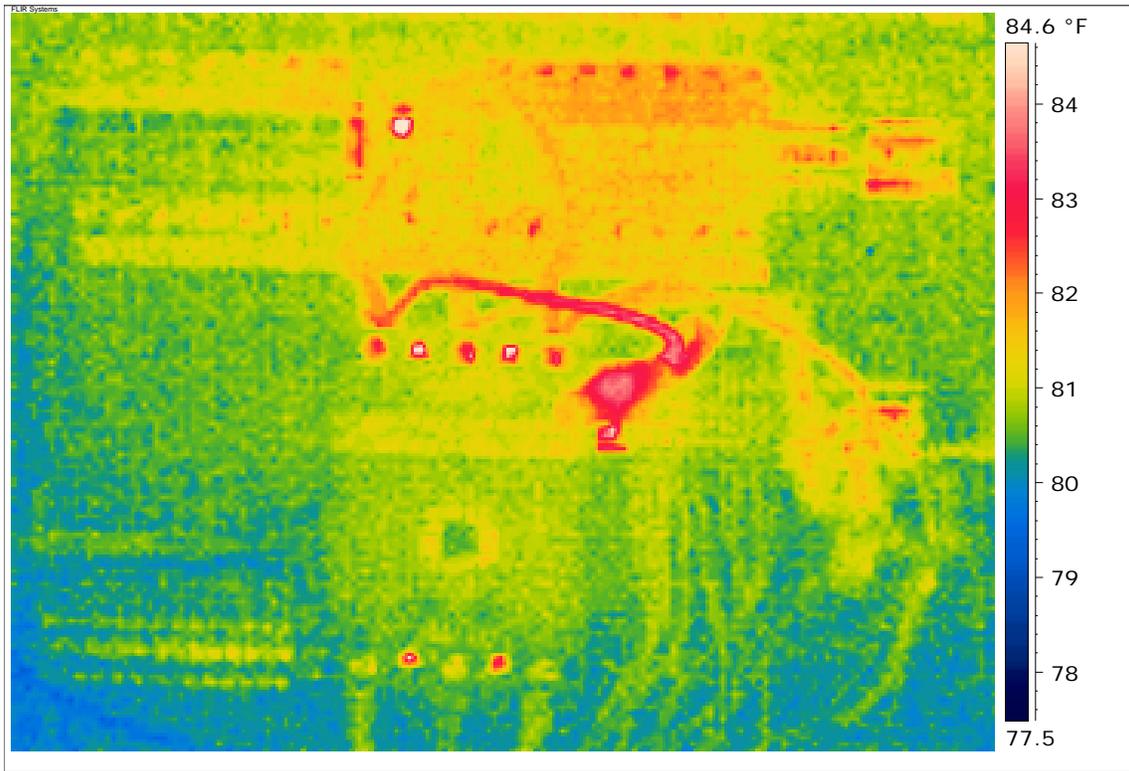
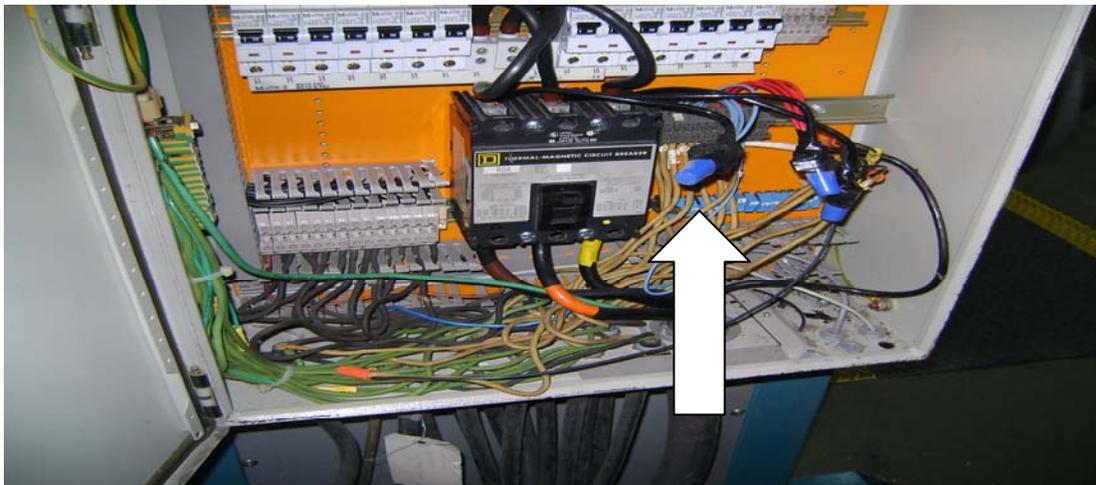
Description: CAB 222 WINDER WIRE NUT CONNECTION
